TEST REPORT EU FACADE TEST 4

| Product name: | EU facade test draft 6 | | |
| File no.: | PGC10028A | Revision no.: | 1 |

Examination of the fire performance of a façade using the large fire exposure.

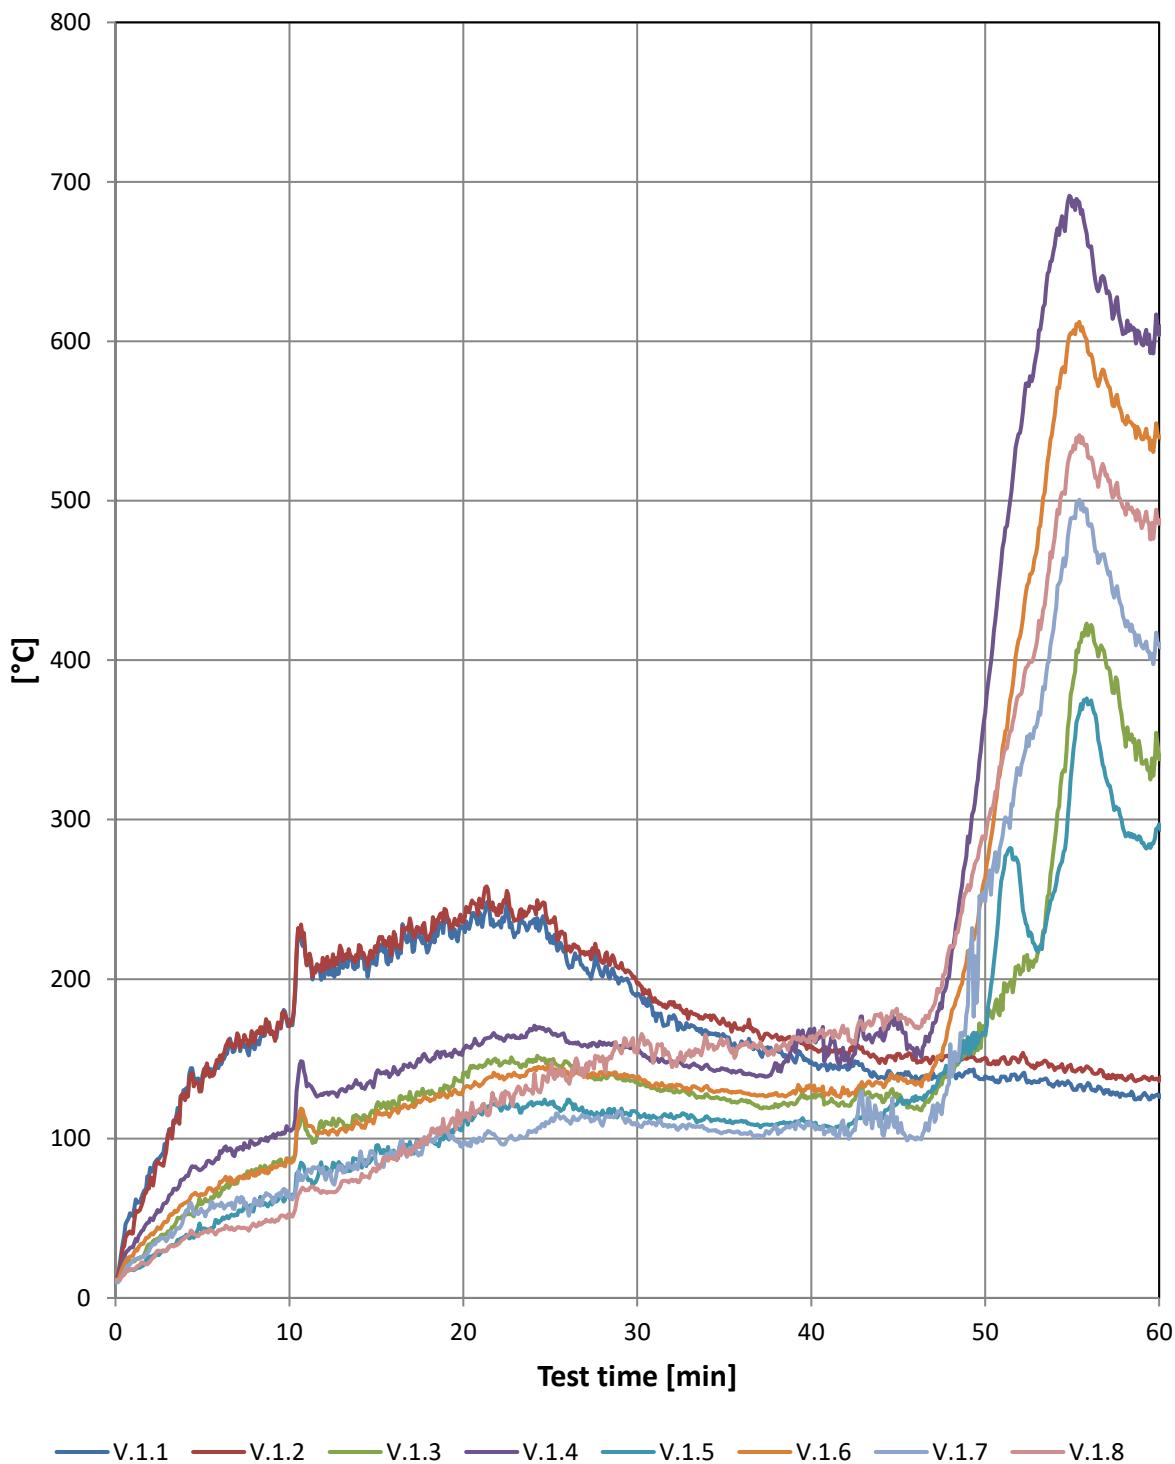
Temperature measured in the ventilated cavity

Temperatures measured after 45 min are not valid, refer to Enclosure 14.0

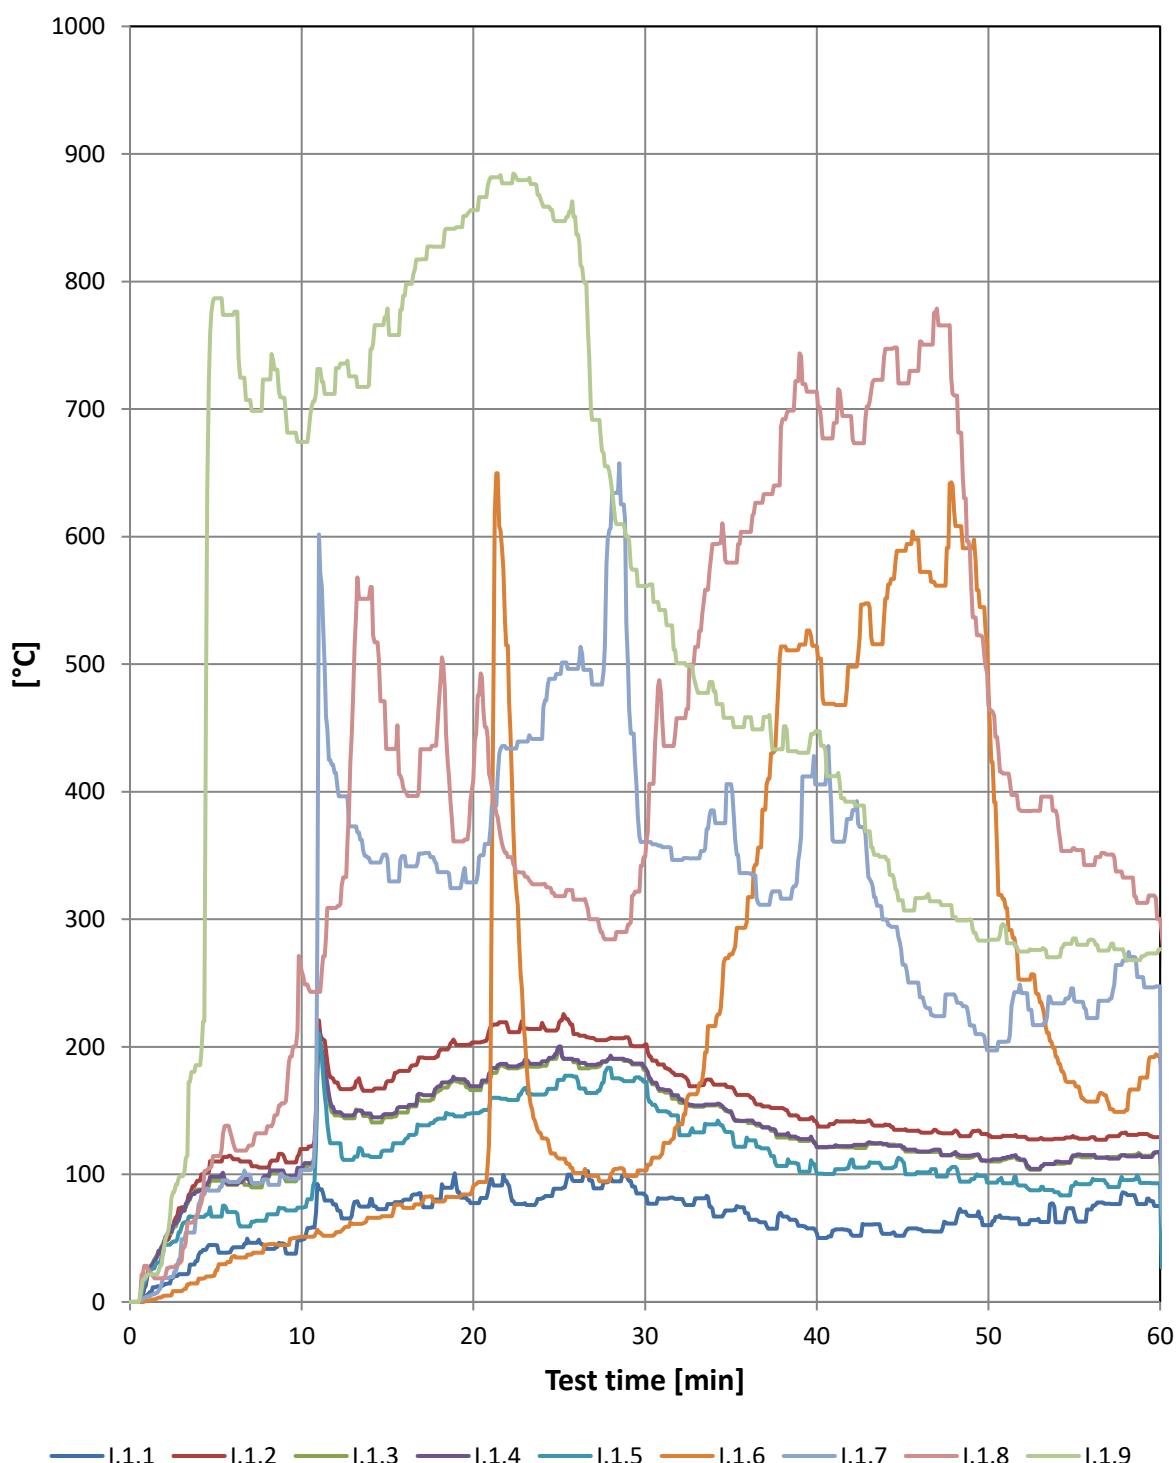
Temperature rise measured according to the standard - 50 mm from facade. Minimum of 30 sec

| Failure [min] | - | - | - | - | - | 21.17 | 10.92 | 13.00 | 4.42 | 4.42 |

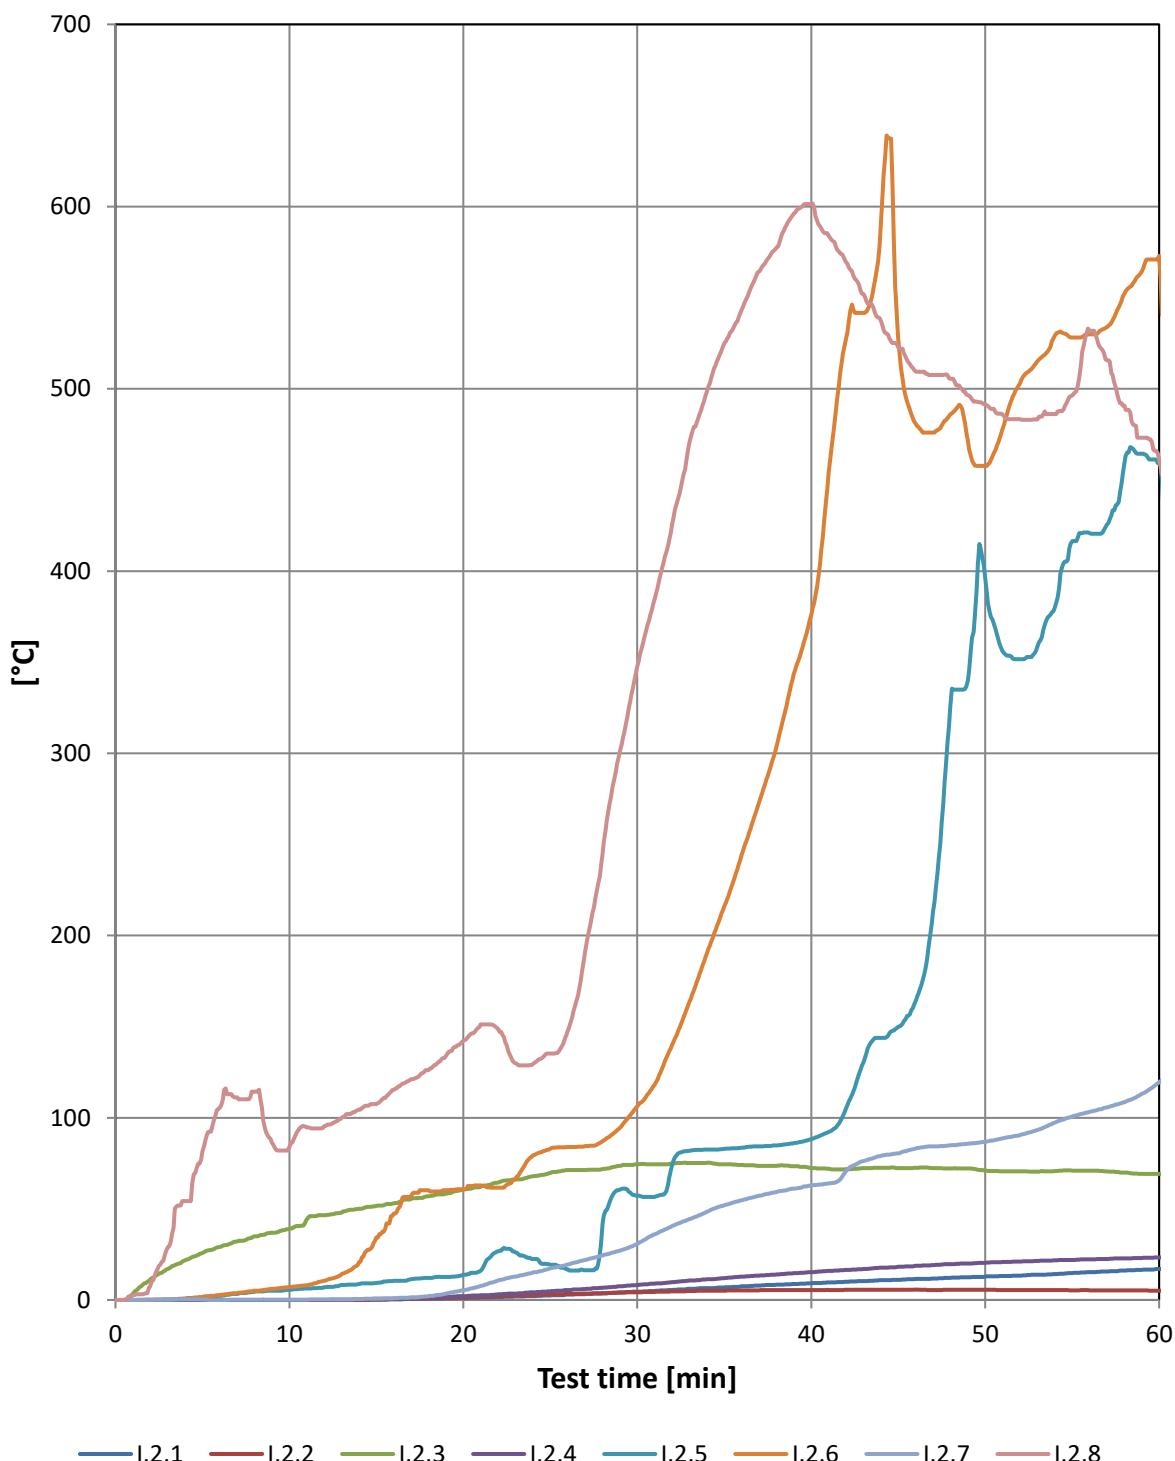
**Temperature rise measured according to the standard - ventilation layer.
Minimum of 30 sec**

| Failure [min] | - | - | - | - | - | 41.50 | - | 34.00 | 34.00 |

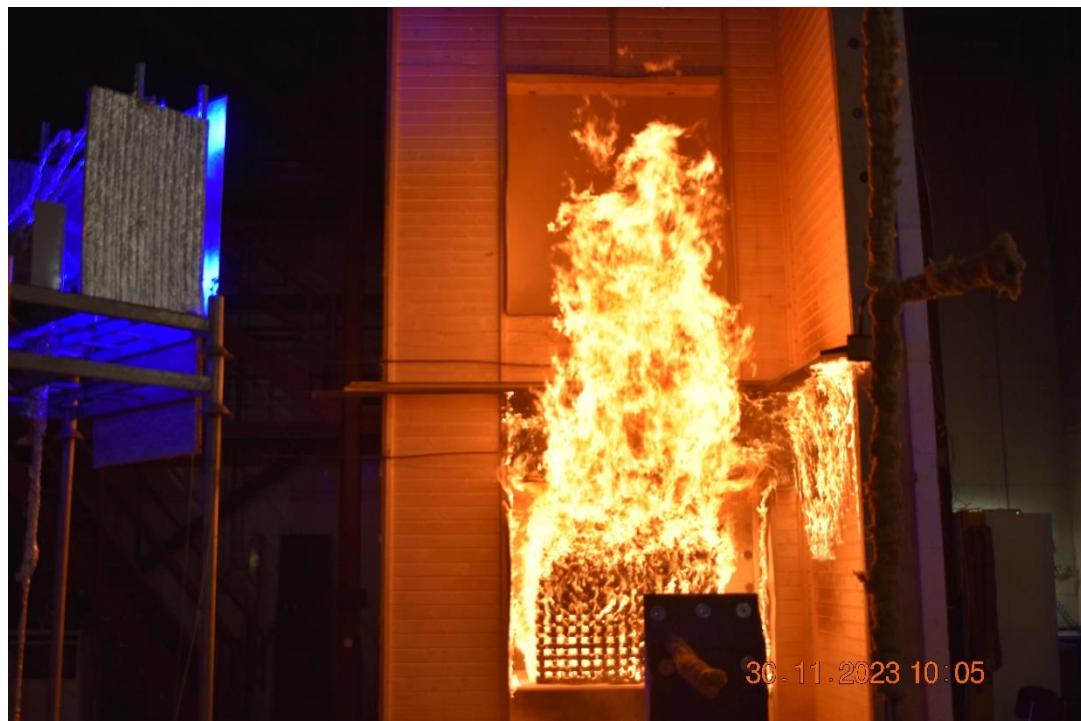
Photo No. 18 Test specimen 4 minutes into the test.

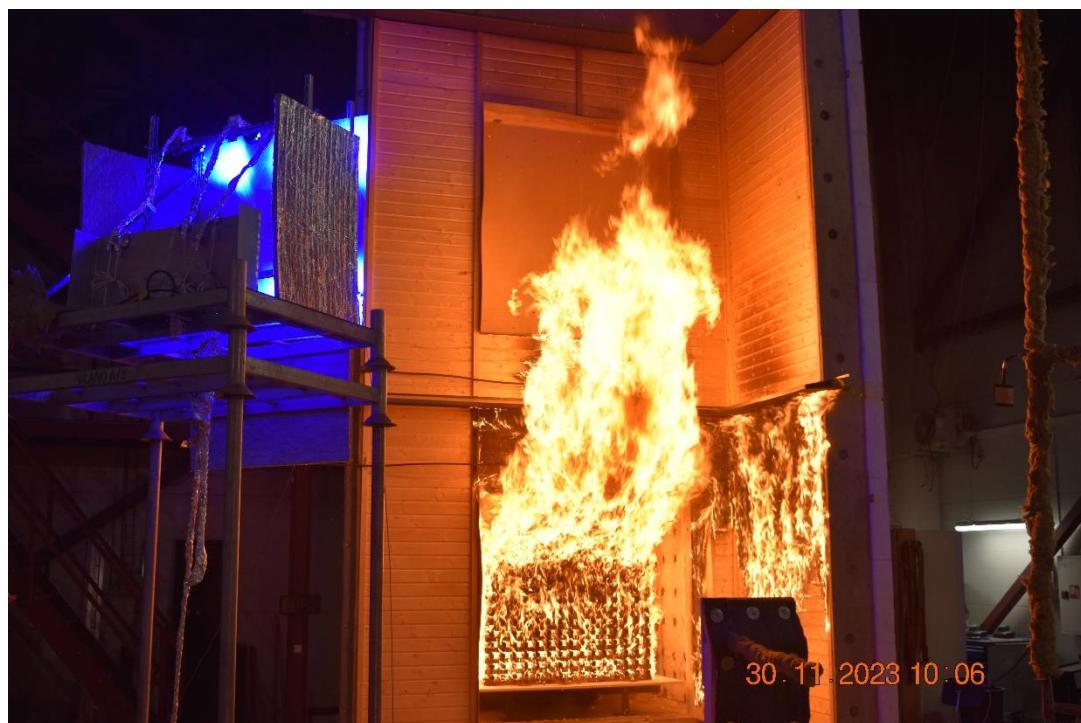
Photo No. 19 Test specimen 5 minutes into the test.

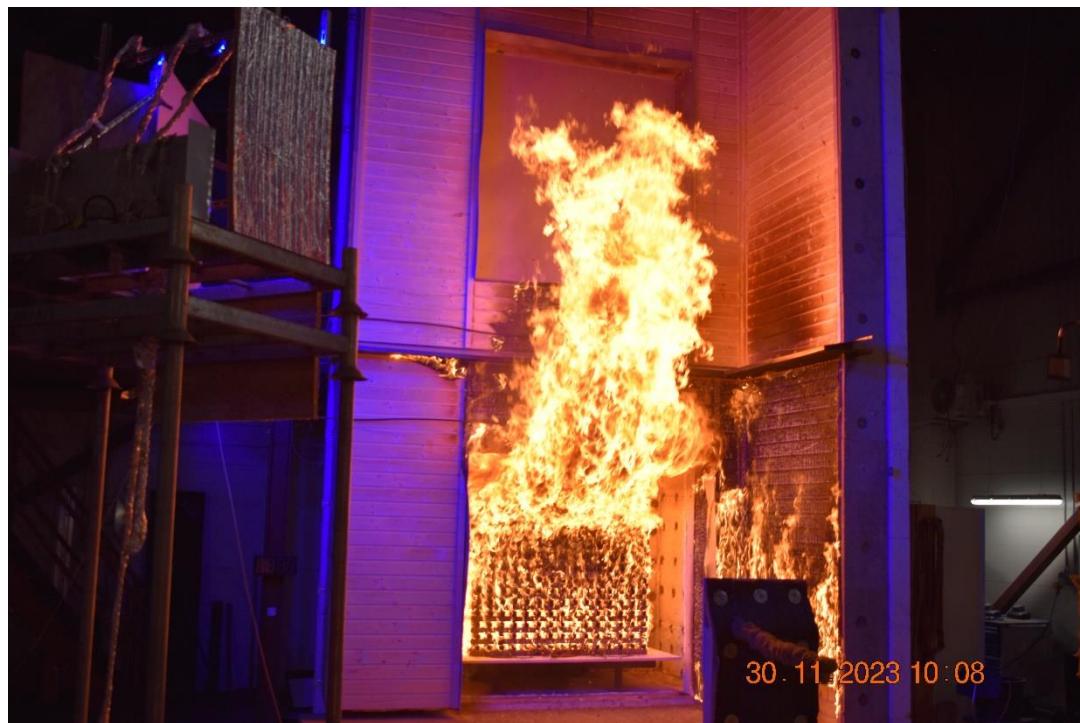
Photo No. 20 Test specimen 6 minutes into the test.

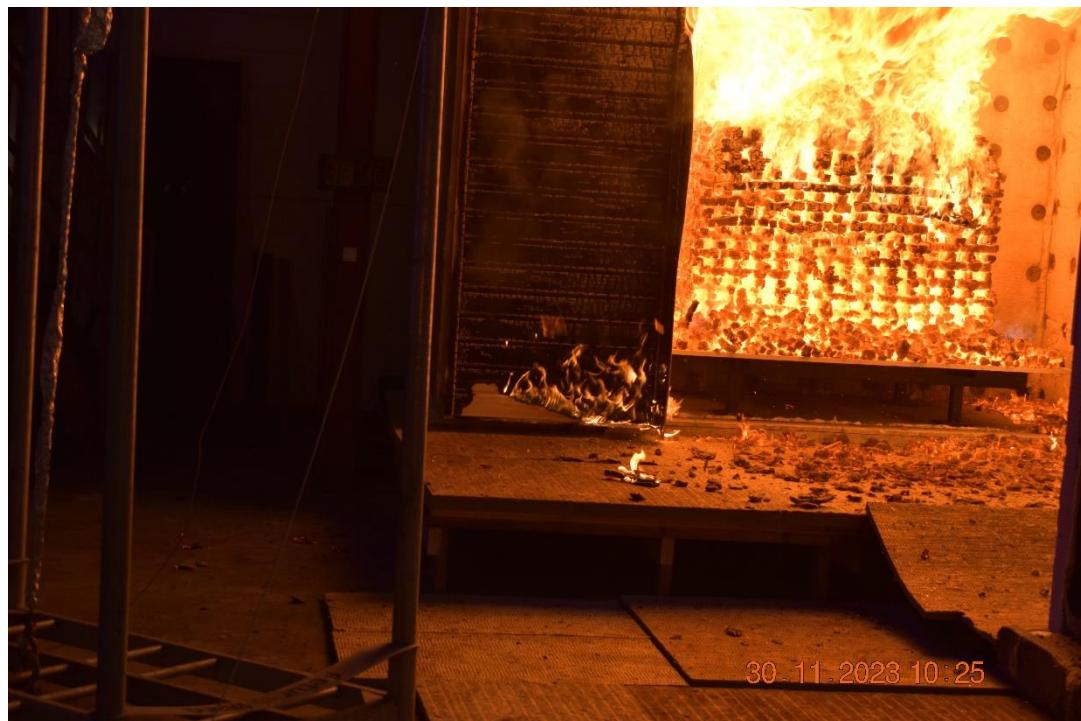
Photo No. 24 Test specimen 21 minutes into the test.

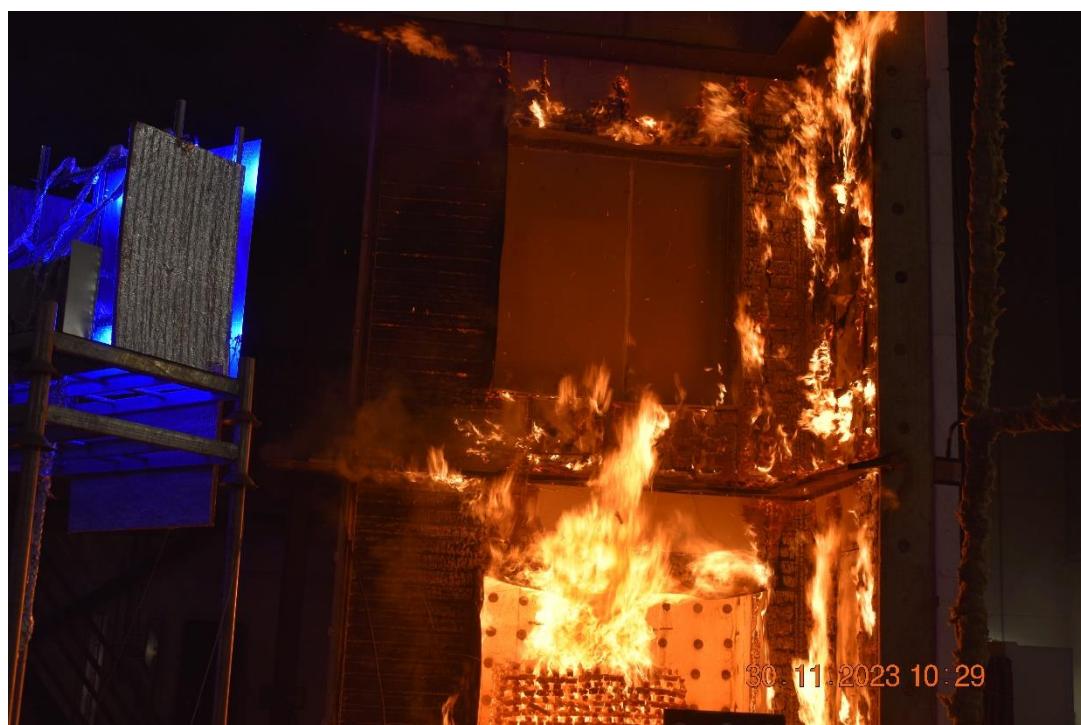
| 25 | Pieces dropped on the floor and continue burning |

| Performance | Criterion | Test result |
|---|---|---|
| | Burning parts | 25 minutes |

Photo No. 25 Test specimen 25 minutes into the test.

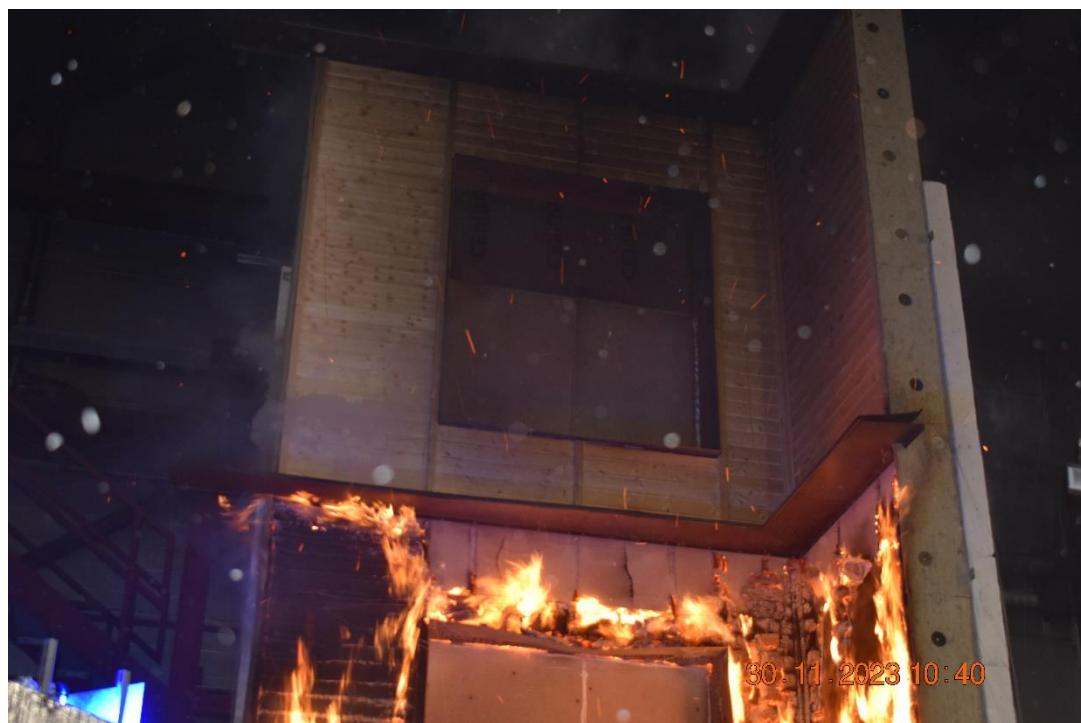
Photo No. 27 Test specimen 36 minutes into the test.

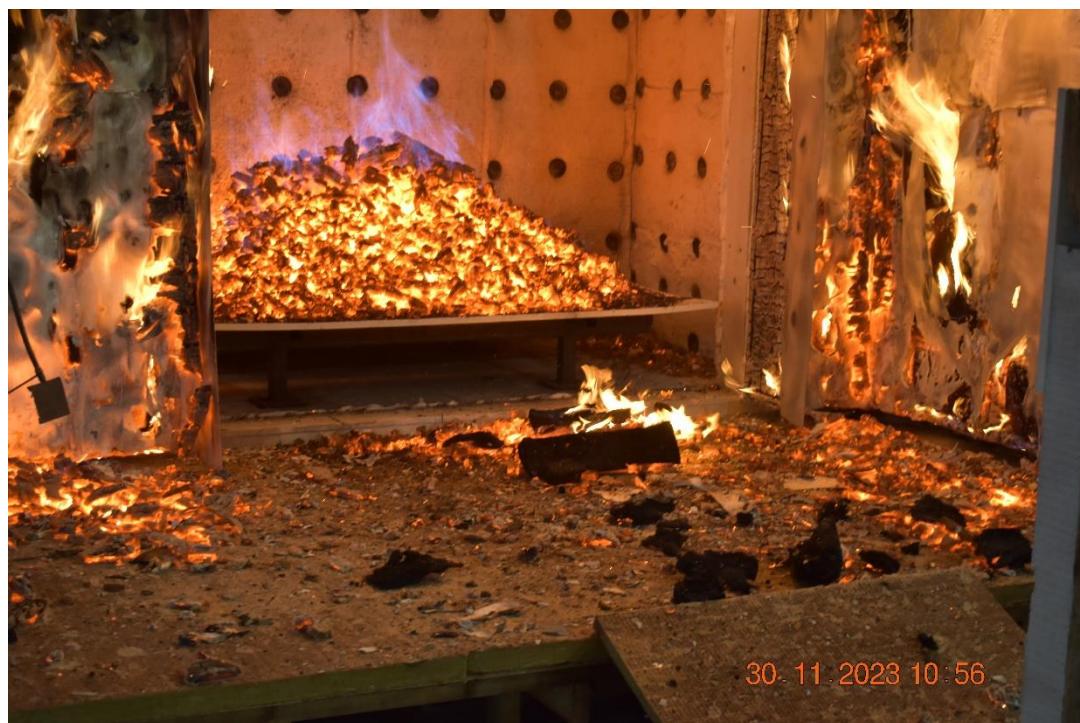
| 43 | The wind breaker between first and second flame deflector on the wing façade start burning |

Photo No. 29 Test specimen 43 minutes into the test.

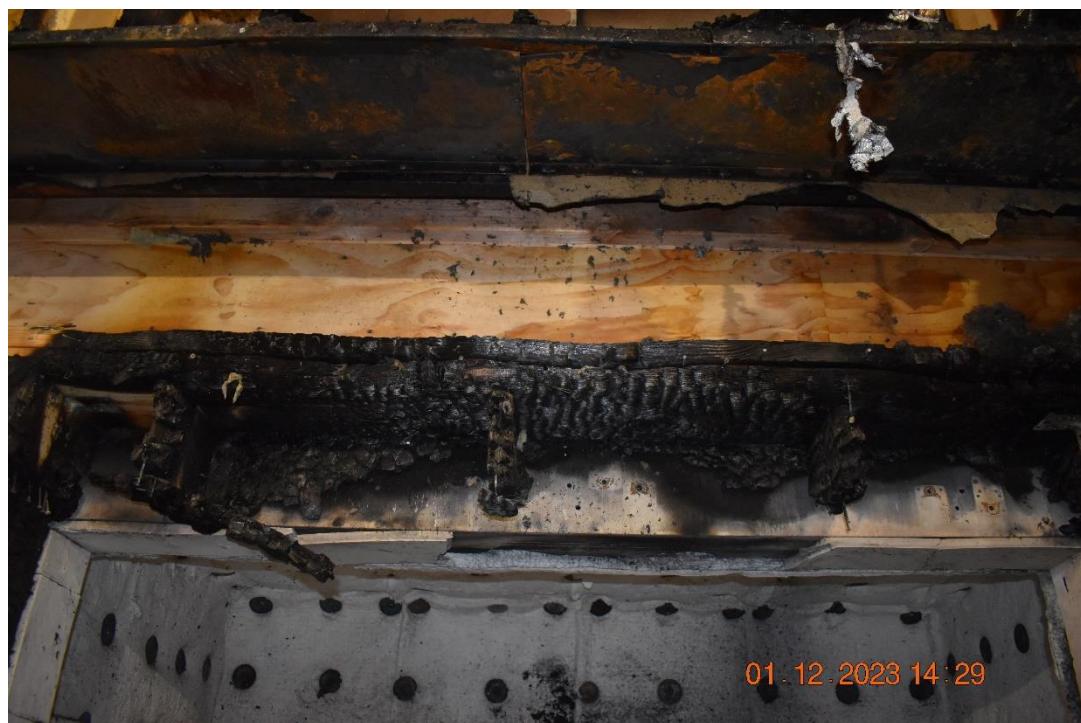
Photo No. 31 Test specimen after the test.

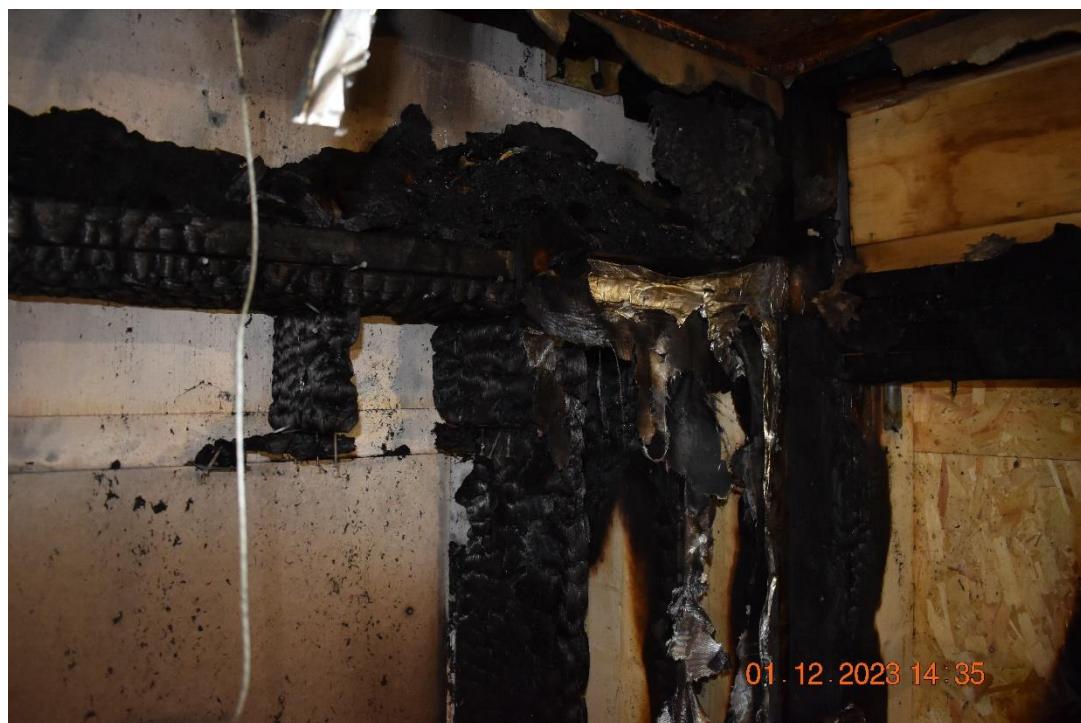
Photo No. 35 Test specimen after the test. Cassette between the fire chamber and the first window.

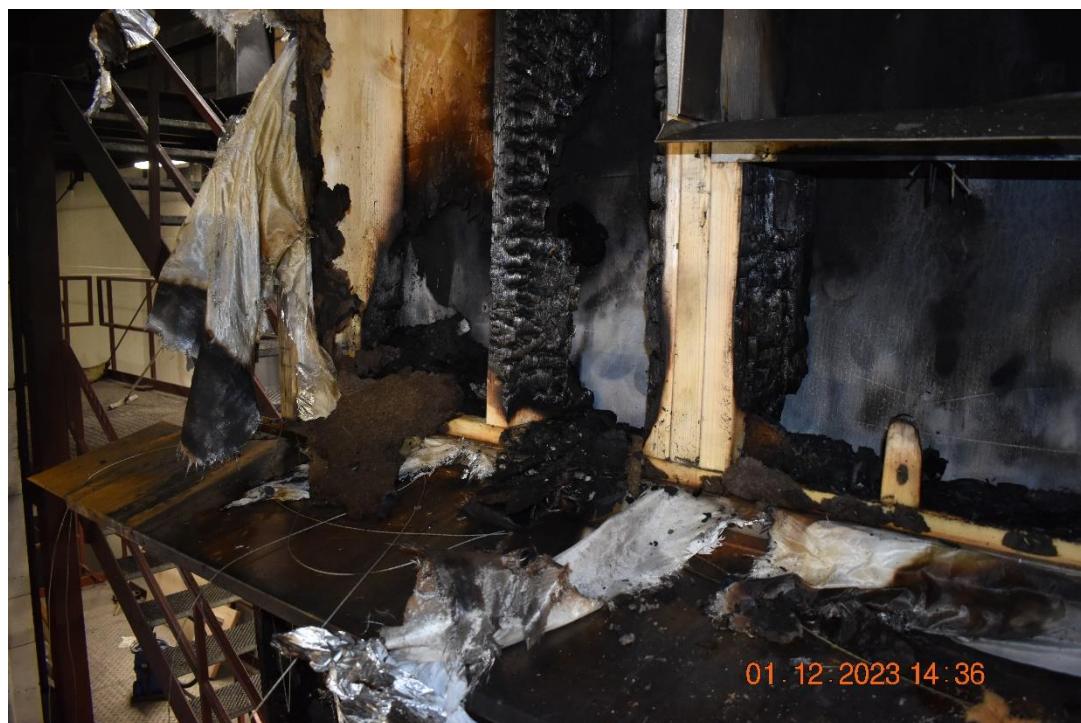
Photo No. 37 Test specimen after the test. Cassette between the first window and second flame deflector.
