# FIRE BEHAVIOUR OF WOOD-CLAD FACADES

TECHNICAL REPORT

Project name		BioFacades: UpHigh. Fire behaviour of wood-clad facades.	
Document ID (filename)		DBI Report wood clad facades.pdf	
DBI project lead:		Mia Fossing Frederiksen <i>mff@dbigroup.dk</i>	
Prepared by:		K. Livkiss <i>kal@dbigroup.dk</i> P. Sudhoff <i>pas@dbigroup.dk</i> G. Zhao <i>gzh@dbigroup.dk</i>	
Revised and commented by:		Helene Mai Anisimov, Magnus Emanuel, Asmus Haastrup, Brian V. Jensen, Christen Kjer-Hansen, Thomas Lindner Nielsen, Mads Møllgren, Niklas Overgaard, Carsten Strüwing Hansen, Emil Thorup, Thomas Mark Venås	
Version	Date	Initials	Changes
1	01-11-2025		First version

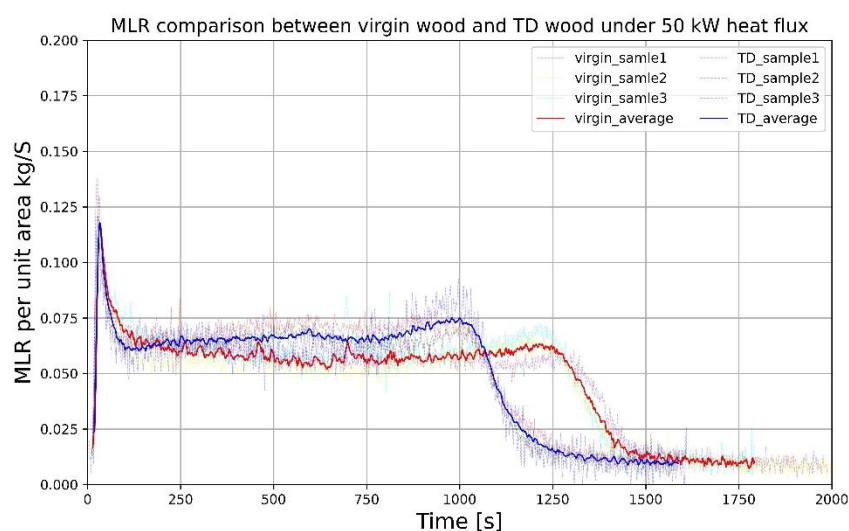
Figure 3: Comparison of mass loss rates between virgin (red) and thermally treated (blue) Scots pine under 50 kW/m<sup>2</sup> heat flux in cone calorimeter tests conducted at DBI.

In a different study, cone calorimeter tests were conducted at DBI using Scots pine wood also used as façade material in the Biofacades:UpHigh project. Both thermally treated and virgin (untreated) wood samples were tested at a heat flux of 25 and 50 kW/m<sup>2</sup> (sample thickness of 22 mm). As shown in Figures 2 and 3, the time to ignition at both heat flux levels is very similar between the two types of wood. Although the average peak mass loss rate for the thermally treated wood is higher than that of the virgin wood, one of the virgin wood tests exhibited a peak mass loss rate exceeding the average peak of the thermally treated samples. Therefore, it is difficult to draw a definitive conclusion regarding which wood type has a consistently higher peak mass loss rate. In the mass loss rate curves, the second peak appears earlier and persists longer in the virgin wood samples compared to the thermally treated ones. This secondary peak is typically attributed to thermal feedback when the heat wave reaches the lower part of the sample. The observed differences are likely due to variations in the thermal inertia between the two material types.

untreated raw pine wood had a density of  $490 \text{ kg/m}^3$ . The moisture content was around 4% for thermal-D wood after 48 h in the conditioning room. For comparison, typical moisture content in construction-grade untreated softwood is about 8-12% but can reach up to 20% in unconditioned or freshly sawn timber. This aligns with the general rule of thumb that ThermoWood has approximately 50% lower moisture content than untreated wood under similar environmental conditions. For comparison the density and moisture content for the BioFacades:UpHigh tests are given in the individual test reports (measured density was  $441.5 \pm 49.5 \text{ kg/m}^3$  for thermally treated pine and  $470 \text{ kg/m}^3$  for non-thermally treated spruce). The pre-testing results of the mass loss cone calorimeter are previously provided in Figure 2 and Figure 3.

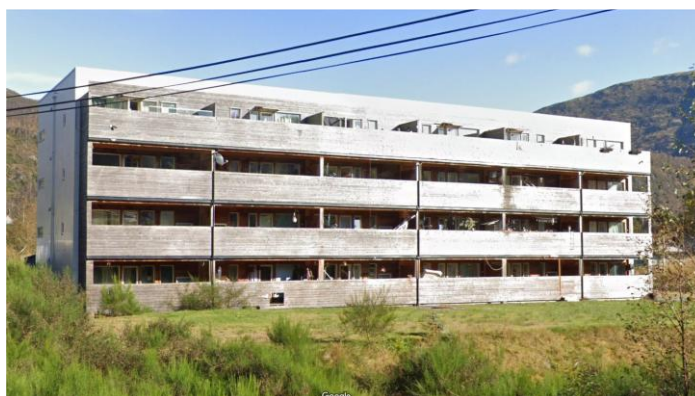
*Figure 7: Wood-cladding balconies on the south side of the building before the fire [18]*

Each apartment featured a balcony on the southwest side of the building, all enclosed by tight-fitted Kebony® balustrades. The partitions between balconies and the cladding on the façade walls were also constructed from the same material. An opening above the partitions separated the balconies on the same floor (see Figure 7). The cladding was also used for the galleries on the northeast side of the building, both on the façade wall and in the dense railings.

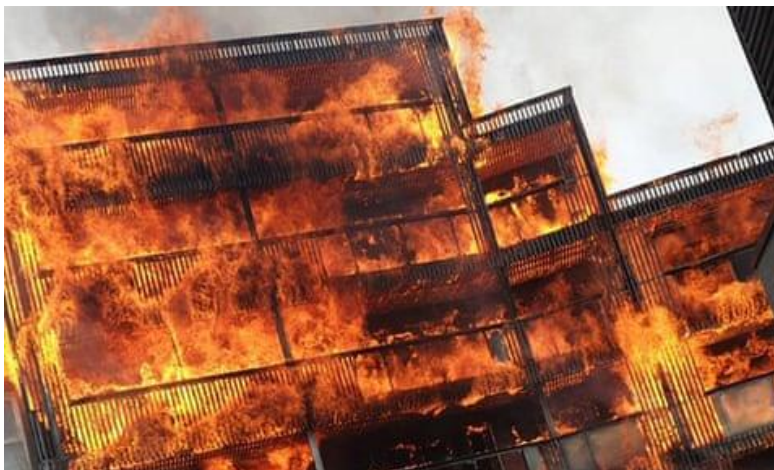
*Figure 9: Barking Riverside fire - Entire section of balconies burning [24]*

that the timber-clad balconies, spanning from the ground floor to the roof, were fully alight (see Figure 9). The incident escalated quickly, and by 15:39, the fire officer on scene requested ten fire engines and an aerial ladder platform to tackle the growing blaze. The fire was brought under control at 18:04 when it was declared “surrounded,” meaning it was contained but not fully extinguished. A final stop message, indicating that the fire had been fully extinguished, was sent at 21:02.

The damage caused by the fire was extensive, particularly to the balconies and external areas of the building. A 20-metre-long section of timber-clad balconies running from the ground floor to the roof was completely destroyed. The fire also caused significant internal damage to several flats. Two flats were utterly destroyed, while another two flats suffered 90% fire damage. Other flats experienced partial destruction, with 30-50% of their interiors damaged. In addition to the internal destruction, the fire reached the roof, causing damage in void spaces beneath the weatherproofing layer.

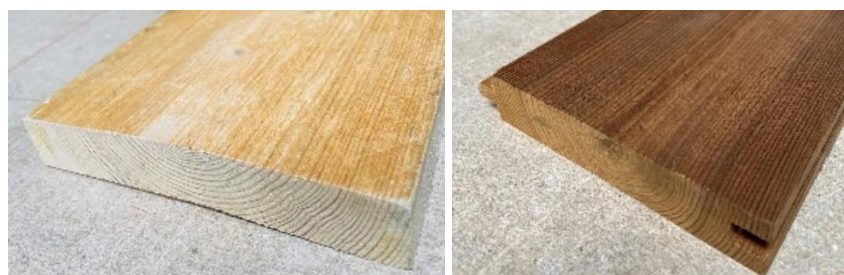
Figure 11: (left) Raw wood of Scots pine, (right) Thermal-D wood.

The thermal D wood, in a 21 mm profile mounted on D-s2, d0 wood battens and A2-s1, d0 gypsum, has been classified with a fire reaction rating of D-s1, d0.

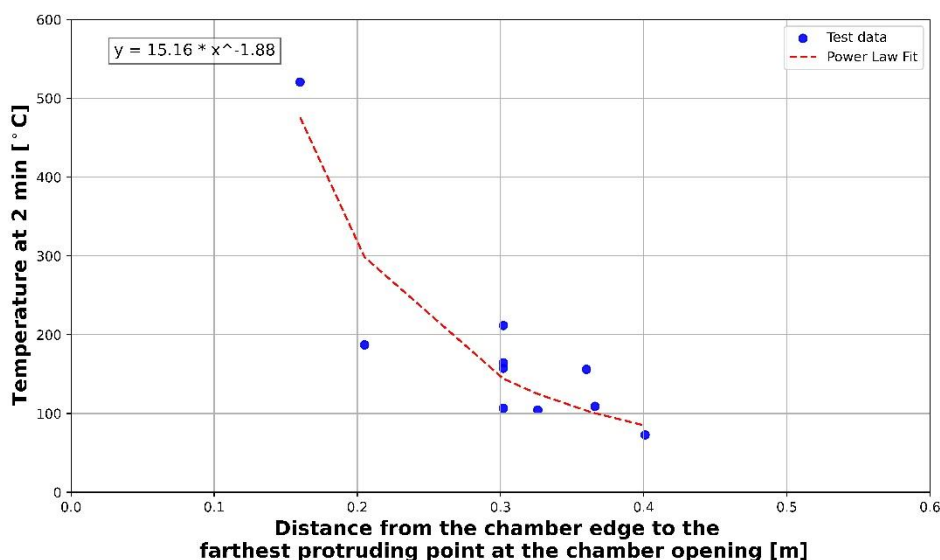
Figure 14: Temperatures on the façade at 2 min right above the chamber.

It is important to note that this relationship applies only to the specific thermocouple location discussed. A larger L1 does not guarantee compliance with test criteria. Rather, L1, together with L2 and L3, should be viewed as critical design parameters that require careful consideration and should not be overlooked in the design process.

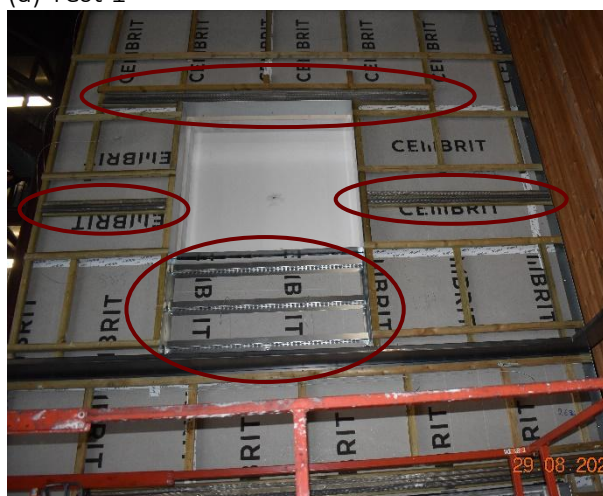
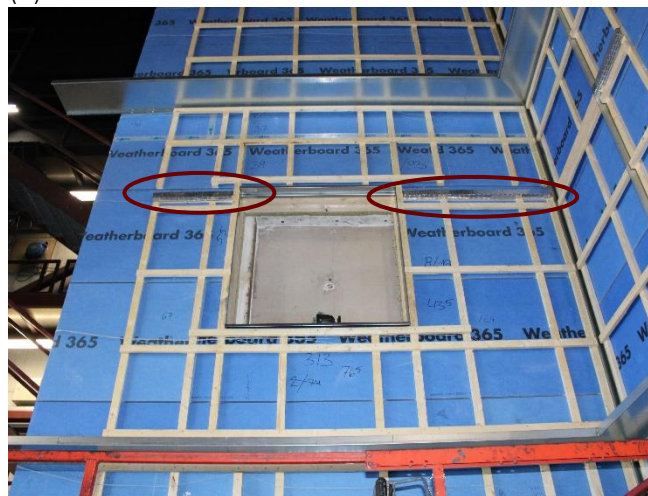
Figure 20: Distribution of the ventilation cavity fire stops in test 1 and test 10

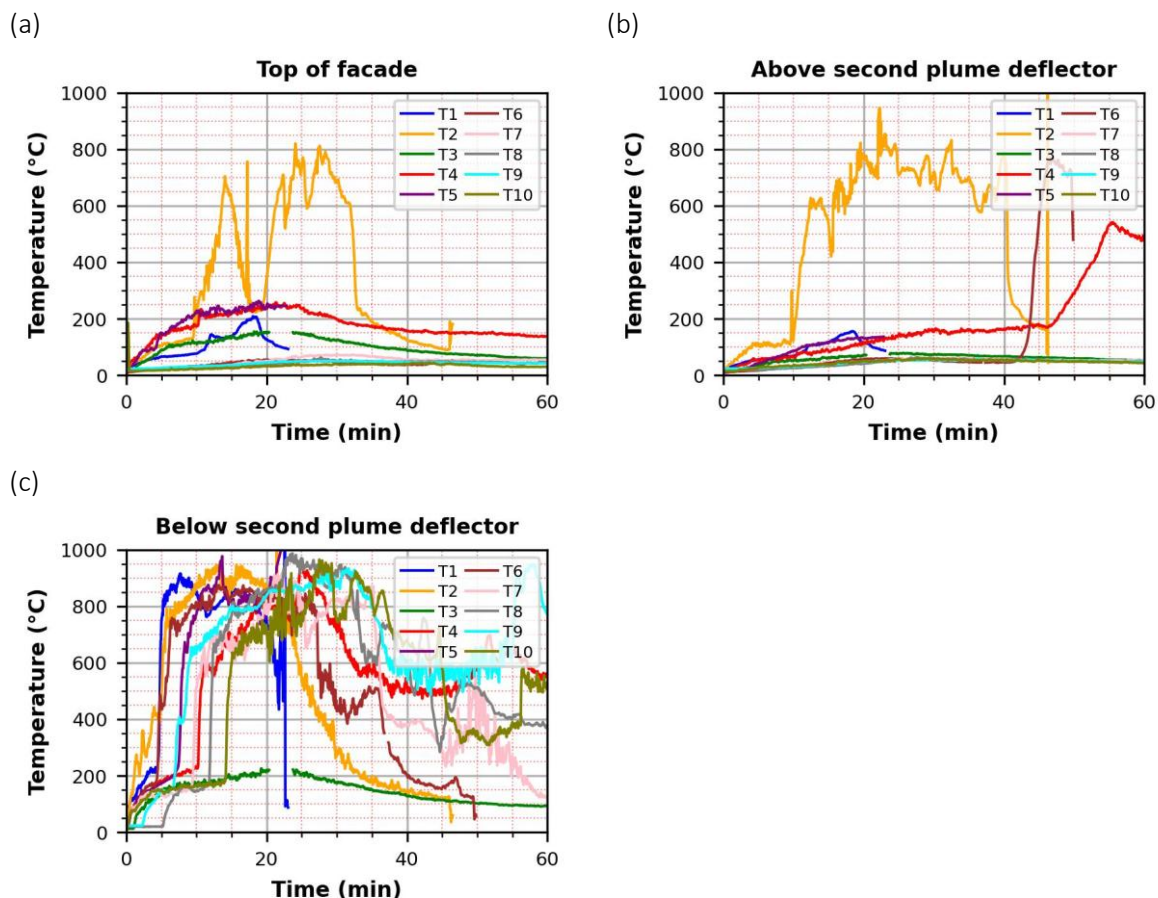
Figure 22: Highest temperatures measured in various locations inside the ventilation cavity (a) top of the façade (second story); (b) top of second plume deflector (second story) (c) below the second plume deflector (first story)

In most of the tests, the temperatures below the second plume deflector (on the first story of the façade), reached levels high enough to be considered as burning. The only exception is Test 3, where the temperatures were below 250°C; however, as can be seen in the individual test report, the ventilation cavity temperatures increased above 700°C in the lower parts of the first floor. The intensity of external burning in Test 3 was relatively low, and the damaged area was small compared to other tests (see Figure 16). In all other tests, the temperatures below the second plume deflector exceeded 800°C, indicating the presence of flames at some point during the test. In Test 10, a sharp temperature rise, indicating flame spread, was observed later compared to other tests (at approximately 16 minutes). This may be attributed to the strategic distribution of cavity fire stops, although further evidence is required to support this claim.

However, no significant benefit for fire stops is observed in Test 1, indicating that other important factors beyond the mere presence of cavity fire stops are at play. The quantity of the fire stops does not substitute for the quality of the design. Test 1 utilized a large number of fire stops, resulting in negligible effect. In many of the tests, the ventilation cavity temperatures on the first floor rose earlier at the higher positions - below the second plume deflector - compared to lower parts on the same floor. In Test 10 the cavity stops location is elevated to the upper window edge along the entire main wall -so slightly higher compared to Test 1. No cavity barriers were placed below the window opening, as it was deemed to be unnecessary.

On the second floor, the measured temperatures seldom reached those indicating the presence of flames. An exception to this is Test 2, where the cavity temperatures already reached over 600°C at 10 minutes, indicating the presence of flames. In Tests 4 and 6, the cavity temperatures significantly increased in the second half of the test, when the wood crib had already burned out. This indicates the importance of continuing to observe the test specimen also after the burn-out of the crib. It is worth noting that no vertical fire spread fail criteria was reached in Test 4, despite the temperatures rising to around 550°C indicating risk of fire spread.

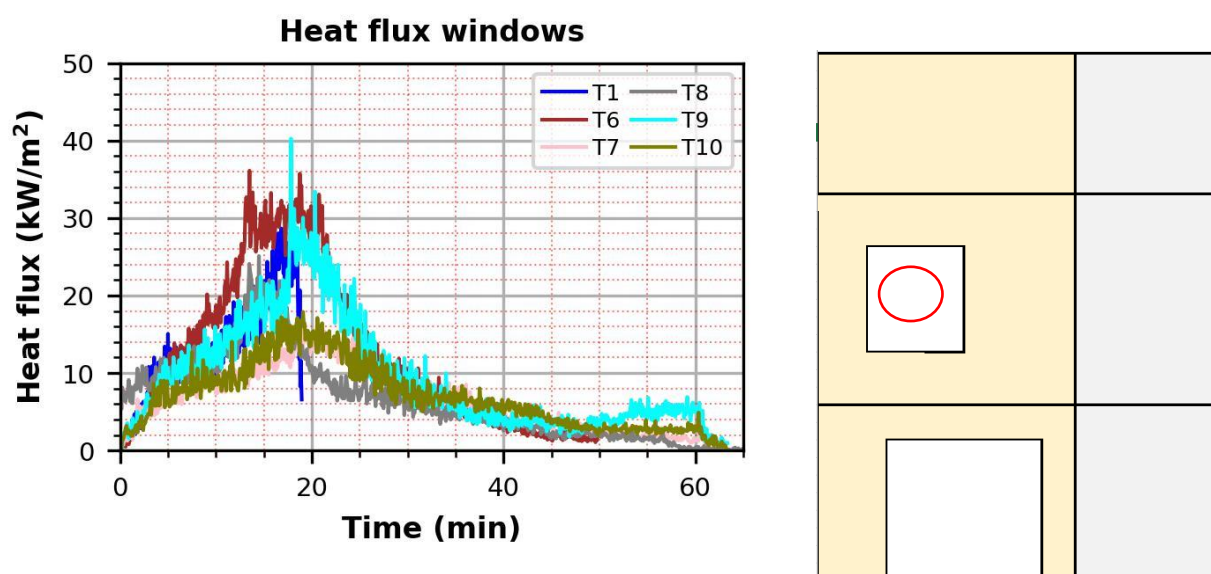
Figure 24: Total heat fluxes measured at the center of the artificial window opening.

The total heat fluxes and the temperatures are presented in the Figure 24. The peak total heat fluxes vary between approximately 20 and 30 kW/m<sup>2</sup> (although instantaneous spikes of up to 40 kW/m<sup>2</sup> are observed), with the lowest values measured in Test 7 and 10. In principle, this heat flux is sufficient to ignite most of the combustible materials at the window level. The individual test reports also contain temperature measurements taken from the heat flux sensors, which are used to check the cooling efficiency achieved with water. The peak temperature observed in all tests was 42°C (Test 10), however, in most tests, the peak temperature was below 35°C.

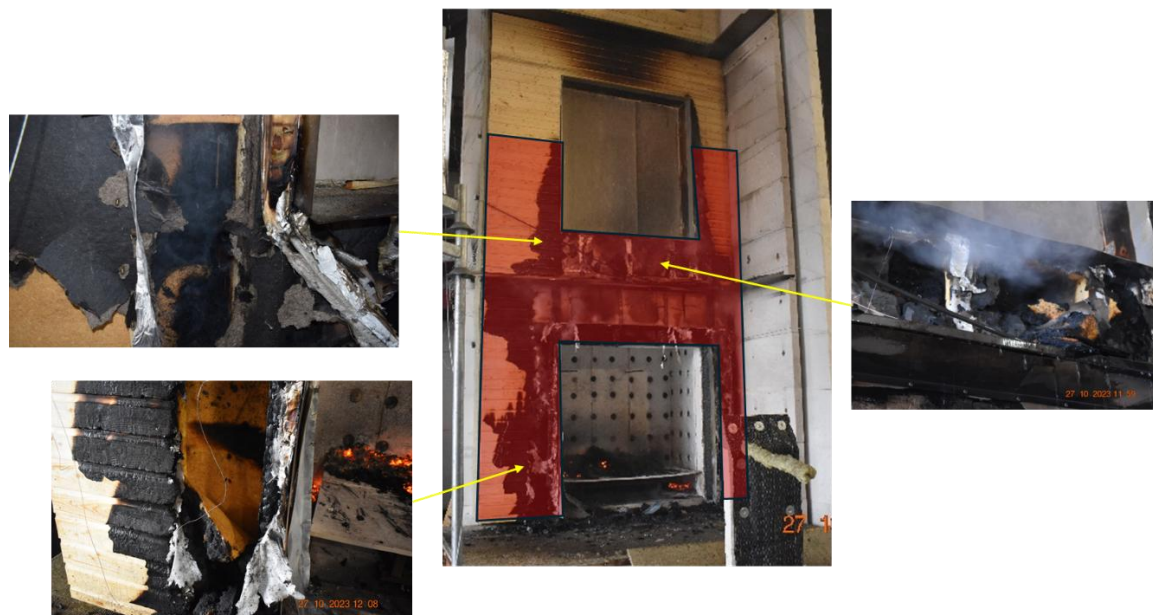
*Figure 26: Areas affected by smoldering insulation (Test 3)*

The results demonstrate that combustible insulation can effectively prevent early burn-through of the façade. Throughout the test, all temperatures behind the insulation remained within the criteria outlined in EN 13501-2, with a maximum temperature rise of 180 K. Different windbreakers were used between the insulation and the ventilation gap. Since temperature measurements behind the windbreaker were not consistently collected across all tests, and the heat exposure levels varied significantly, it is difficult to assess the windbreaker's contribution to fire performance accurately. Generally, a non-combustible windbreaker acts as an additional protective layer, shielding the cassette structure from direct thermal attack. However, in the area approximately 1 meter around the combustion chamber, the fire intensity was extremely high, resulting in burn-through in all tests—regardless of the windbreaker material. Consequently, smouldering was observed in all tests that included bio-based insulation materials.

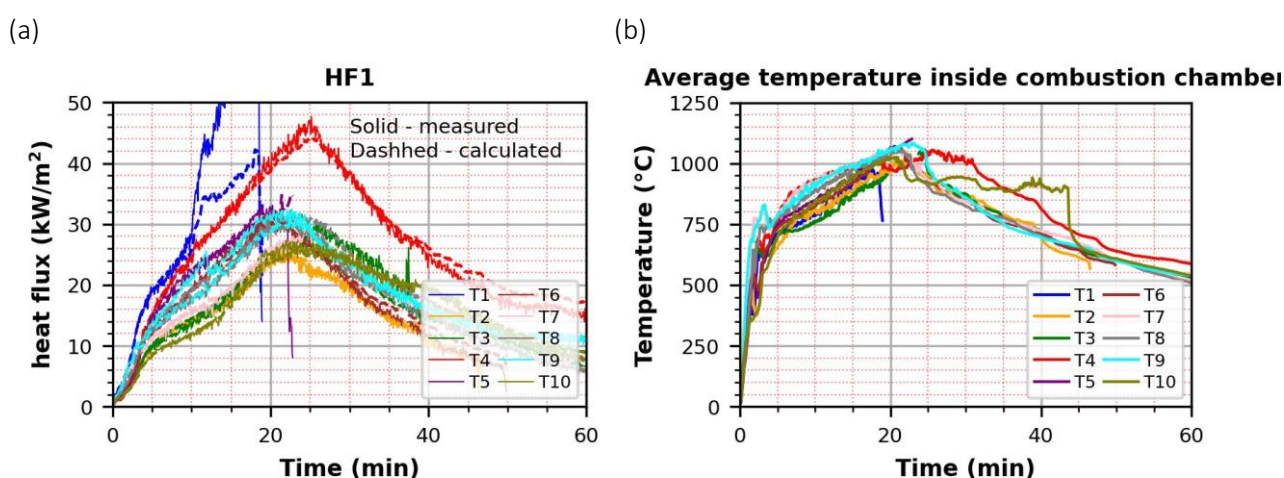
Figure 28: (a) Heat fluxes on the station "HF1". Solid lines show values measured by heat flux sensor and dashed lines show calculated values from plate thermometer measurements (b) temperatures measured inside the combustion chamber

The heat fluxes in position HF 1 are presented in Figure 28 along with the temperature measured inside the combustion chamber. The total heat flux (combined radiation and convection) at a distance of 3 m in front of the façade main wall reached its peak of around 45 kW/m<sup>2</sup> (construction 4). Other tests showed significantly lower heat flux levels, between 25 and 35 kW/m<sup>2</sup>. In test 1, the heat flux was measured 2 m in front of the façade, showing relatively high peak values of about 60 kW/m<sup>2</sup>. Nevertheless, it did not match with the calculations based on plate thermometers and likely can be attributed to technical error during the measurement process. This measurement position HF1 is likely to be little influenced by the burning of the façade itself, but more likely to be directly influenced by the wood crib. As shown by the Figure 28 (b), the chamber temperatures were also one of the highest in Test 4 (along with Test 7 and 9), indicating the influence of the wood crib to the measurements.

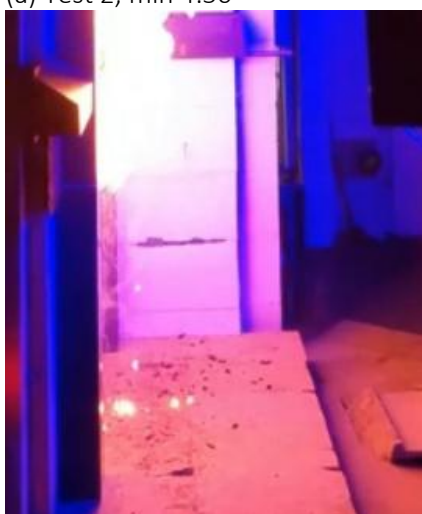
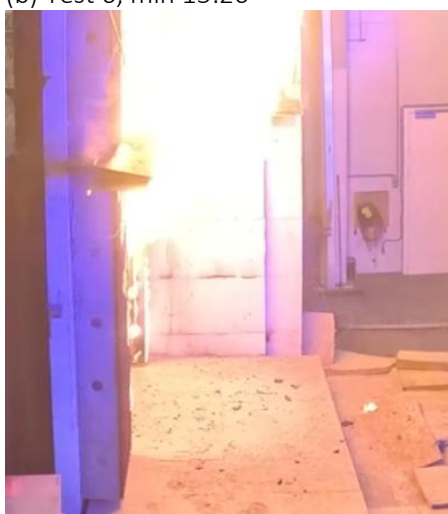
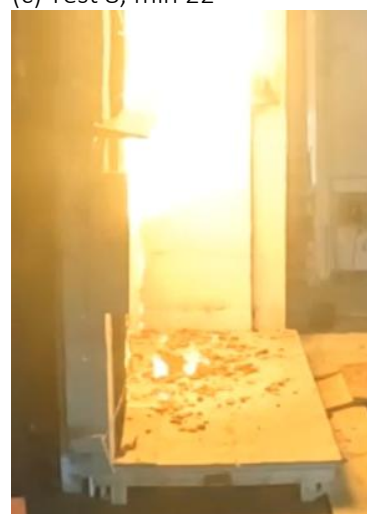
Figure 31: Formation of burning parts at the base of the façade rig

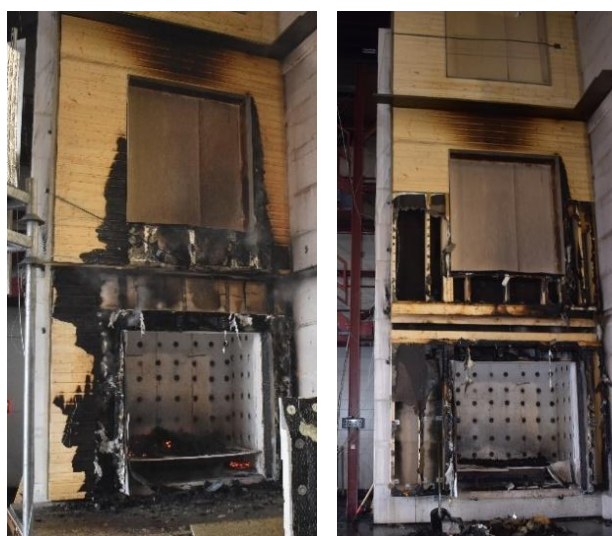
Figure 35: Charred areas after test (left) and dismantled areas, where smoldering was observed (right) in Test 3

The use of combustible insulation, such as a windbreaker or cavity insulation in exterior walls, can facilitate smouldering fires, posing an additional challenge to firefighting efforts. Accessibility, detection, and opening the construction are key factors in controlling and extinguishing cavity fires. The results of the BioFacades: UpHigh project showed that smouldering of combustible insulation occurred mainly in the initial phase in areas where the cladding exhibited significant charring (see Figure 35). Additionally, detection tools such as infrared (IR) cameras and carbon monoxide monitors can be utilized to detect cavity fires more effectively.

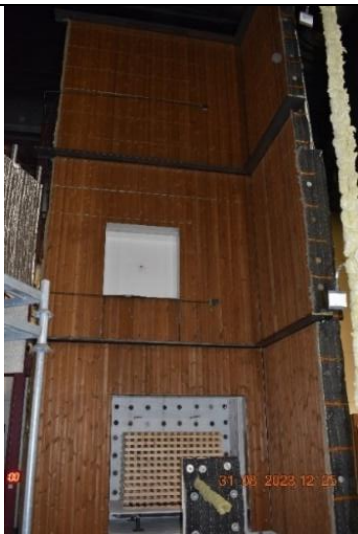
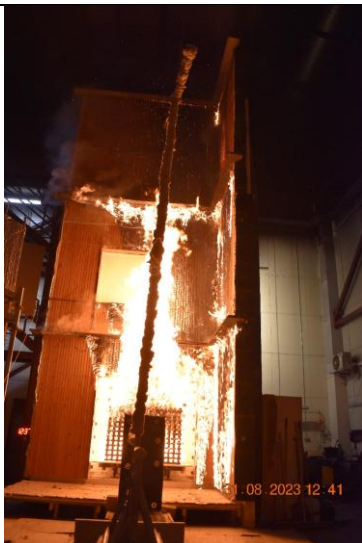
No	Prior the test	After or late stage of the test
Test 1

Table 7 Photos of test specimens prior and after the test and the plume deflector

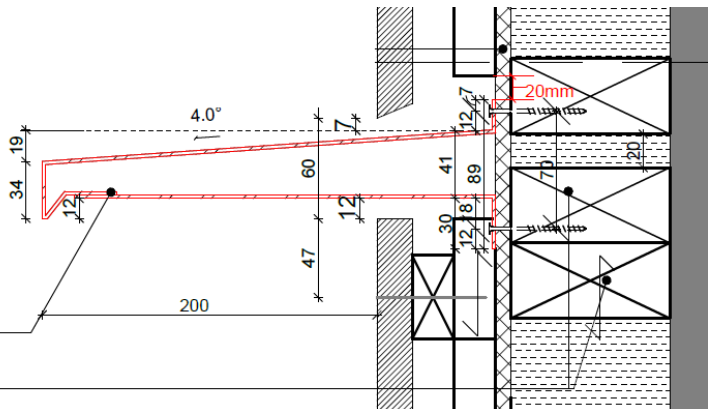
<div> <div> <p><b>Brandskørt</b></p> <ul style="list-style-type: none"> <li>- 2 mm stålprofil</li> <li>- Styrke S235</li> <li>- Hældning 4 grader</li> <li>- Fastgøres med RF Skrue m. borespids, RedHorse CORONA™ RXB 4.8 X 60 #1 TX20 EPDM-9.5B</li> <li>- Top- og bundprofil befæstes med RF Popnitte Gesipa (no. 1433628) 4.0x8.0 mm, A2.</li> </ul> <p><b>Træregel</b></p> <ul style="list-style-type: none"> <li>- Konstruktionstræ C24, 45x95 mm</li> </ul> </div>
