# ORANGERI – TEST REPORT

Written by: Aline Uldry  
[ald@dbigroup.dk](mailto:ald@dbigroup.dk)  
Date: 03-05-2023

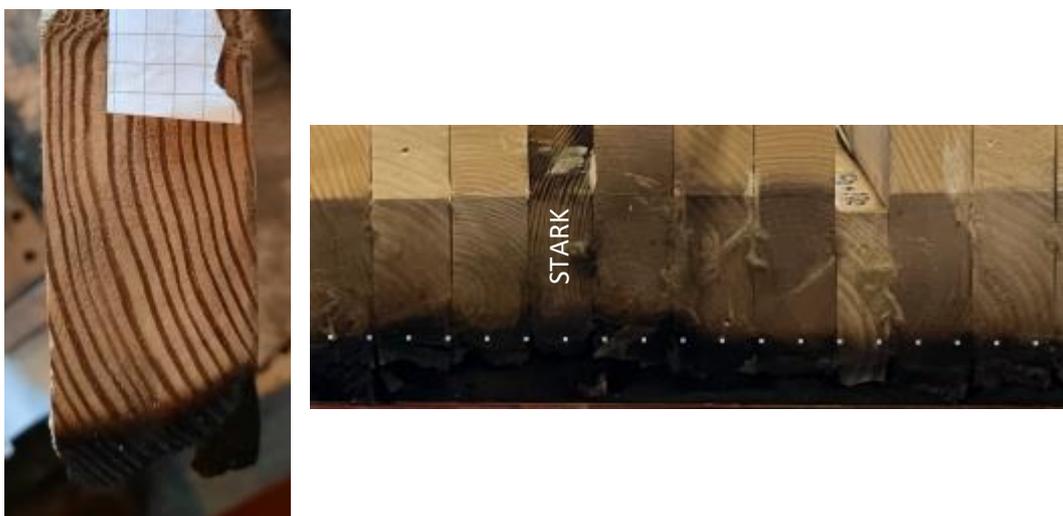
Figure 4 shows the char line for the Stark sample as well as for the whole specimen. The char line on the Stark sample is not even, as would have been expected. One side of the sample is significantly more charred than the other, with a rounding effect. On the whole specimen, the Stark sample also appears more charred, as well as the pieces on either side of it.

If the sample simply had a high charring rate, an even char line would be expected. Thus, those results indicate a probable failure of the specimen, causing excess charring on one side of the Stark sample. This failure could come from a delamination between the Stark sample and the buffer, or from an unexpectedly low-quality buffer which burned faster than expected.

Figure 4. Char line of the Stark sample (left) and char line of whole specimen (right), with the Stark sample highlighted.

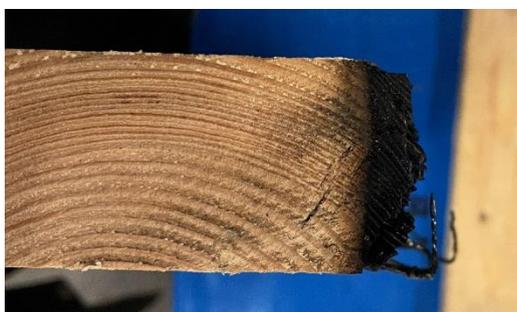
For comparison, Figure 5 shows the char line inside sample M2, which is almost completely flat.

*Figure 5. Cut of sample M2, with a very flat char line.*

In this case, a rounding of the char line on the cross section is expected. Observing Figure 5, the char line of sample M2 is almost completely flat.

This means the difference in charring rate cannot clearly be attributed to the test method. It is concluded that the explanation lies in a combination of imprecise measurements and slightly accelerated charring due to the surrounding wood.
