# TEST REPORT LOADBEARING WALL

<b>Name of sponsor:</b>	Byggefirmaet Logik & Co. A/S		
<b>Product name:</b>	REI60 wall		
<b>File no.:</b>	PGA11985A	<b>Revision no.:</b>	0
<b>Test date:</b>	21-07-2021	<b>Date:</b>	10-08-2021
<b>Pages:</b>	10	<b>Encl.:</b>	40
<b>Ref:</b>	KLK	/ NOL

Examination of the fire-resistance of a load-bearing wall.

EN 1365-1:2012 Fire resistance tests for loadbearing elements — Part 1: Walls

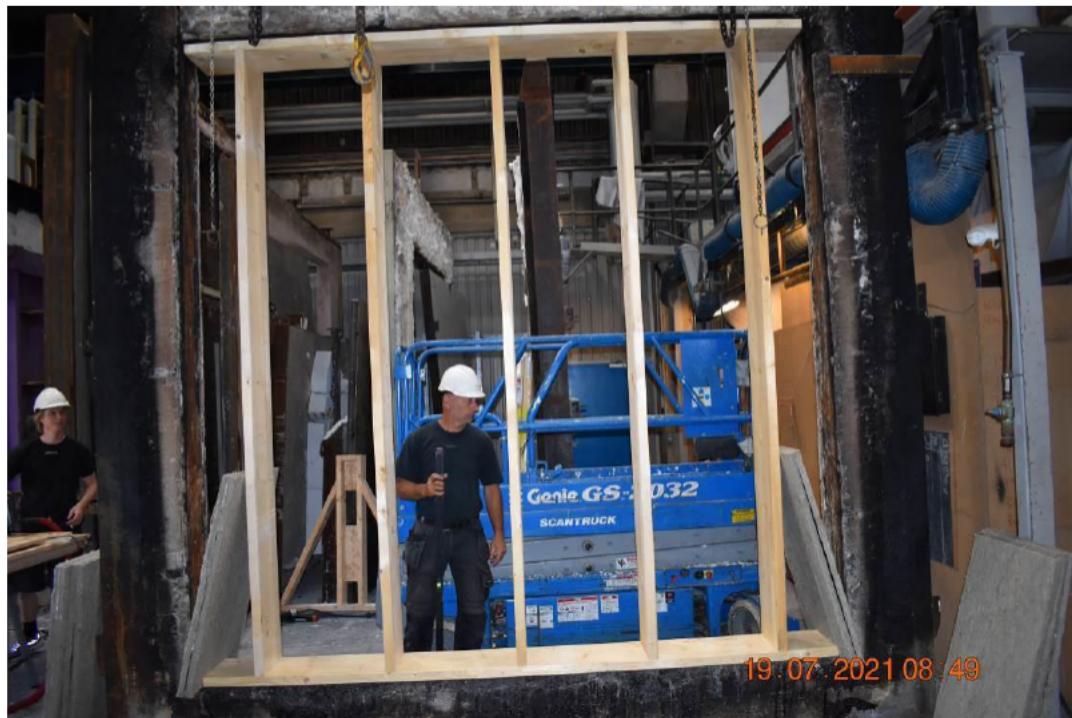
Photo No. 1 Free edge was established along both vertical edges of the test specimen.

A total of 5 load bearing studs were used in the wall construction, all 2910 mm high. The studs are the same material as the top and bottom profiles. The load bearing studs were spaced c/c 600 mm. The first two load bearing studs were fixed 243 mm. away from the DBI-frame edges to avoid edge effects.

Free edge was established along both vertical edges of the test specimen (2 x 25 mm stone wool with alu-foil in each side) to allow for unrestrained deformation of the test specimen.

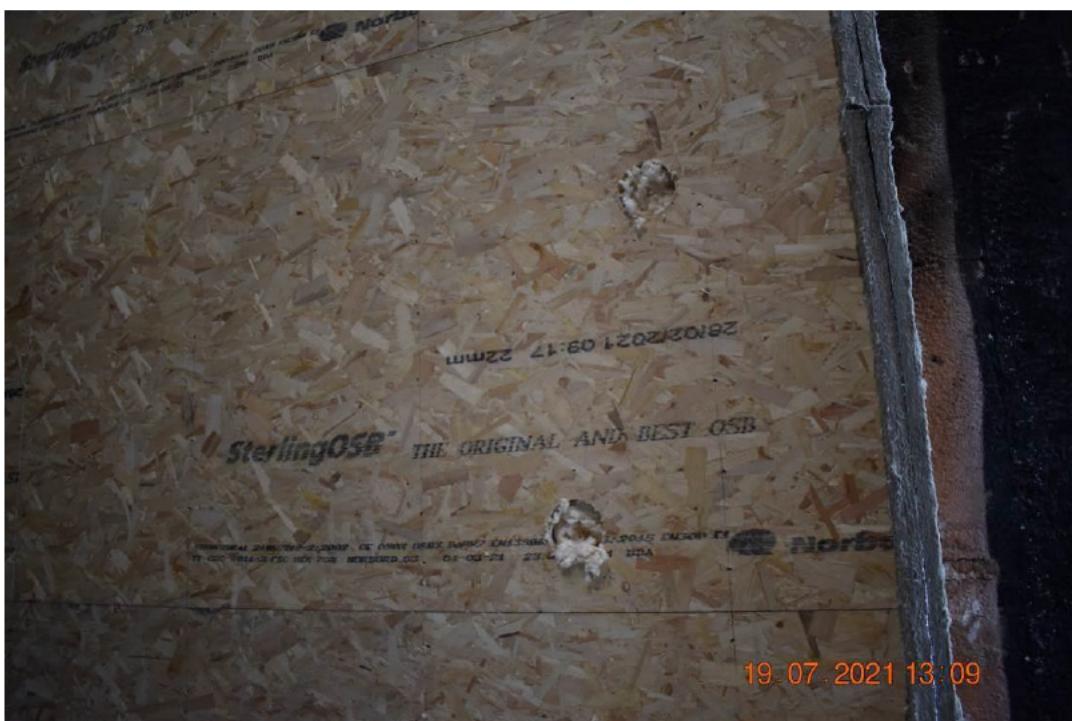
Photo No. 2 Holes in the wall showing the wood fibre insulation between wooden studs.

295 mm thick wood fibre insulation with a nominal density of 43 kg/m<sup>3</sup> designated "Woodfibre AIR" was blown in between the loadbearing studs and top and bottom profiles. The insulation was blown in after the first layers on both sides of the studs were mounted. A hole was drilled in the OSB board approximately 1500 mm from the bottom. After the insulation was completed the wood from the hole was put back into place with designated Gul pro alpha vapor barrier tape.

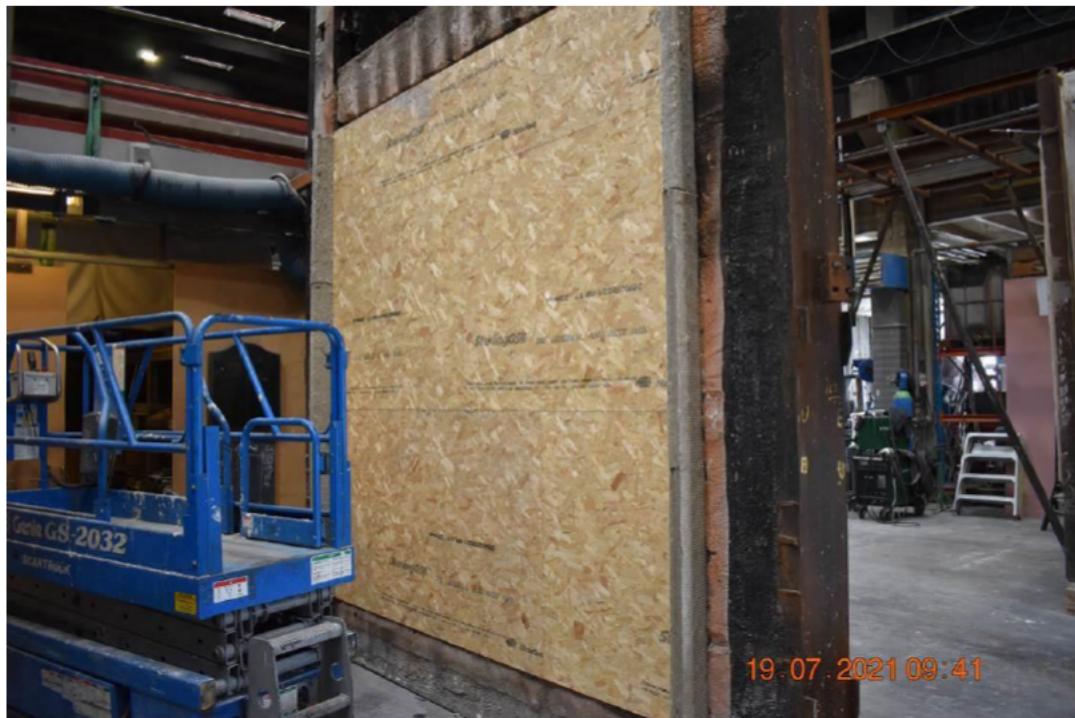
Photo No. 3 Layer of OSB-3 mounted to the studs of the wall on the unexposed side.

**Inner layers (unexposed side)** A 22 mm thick OSB3 board (nominal density 650 kg/m<sup>3</sup>, EN 13986:2004 + A1:2015) was mounted on the unexposed side to the load bearing studs with 2.8 x 75 mm strip nails, designated "TJEP GF Strip Nails 2.8 x 75 mm" at c/c approx. 150 mm. The OSB boards had the maximum dimensions of 2440 x 1220 mm.  
See sponsor drawing no. 2 and photo no. 3.

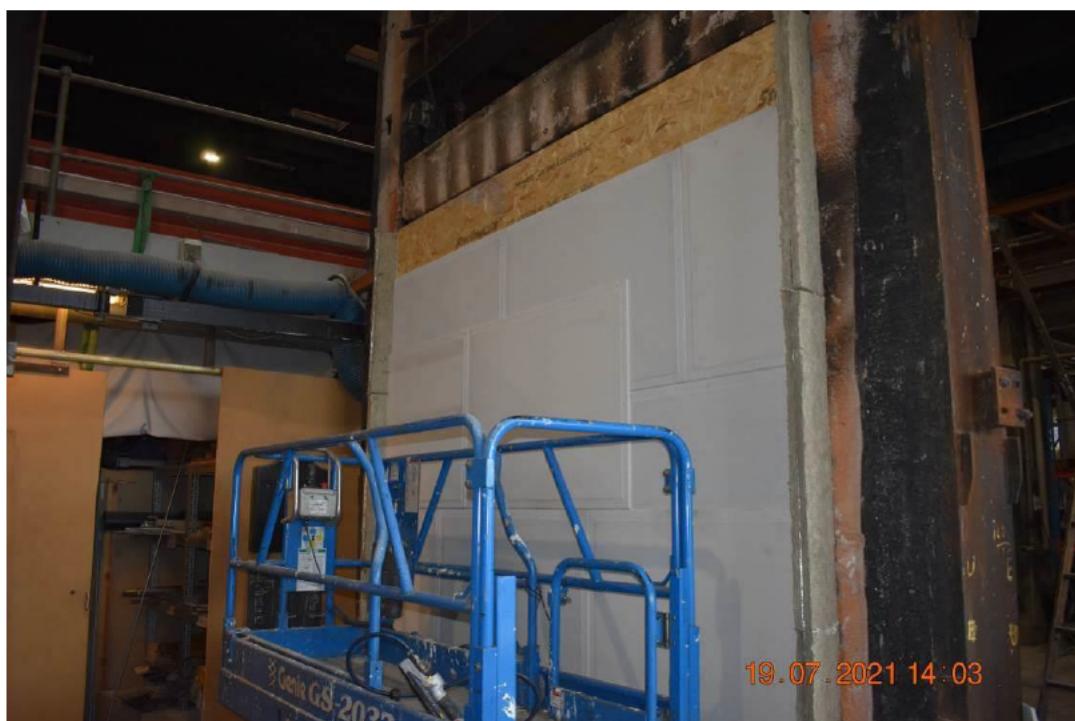
Photo No. 4 Both layers of fibre gypsum boards mounted to the OSB-3 board.

Fibre gypsum boards Two layers of 12.5 mm thick gypsum fibre boards designated "Fermacell Gypsum Fibreboard" (type EN 15283-2, ETA-03/0050) with a nominal density of 1150 kg/m<sup>3</sup> were fixed with designated TJEP PZ 16 Staples 30 mm with glue, galvanized at a c/c of 400 mm through the gypsum board into the 22 mm OSB3 board for the first layer and for the second layer TJEP PZ 16 Staples 50 mm with glue, galvanized at a c/c of 200 mm. The staples were fixed 10 mm from the board edges and 50 mm from the board corners. A full-size board measured 900 x 1200 mm.  
See sponsor drawing no. 4 and photos no. 4 - 5.

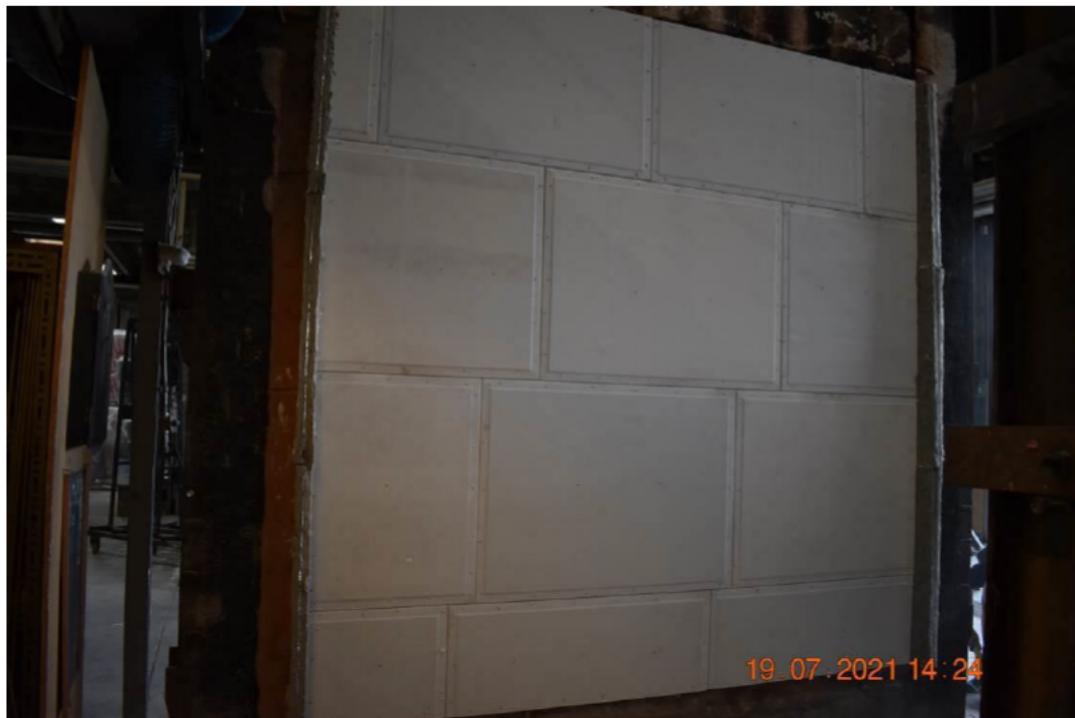
Photo No. 5 Finished layers of the fibre gypsum boards on the unexposed side.

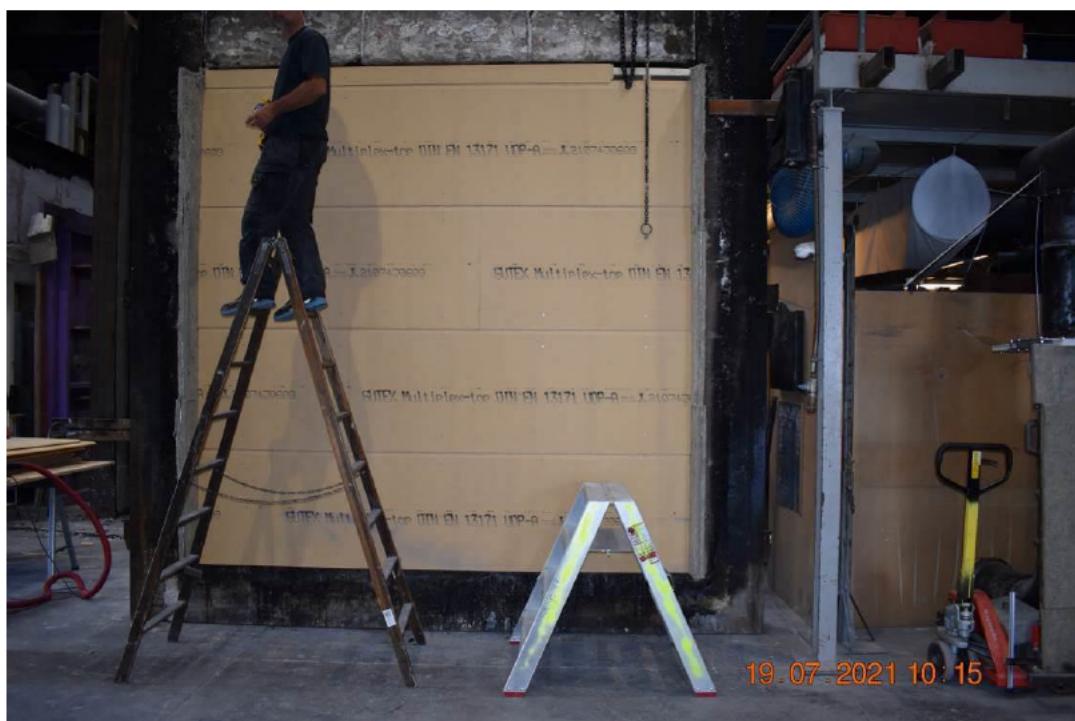
Photo No. 6 Layer of wood fibre board mounted to studs on the exposed side.

**Outer layers (exposed side)** A 22 mm thick Wood fibre board, designated GUTEX Multiplex-top (nominal density 220 kg/m<sup>3</sup>, (type EN 13171:2012 + A1:2015) was mounted to the load bearing studs on the exposed side with chipboard screws designated Eurotech ruspert chipboard ph tx 5.0 x 80 mm with a minimum of 2 screws per stud per board. The wood fibre boards had the maximum dimensions of 750 x 2500 mm.  
See sponsor drawing no. 3 and photo no. 6.

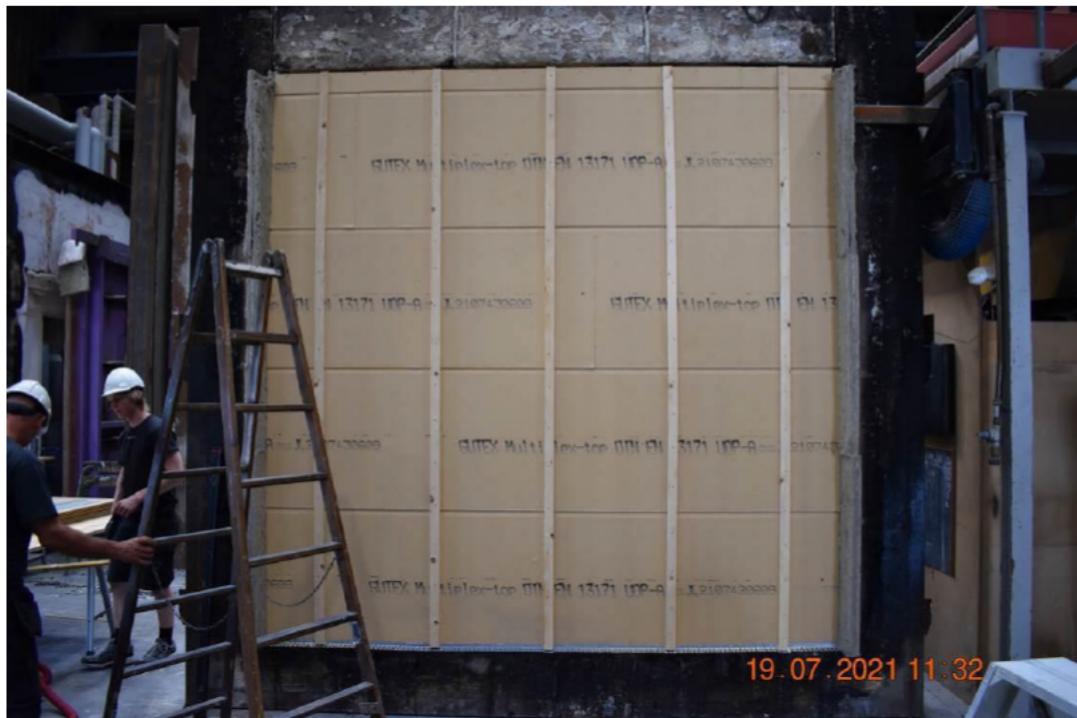
Photo No. 7 Spacer studs is being mounted on the exposed side.

Wood studs/spacers 18 x 46 mm pine wood studs/spacers (nominal density 450 kg/m<sup>3</sup>) were fixed to exposed side on the wood fibre board and the load bearing studs. with 2.8 x 75 mm strip nails, designated "TJEP GF Strip Nails 2.8 x 75 mm" at c/c of 200 mm.  
See sponsor drawing no. 3 and photo no. 7.

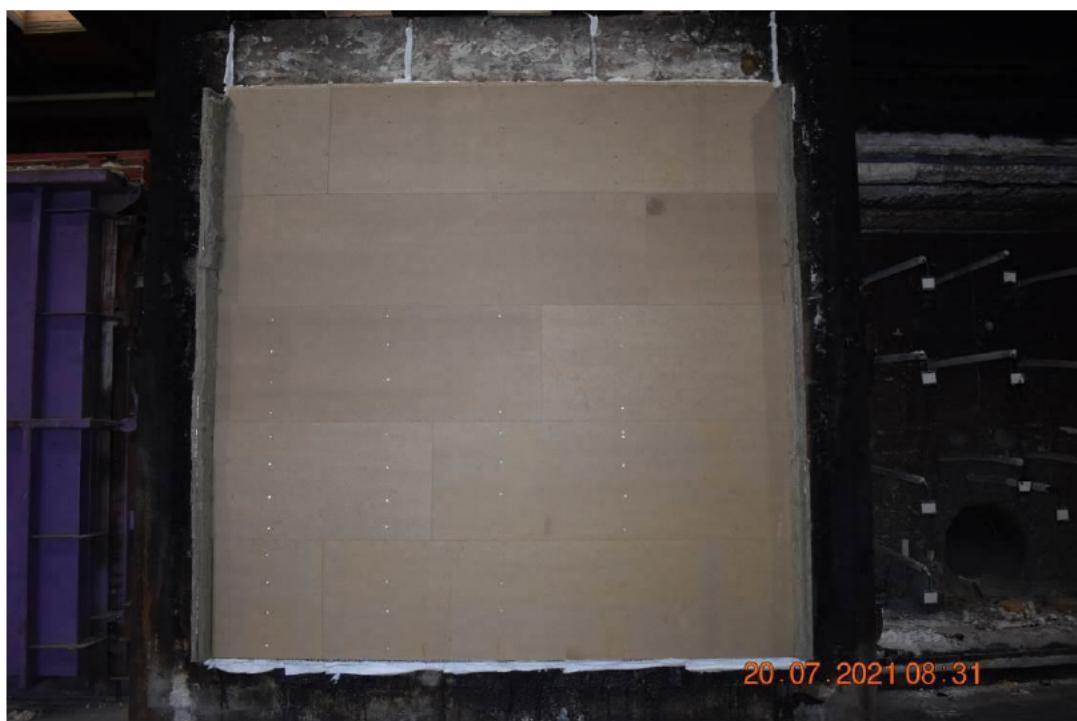
Photo No. 8 Layer of chipboard mounted to studs/spacers on the exposed side.

Chipboard A 12 mm thick chip board, designated spånplade TG4 (nominal density 690 kg/m<sup>3</sup>, (type EN 13171:2012 + A1:2015) was mounted to the wooden studs/spacers and the load bearing studs on the exposed side with chipboard screws designated Eurotech ruspert chipboard ph tx 5.0 x 60 mm with a c/c of 200 mm. The chip boards had the maximum dimensions of 1220 x 2500 mm.  
See sponsor drawing no. 5 and photo no. 8
