Test Report EU facade test 1

Name of sponsor:	DBI		
Product name:	EU facade test draft 6		
File no.:	PGC10025A	Revision no.:	0
Test date:	31-08-2023	Date:	05-10-2023
Pages:	12	Encl.:	97
Ref:	CHB	/	CHD

Examination of the fire performance of a façade using the large fire exposure.

ASSESSMENT OF FIRE PERFORMANCE OF FACADES USING LARGE FIRE EXPOSURE

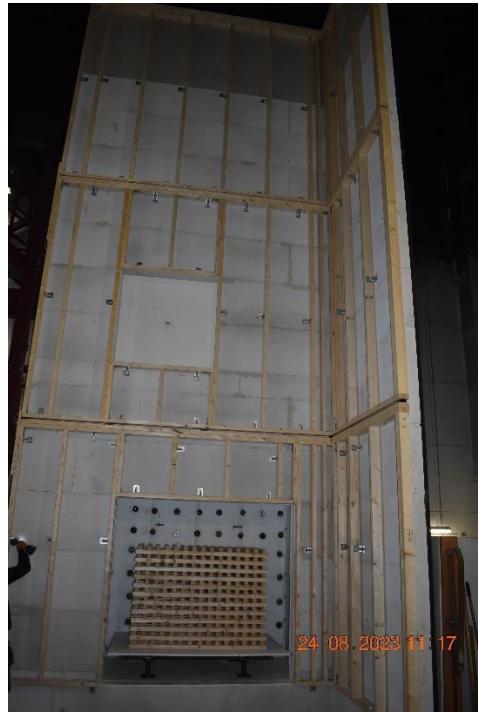
Photo No. 2 Prefabricated cassettes mounted on the façade rig.

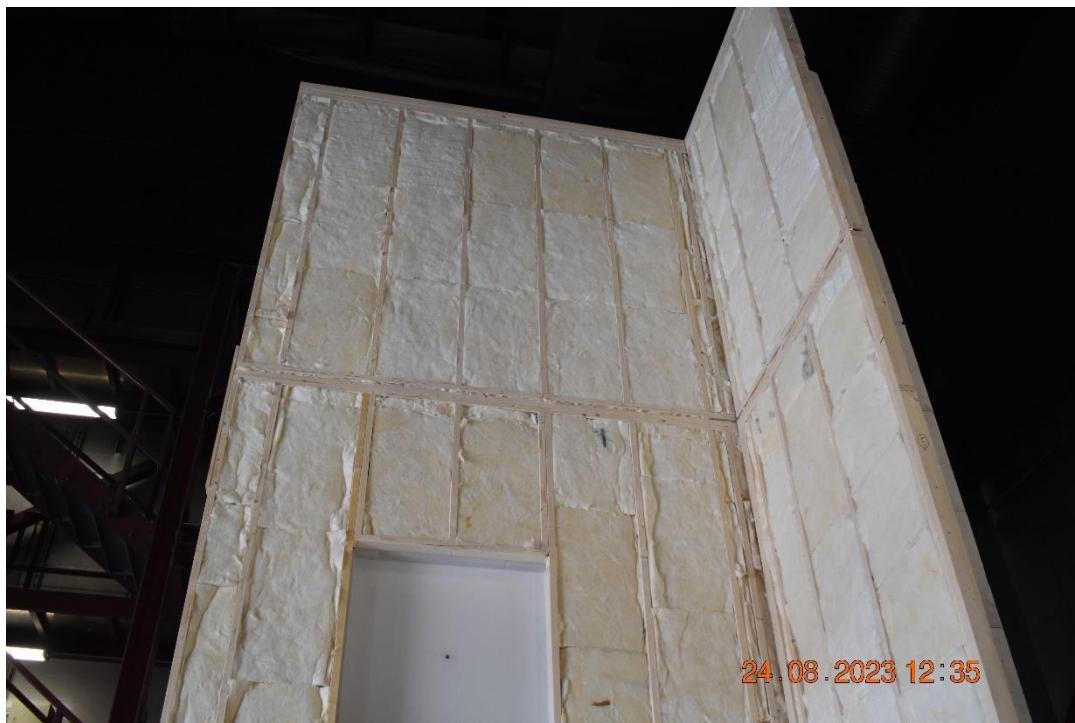
Photo No. 3 Isolation layer applied to the façade.

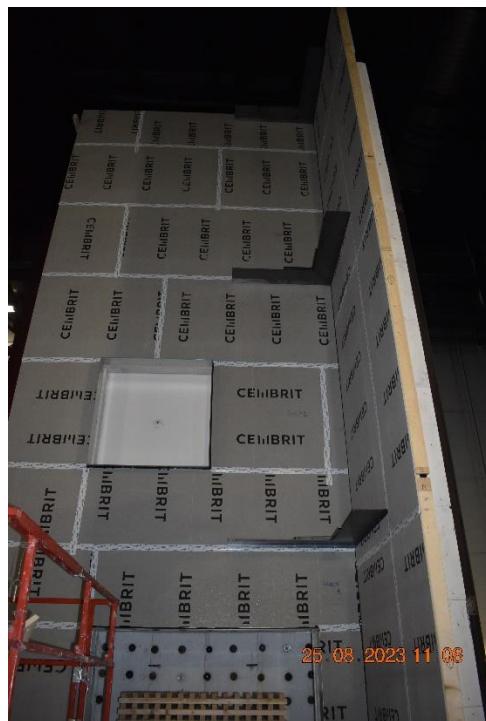
Photo No. 4 Cembrit boards mounted to the prefabricated cassettes.

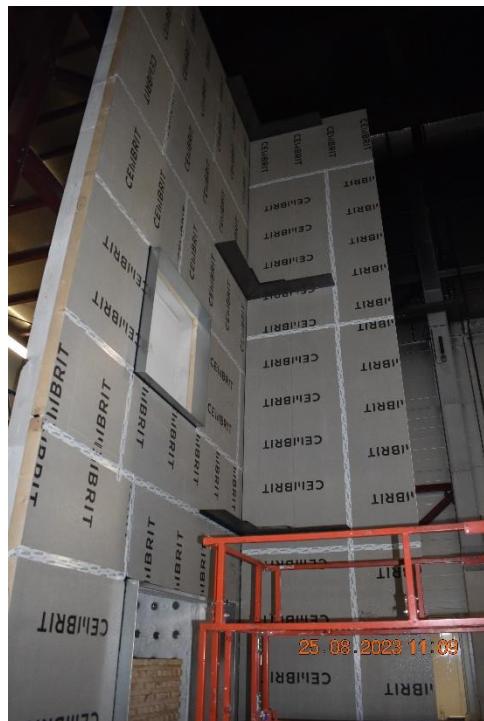
Photo No. 5 Steel profiles around window and fire chamber has been installed.

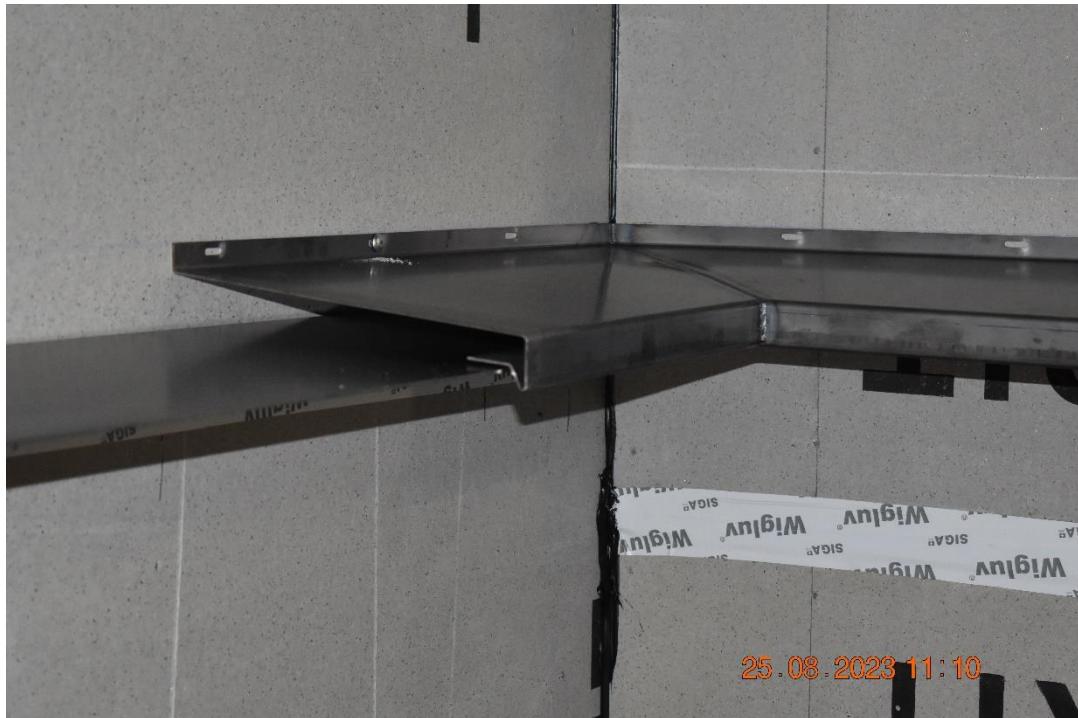
Photo No. 6 Fire breakers are being mounted.

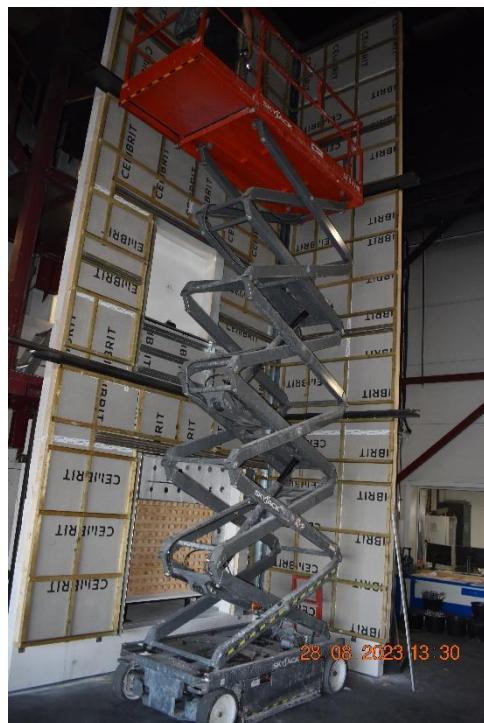
Photo No. 7 Cross formwork and firestop have been mounted.

- Fire stop:** One horizontal formwork board made of pressure impregnated spruce with a nominal density of 450 kg/m³ was mounted on the Cembrit board as a substrate for each firestop. The formwork was mounted in the same way as the rest of the formwork and had dimensions 22 x 110 mm.
The firestop was designated FB Cavity valve 28 mm (23x1130x105 mm). The cavity valve was fixed with 3 stainless screws per 1130 mm designated RedHorse ETX MH RX5, 4.8 x 29mm. The attachment carried out in the flat part of the net against the formwork board. The screws were mounted 40 mm from the end, in the middle and 40 mm from the opposite end. The valve was mounted so that the black expanding graphite insert is at the bottom. The graphite was centered and vertical in the valve. The positioning of the firestops is shown on drawing K01_H4_N04.

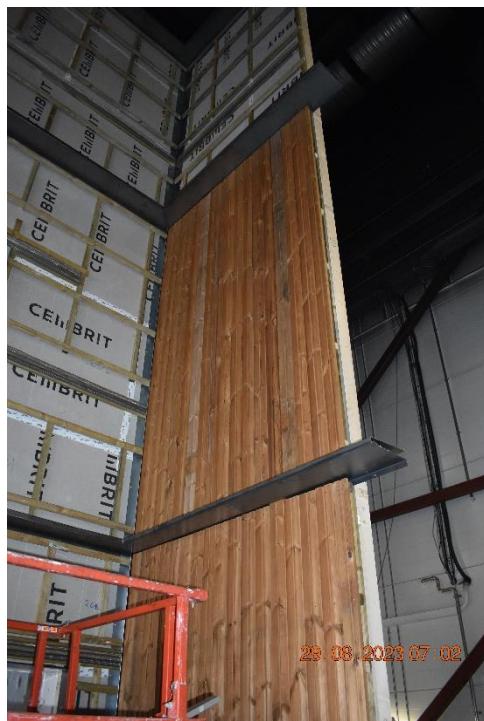
Photo No. 8 Cladding is being mounted.

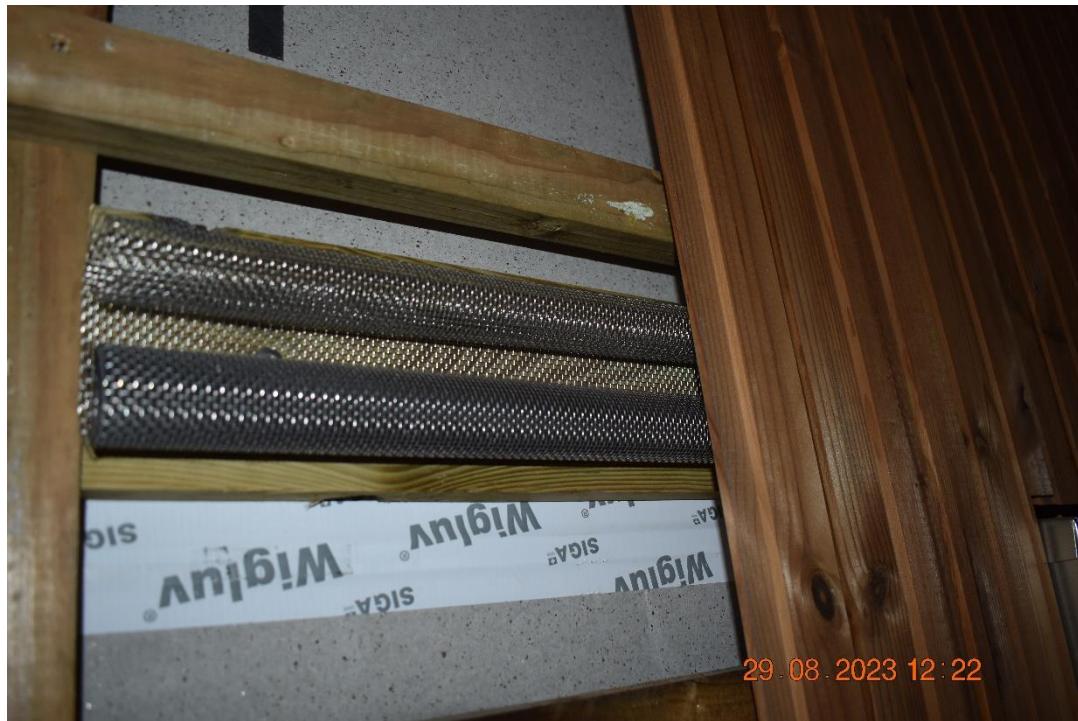
Photo No. 9 Detail of firestop and cladding.

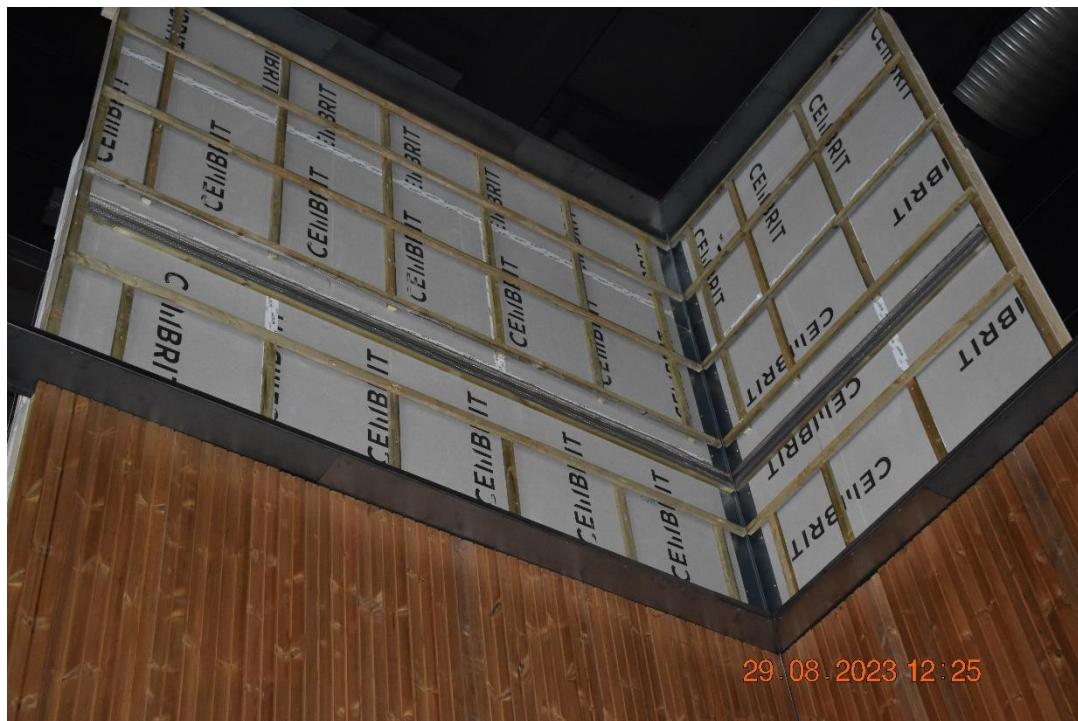
Photo No. 10 Cladding have been mounted on the two lower levels.

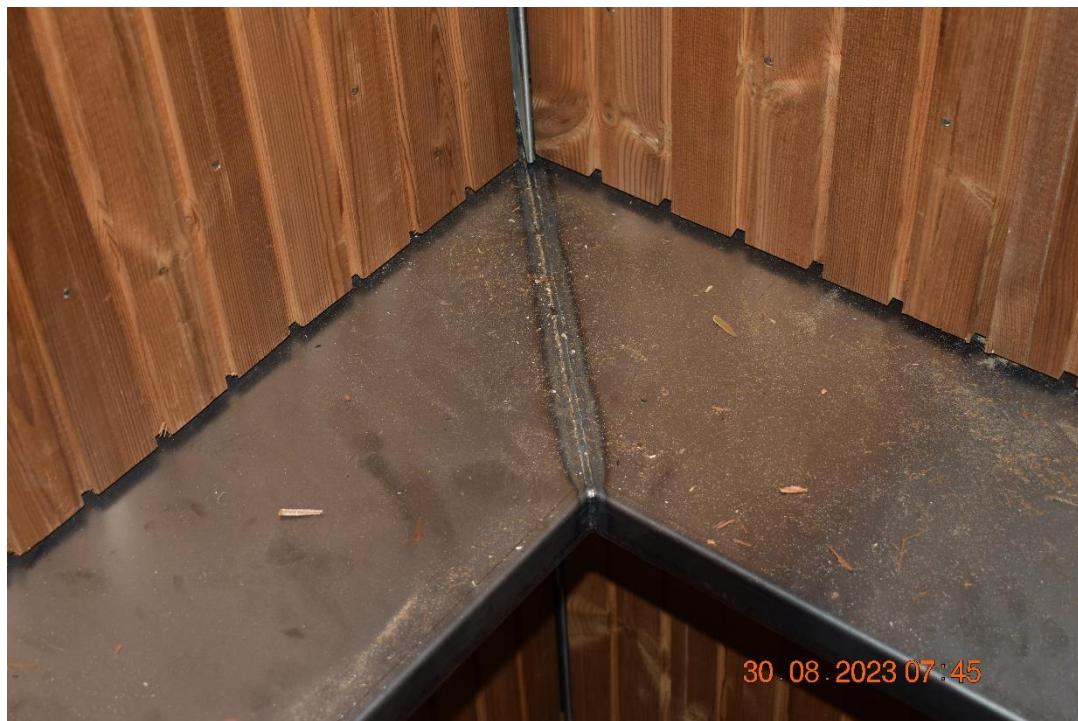
Photo No. 11 Connection between the main façade and wing.

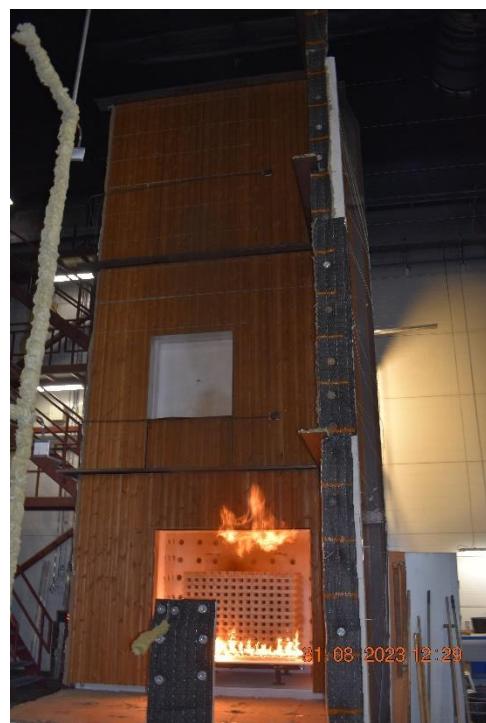
Photo No. 13 Façade before start test.

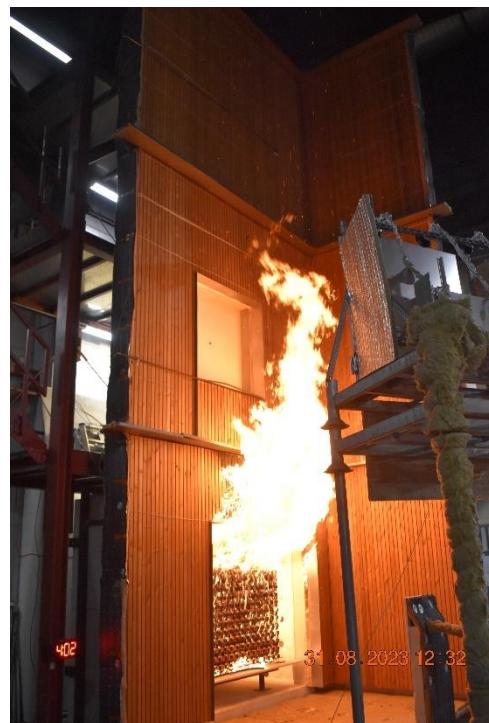
Photo No. 14 Test specimen at start test.

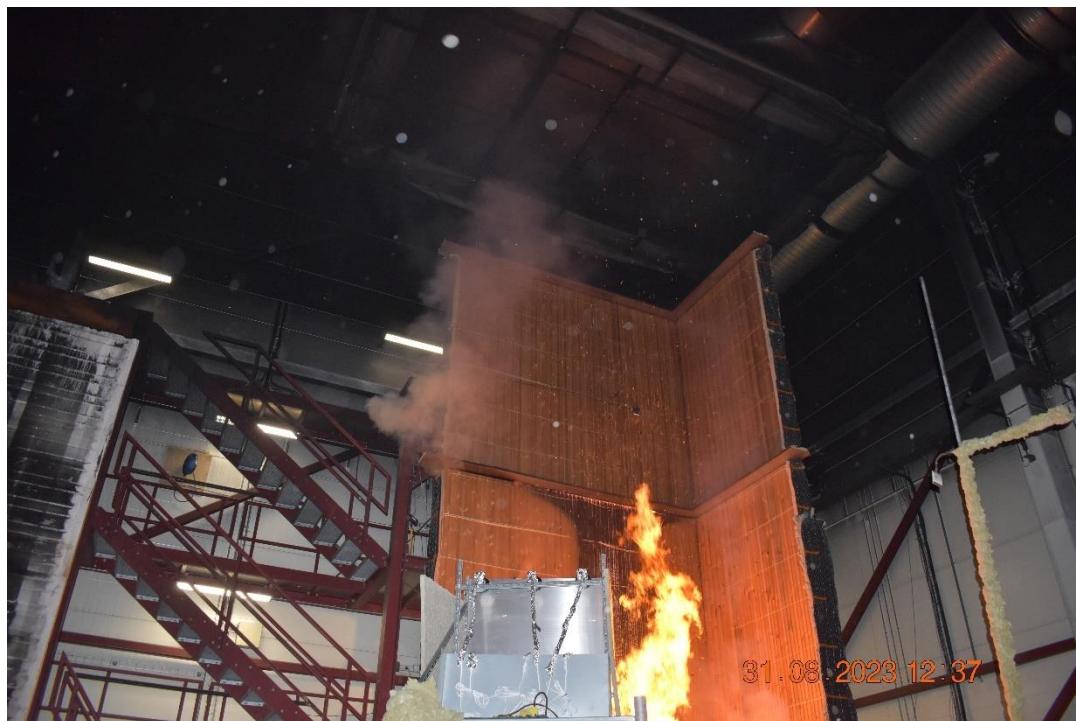
Photo No. 16 Test specimen 6 minutes into the test.

Time / Minutes	Visual observations:
0	Test commences
1	Crib burning
2	Façade boards above crib starts to burn
4	Fire breaker above fire chamber starts to deform
4	Flame increases in façade above the fire chamber
5	Flames increases close to second fire breaker
5	Wing starting to smoke near fire chamber
7	Steel profiles on bottom and sides of window starts to deform
9	Flames increases below the second fire breaker
10	Wing starts burning at same height as the top of the fire chamber
11	Wing starts burning between fire breaker 1 and 2
12	All levels are burning
12	Flames are decreasing in the top of the main façade and the wing
13	Flames are decreasing in the top of the main façade and the wing. Only fire near the corner in the top level
14	Flames decreasing slightly
15	No changes
16	Flames slightly increases
18	Test stopped due to safety reasons

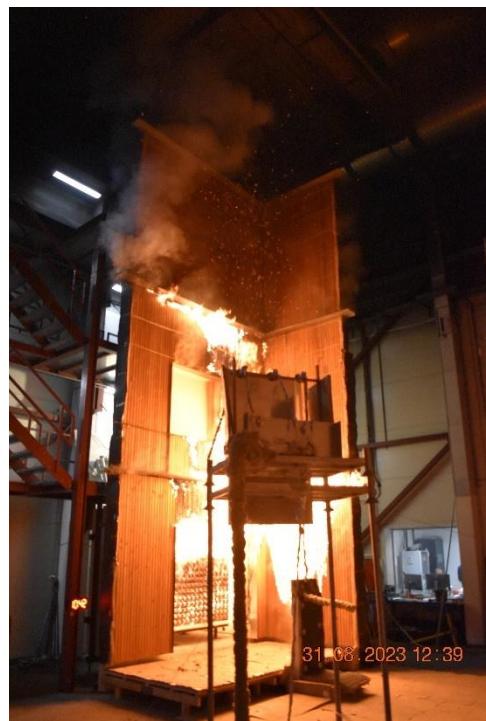
Photo No. 17 Test specimen 8 minutes into the test.

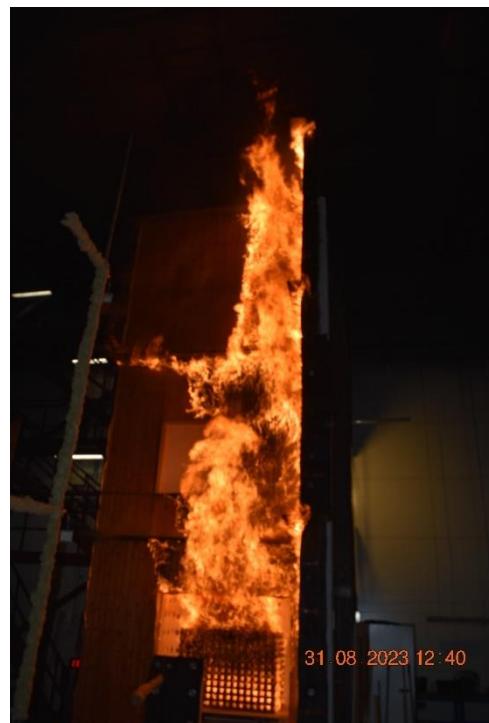
Photo No. 18 Test specimen 10 minutes into the test.

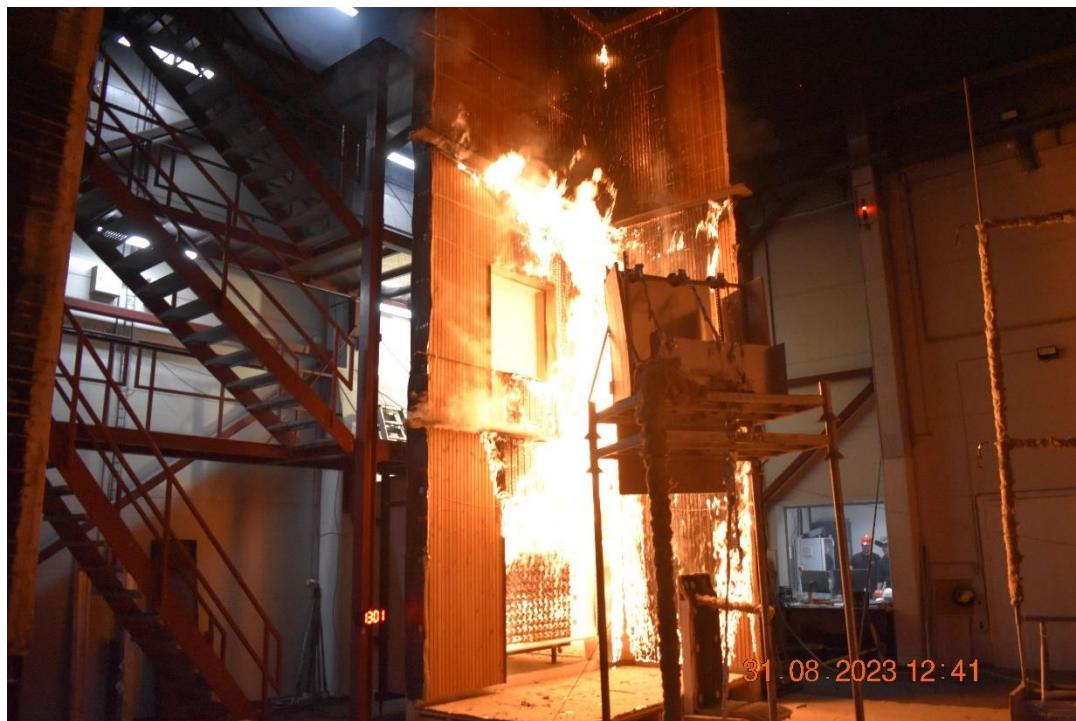
Photo No. 19 Test specimen 11 minutes into the test.

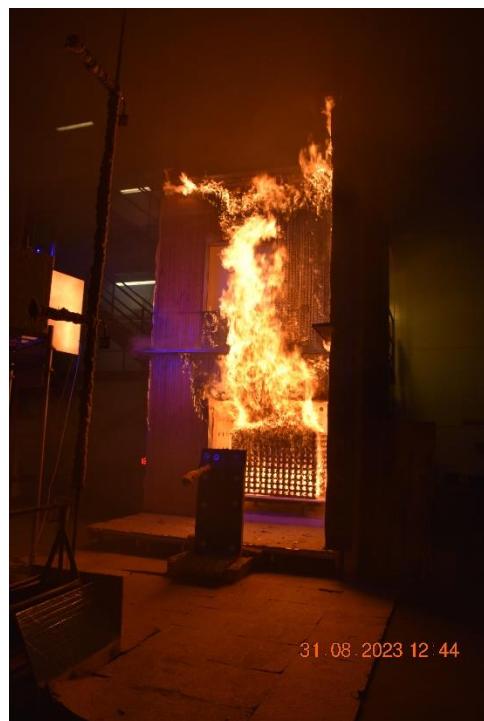
Photo No. 20 Test specimen 12 minutes into the test.

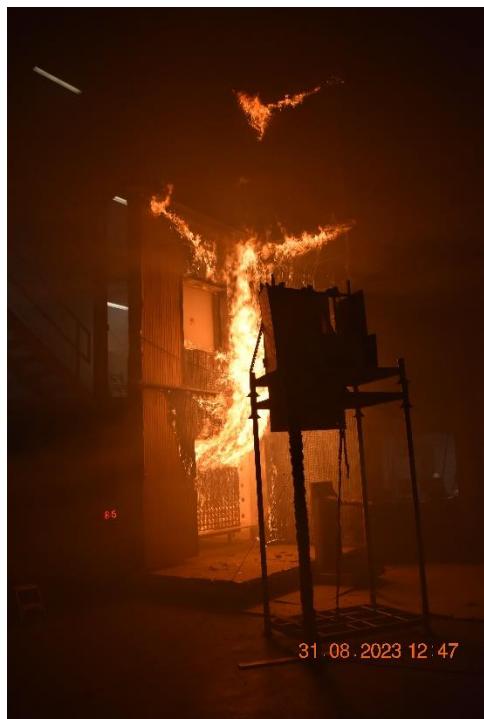
Photo No. 21 Test specimen 15 minutes into the test.

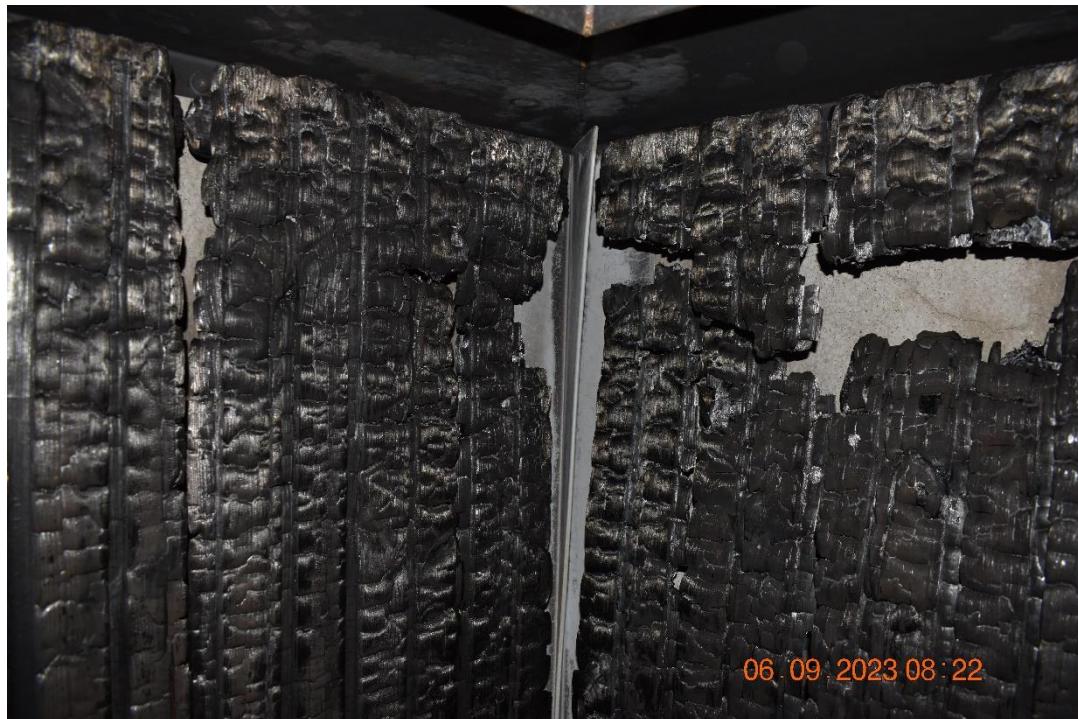
Photo No. 22 Test specimen 18 minutes into the test.

The test was terminated after 18 minutes due to there was a risk to the safety of personnel or impending damage to equipment.

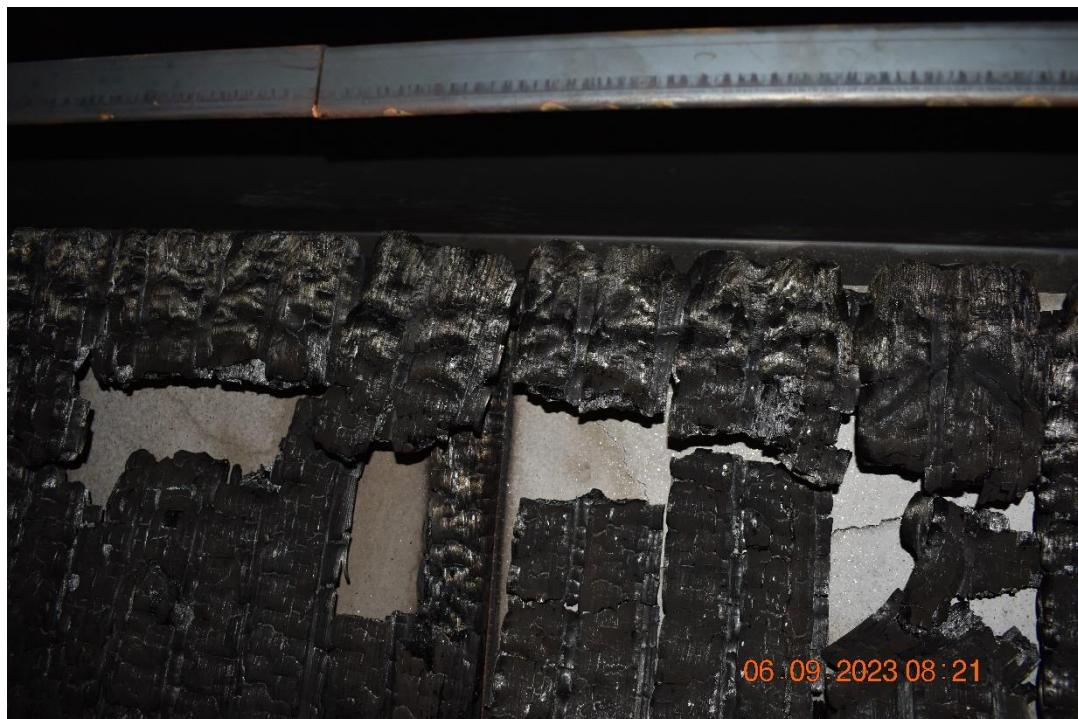
Photo No. 23 Test specimen after the test. Detail photo of cladding in the corner below the first flame breaker.

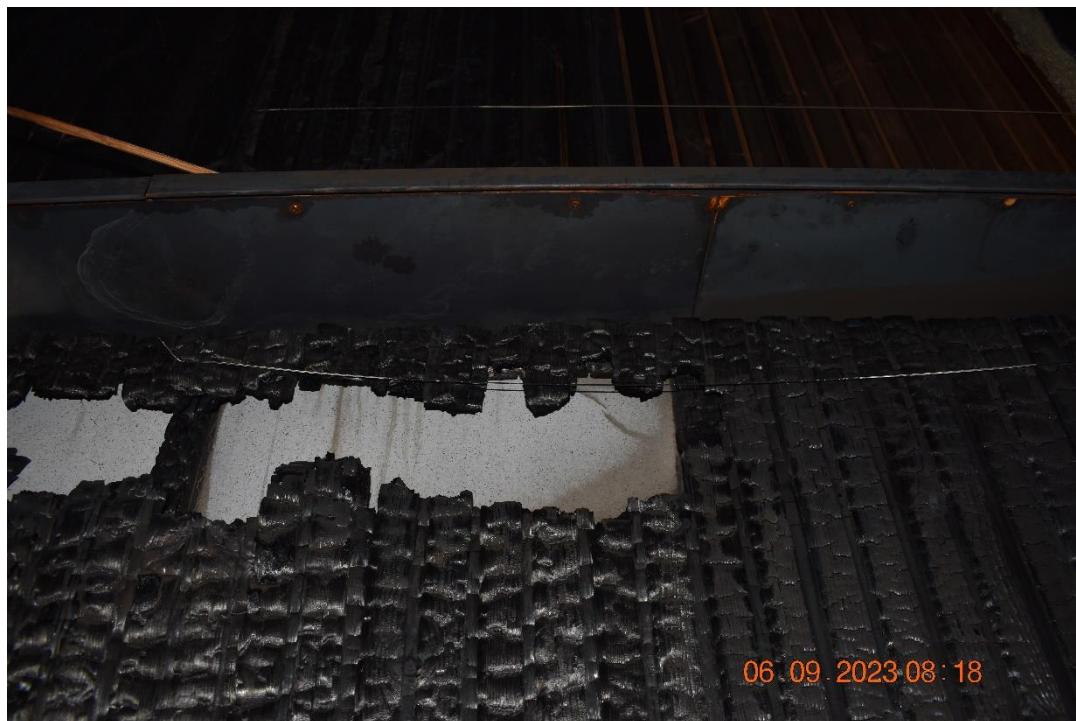
Photo No. 24 Test specimen after the test. Detail photo of cladding above the fire chamber.

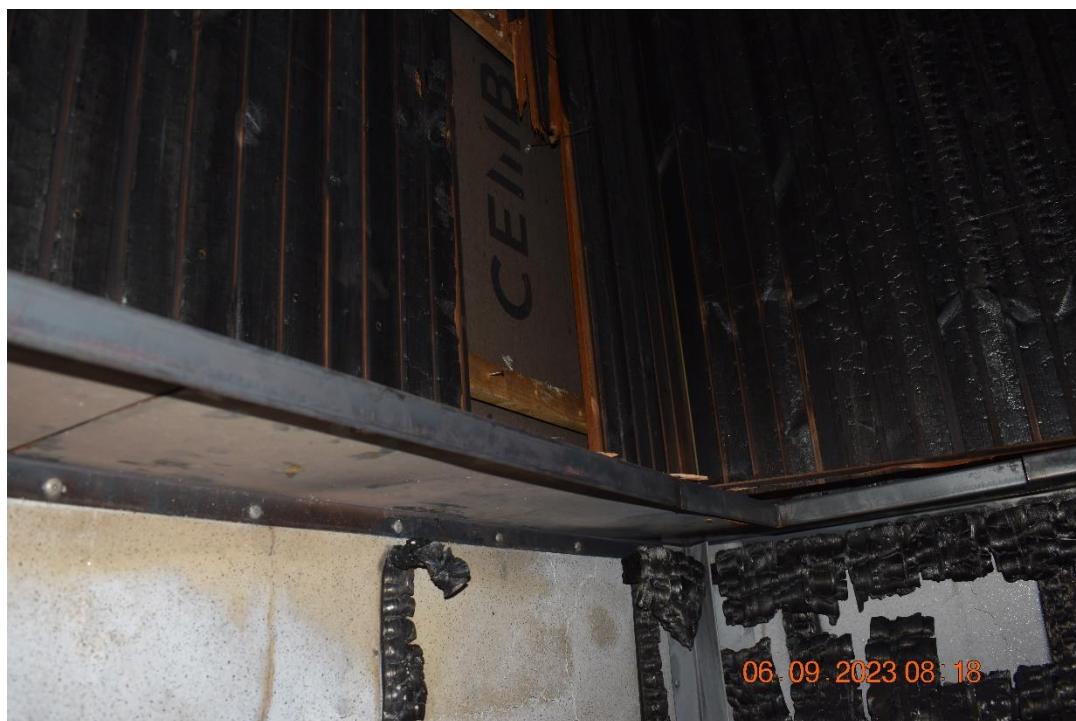
Photo No. 25 Test specimen after the test. Detail photo of cladding above the fire chamber.

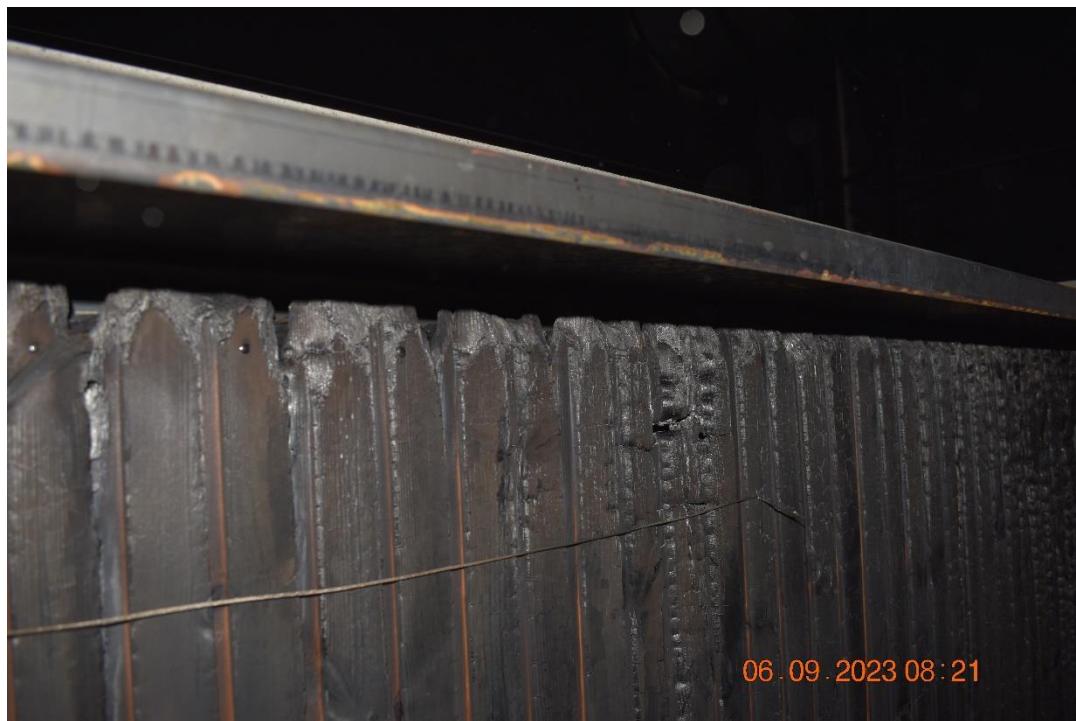
Photo No. 26 Test specimen after the test.

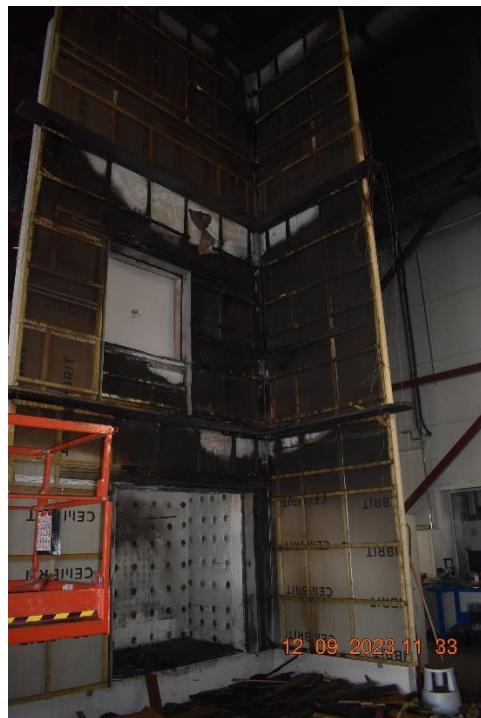
Photo No. 27 Test specimen after the test. Top of main façade.

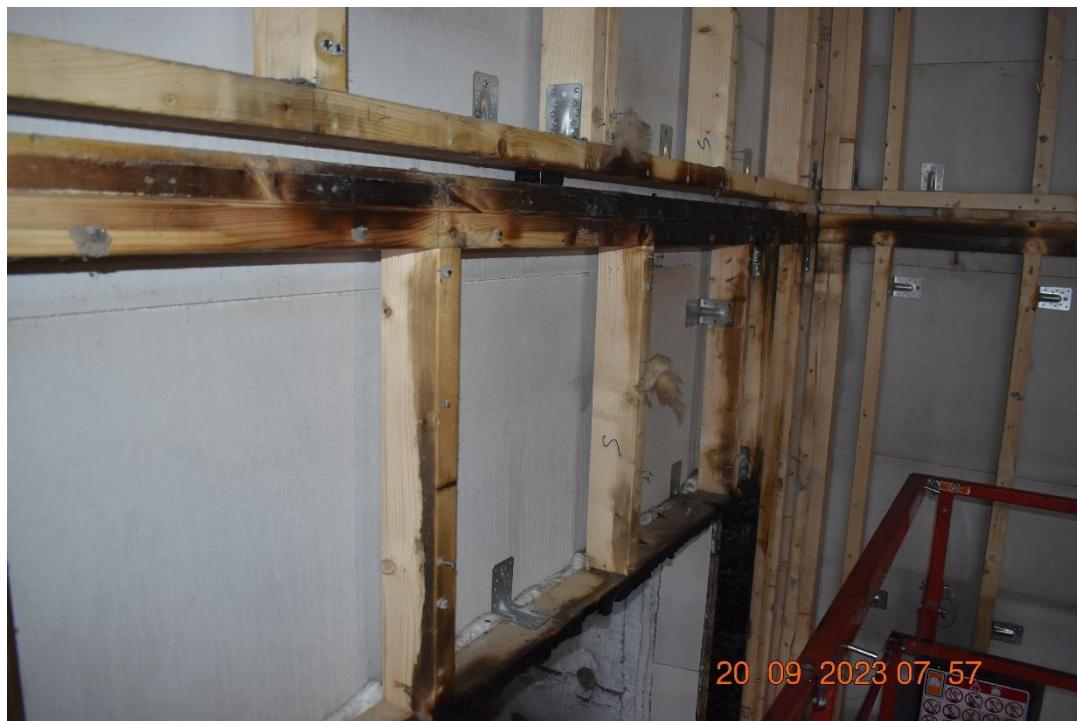
Photo No. 28 All cladding has been removed.

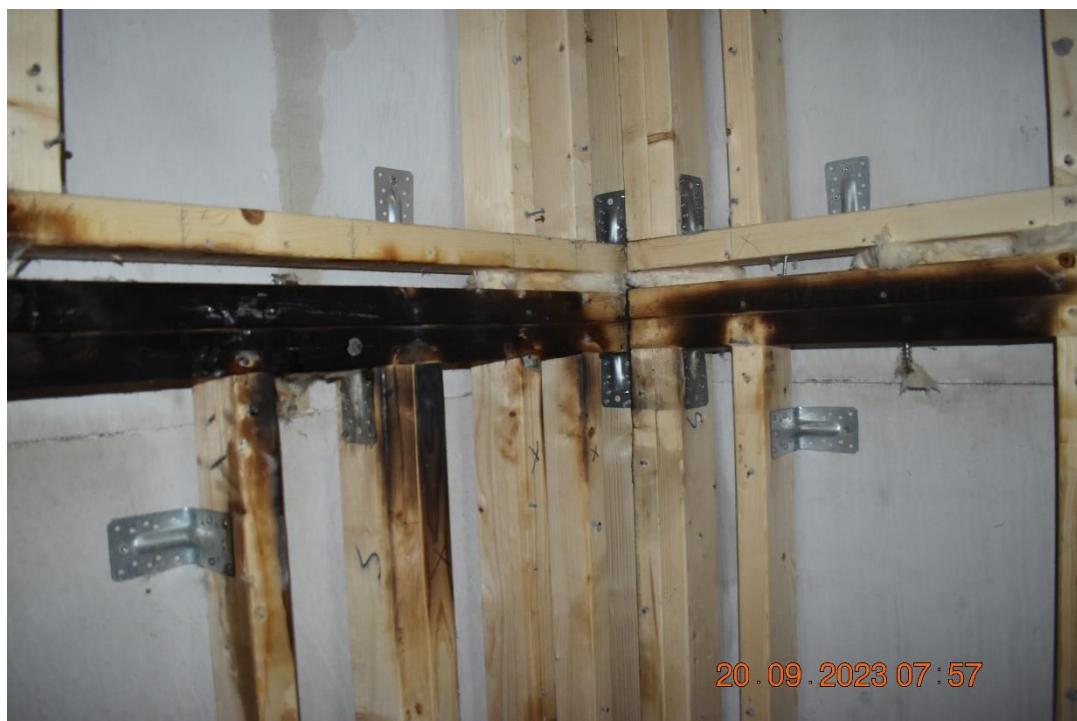
Photo No. 29 Windstopper and insulation has been removed.

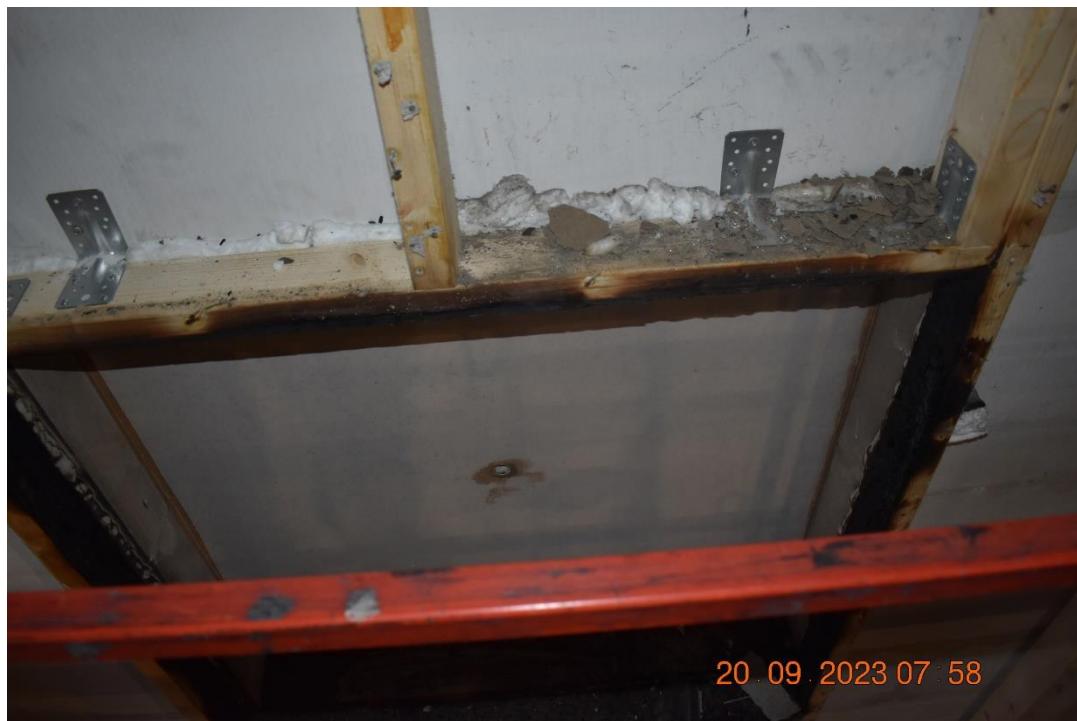
Photo No. 30 Construction wood in the corner at first level.

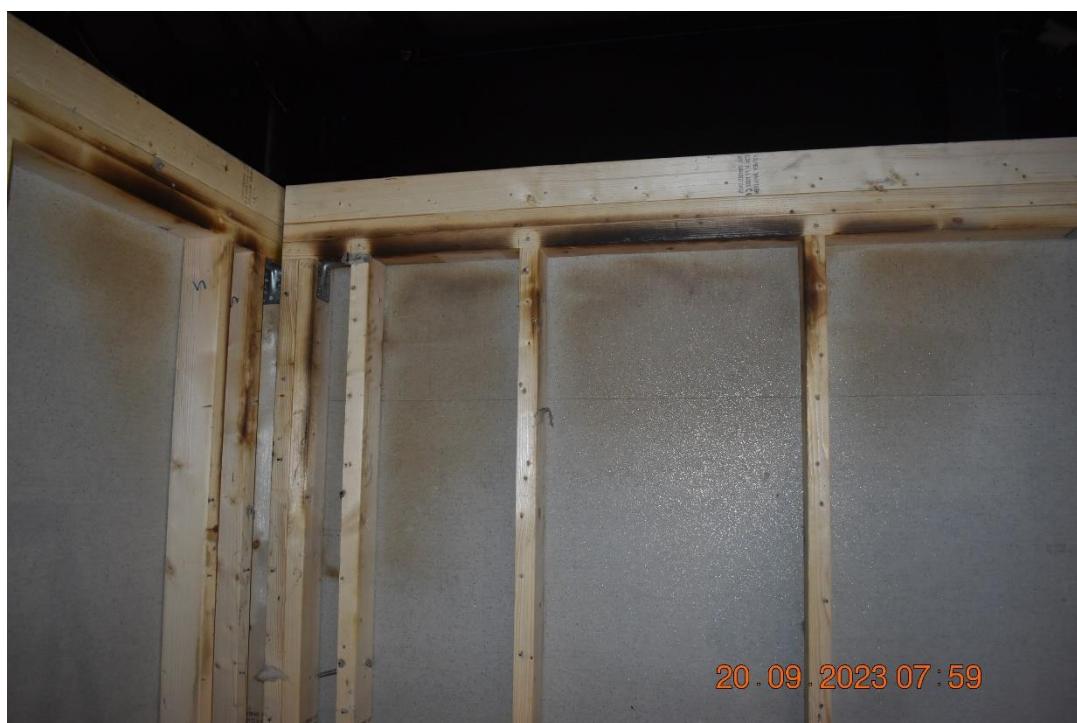
Photo No. 31 Construction wood in at first level.

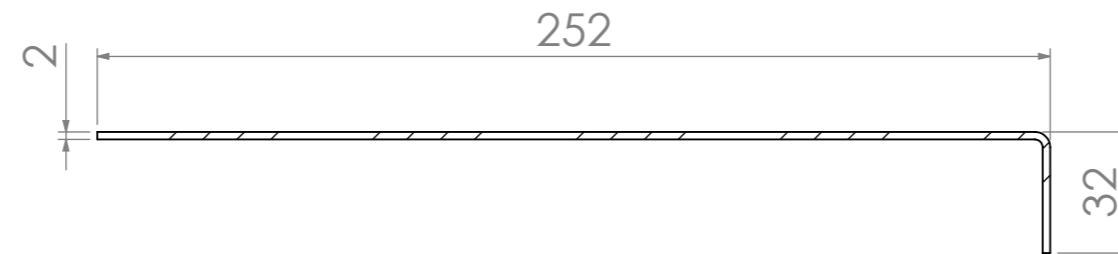
SECTION A-A
SCALE 1 : 2

NAME	DATE	Folder name: X:\DBI\
DRAWN casper	13-07-2023	Customer: DBI
		Title: Hjørne, underdel, samlet
		MATERIAL:
		DWG NO.
		REVISION
		GKB-114938-HJ2
Hvor intet andet er angivet, er tolerancer i henhold til DS/ISO 2768-1(m) Alle mål er i millimeter, medmindre andet er angivet. Tegningen må ikke skaleres.	WEIGHT: 9.50	SCALE: 1:10
		A3 SHEET 1 OF 1
