# TEST REPORT EU FACADE TEST 3

<b>Name of sponsor:</b>	CPH Village Holding ApS		
<b>Product name:</b>	EU facade test draft 6		
<b>File no.:</b>	PGC10027A	<b>Revision no.:</b>	0
<b>Test date:</b>	27-10-2023	<b>Date:</b>	07-12-2023
<b>Pages:</b>	13	<b>Encl.:</b>	92
<b>Ref:</b>	CHD	/	CHB

Examination of the fire performance of a façade using the large fire exposure.

ASSESSMENT OF FIRE PERFORMANCE OF FACADES USING LARGE FIRE EXPOSURE

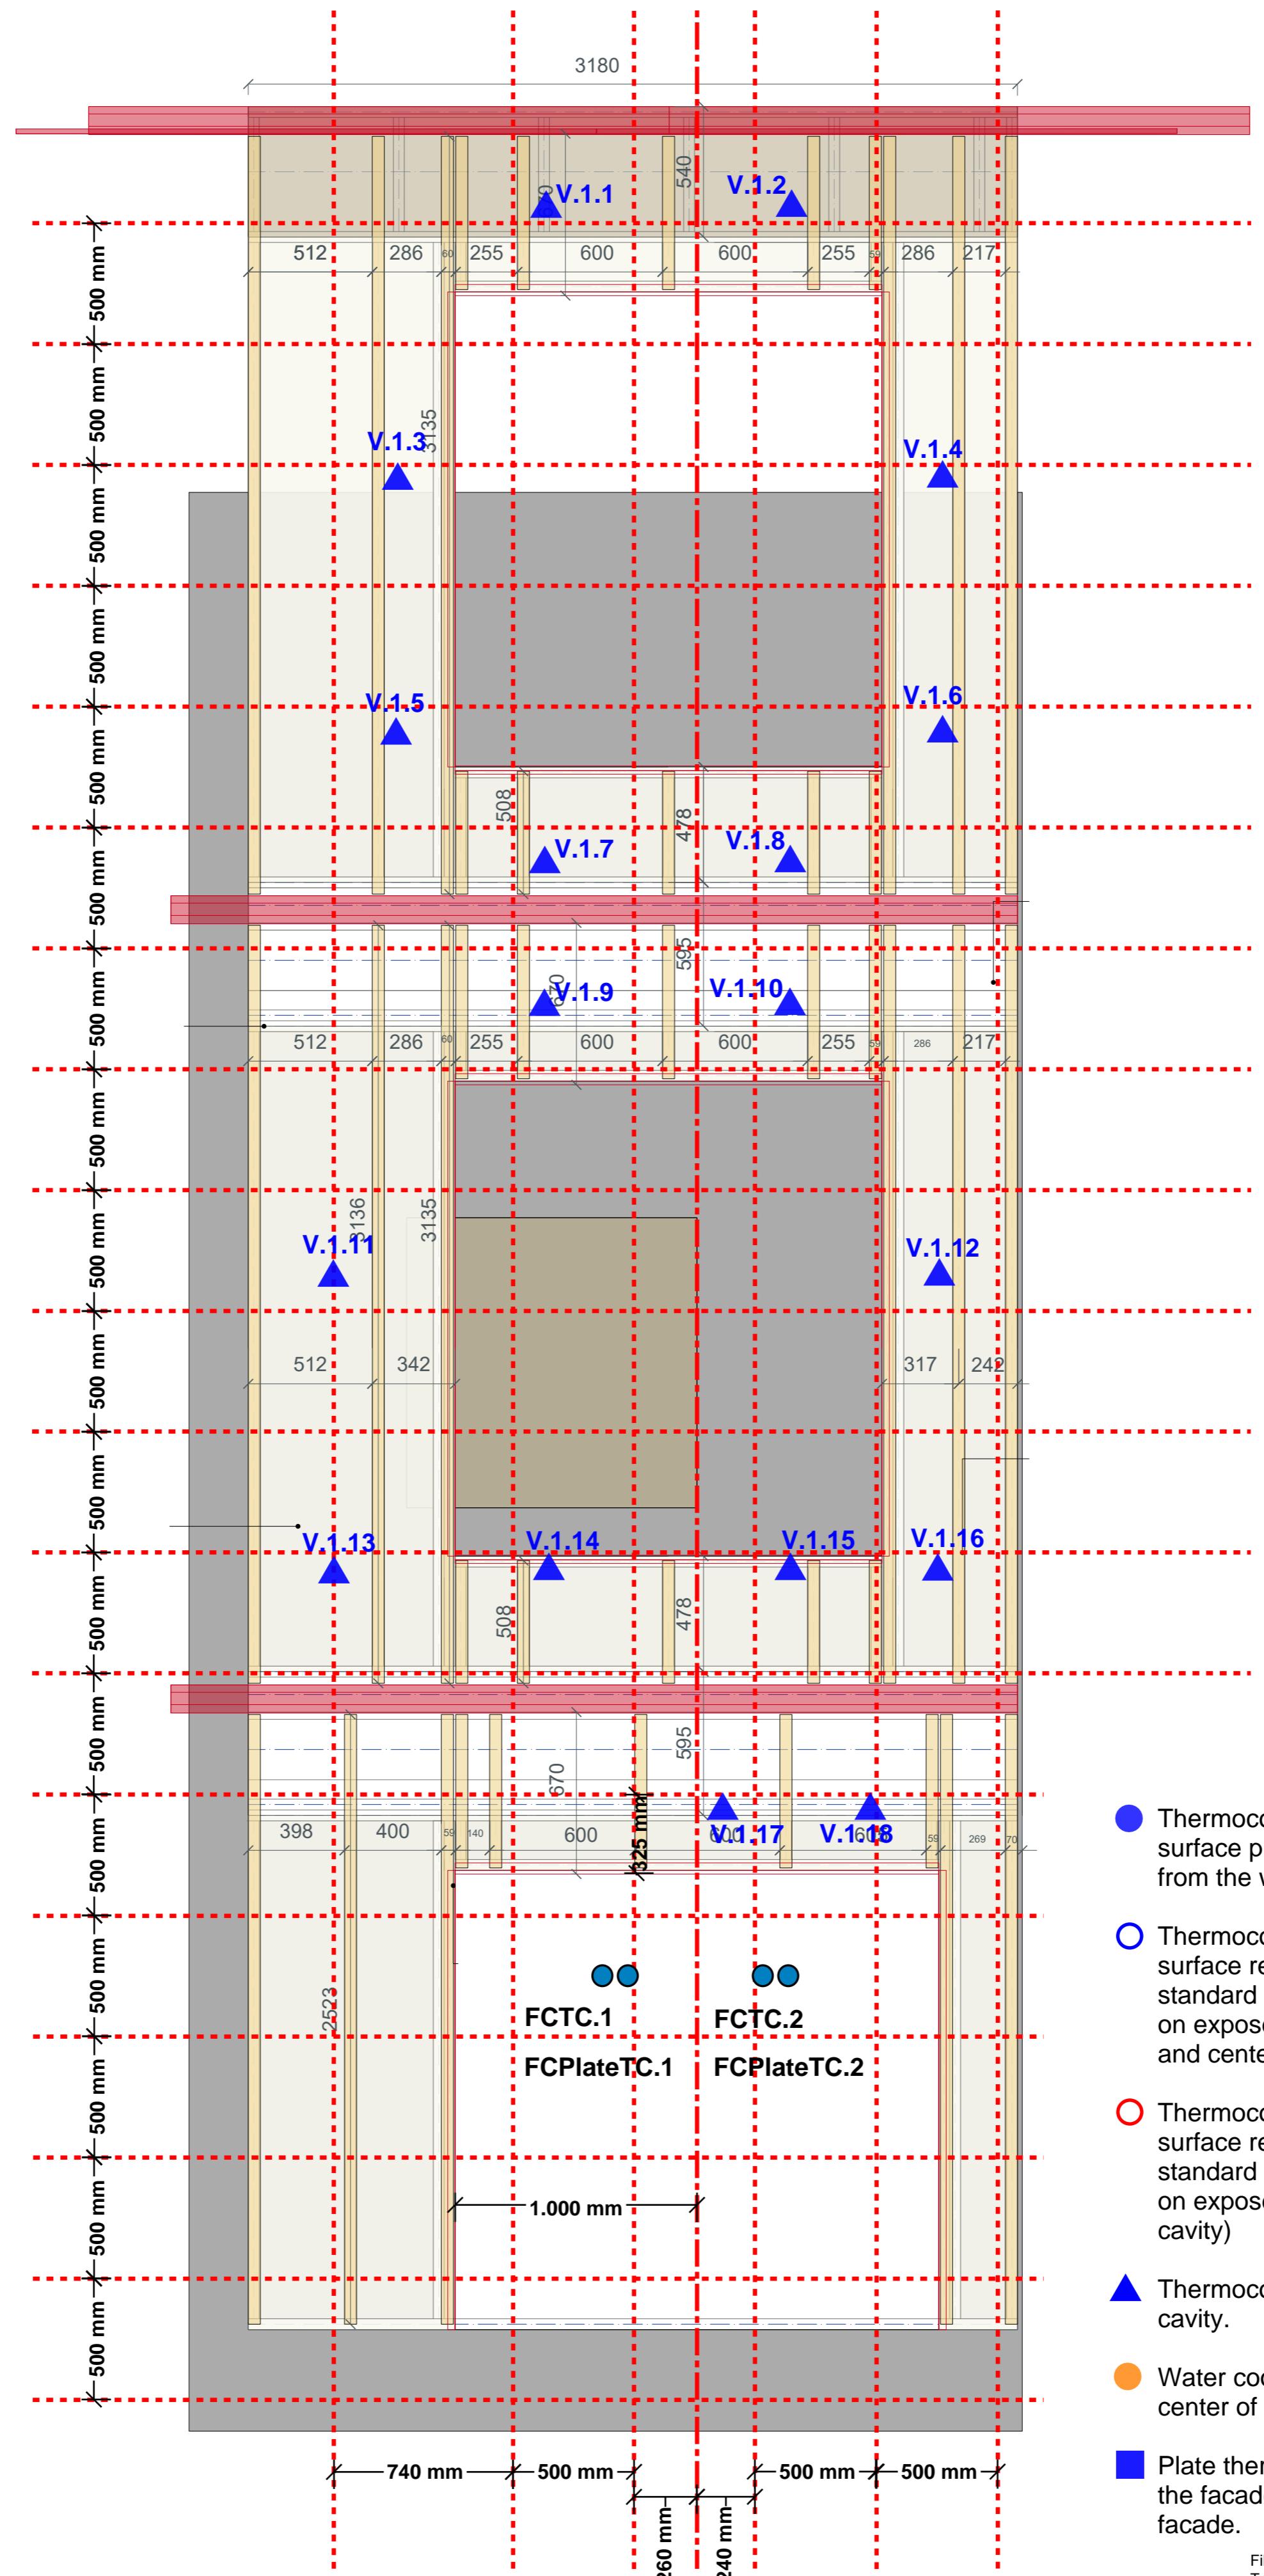
- Thermocouple location on the facade surface proposed by Guoxiang (5 cm from the wood panel surface).
- Thermocouple location on the facade surface required according to the standard (3 measurements: 5 cm out on exposed surface, middle of cavity and center of insulator).
- Thermocouple location on the facade surface required according to the standard (2 measurements: 5 cm out on exposed surface and middle of the cavity)
- ▲ Thermocouple within the ventilated cavity.
- Water cooled heat flux censor at the center of the secondary window.
- Plate thermometer at the surface of the facade, flush to the surface of the facade.

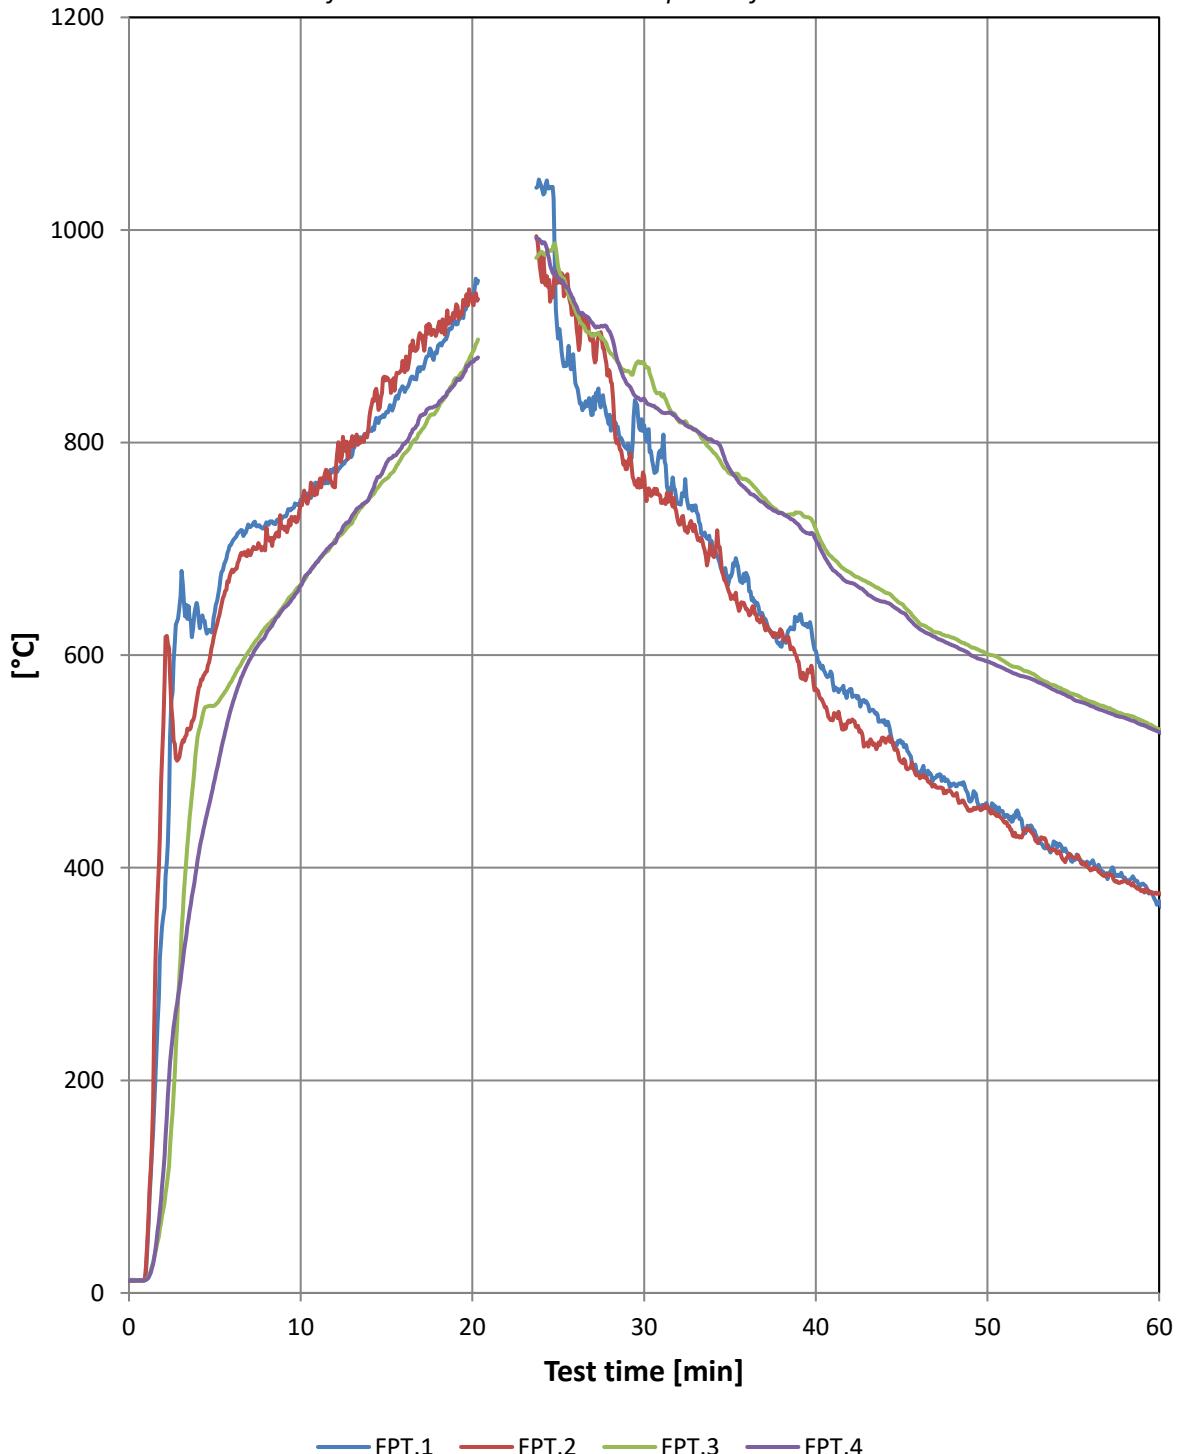
## The temperature in the fire chamber during the test

*A 3-minute mechanical failure caused all thermocouples to fail between 20 and 23*

*FireChamberPlateTC.1 FireChamberPlateTC.2  
FireChamberTC.1 FirechamberTC.2*

Enclosures 2.0 and 2.1	The temperature in the fire chamber during the test  A 3-minute mechanical failure caused all thermocouples to fail between 20 and 23
Enclosures 3.0 and 3.1	Ambient temperature The ambient temperature in the laboratory during the test
Enclosures 4.0 and 4.1	Flux in Location 1
Enclosures 5.0 and 5.1	Temperature measured in the ventilated cavity

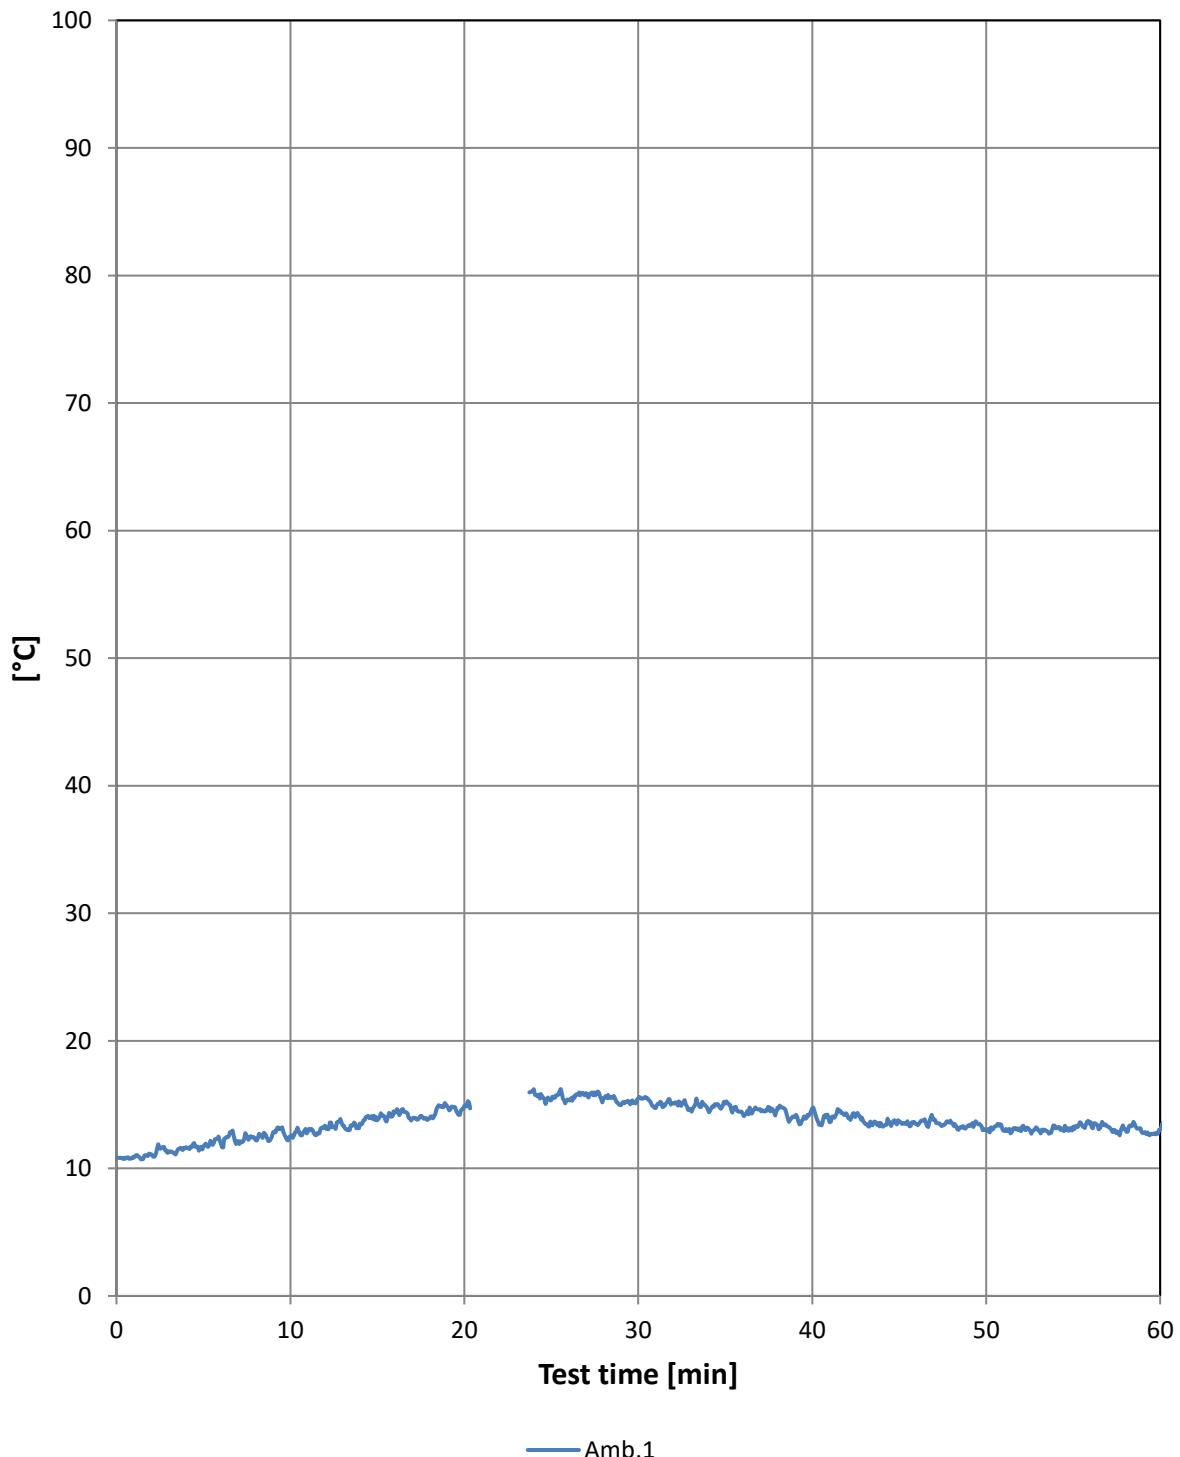
## Ambient temperature

*The ambient temperature in the laboratory during the test*

*A 3-minute mechanical failure caused all thermocouples to fail between 20 and 23*

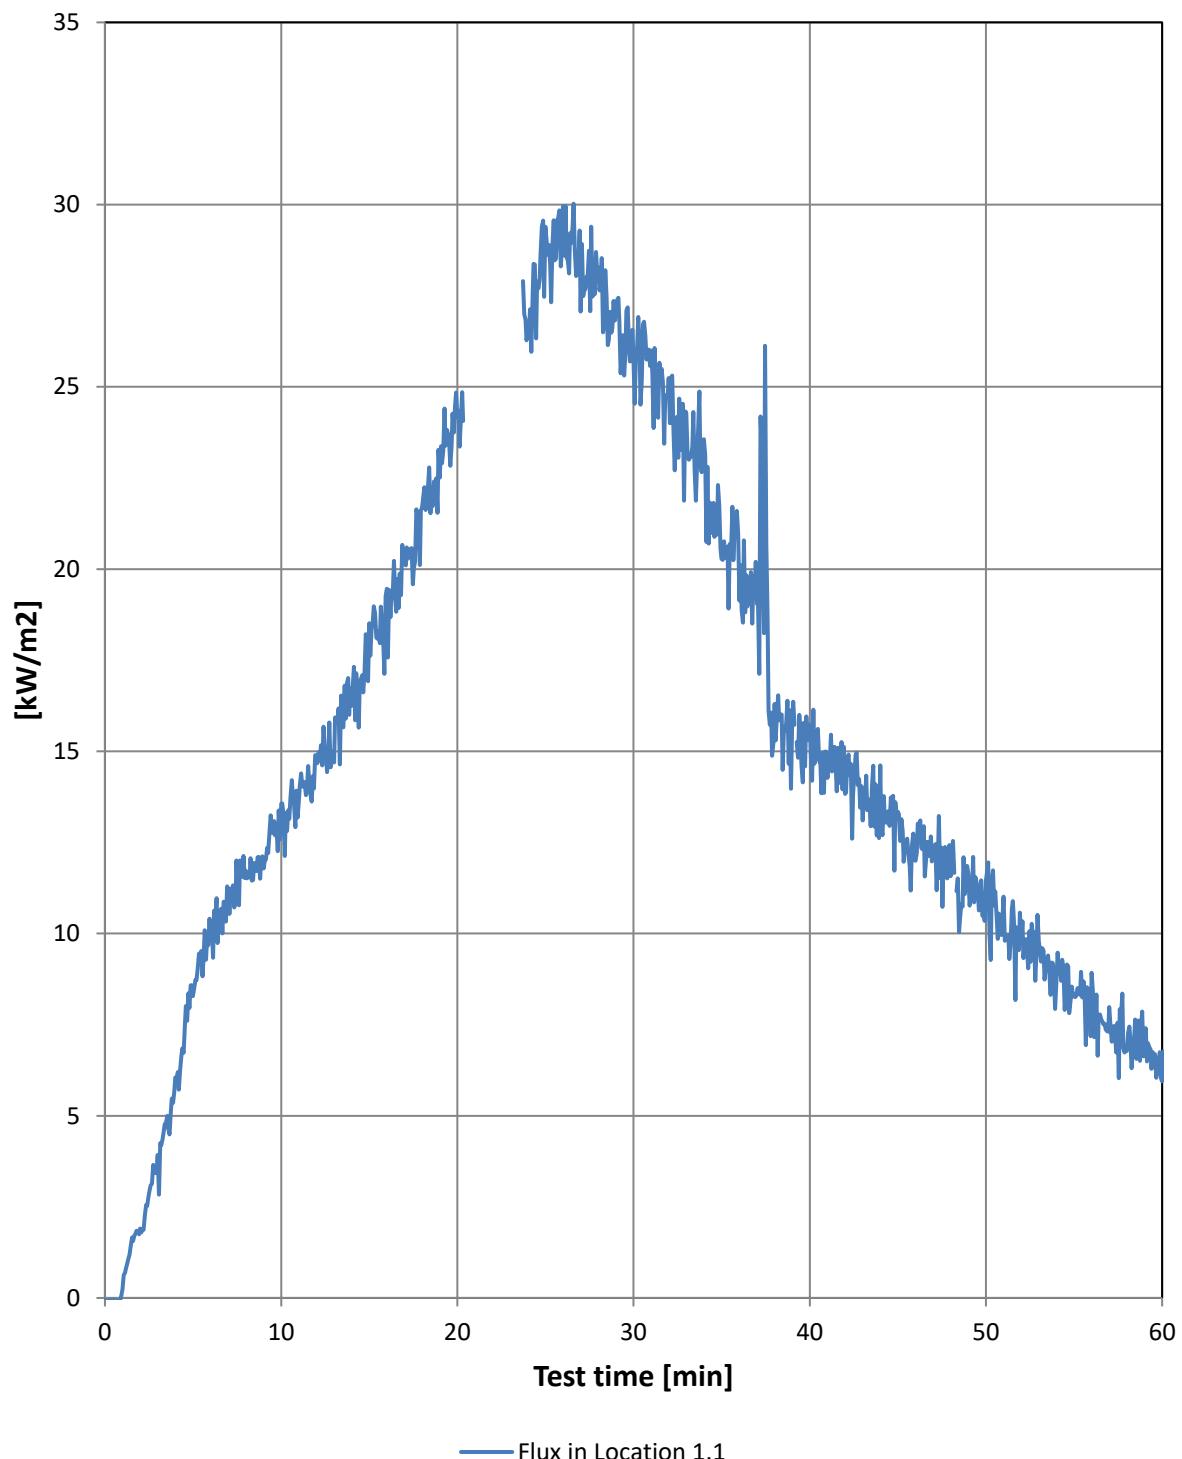
## Flux in Location 1

A 3-minute mechanical failure caused all thermocouples to fail between 20 and 23

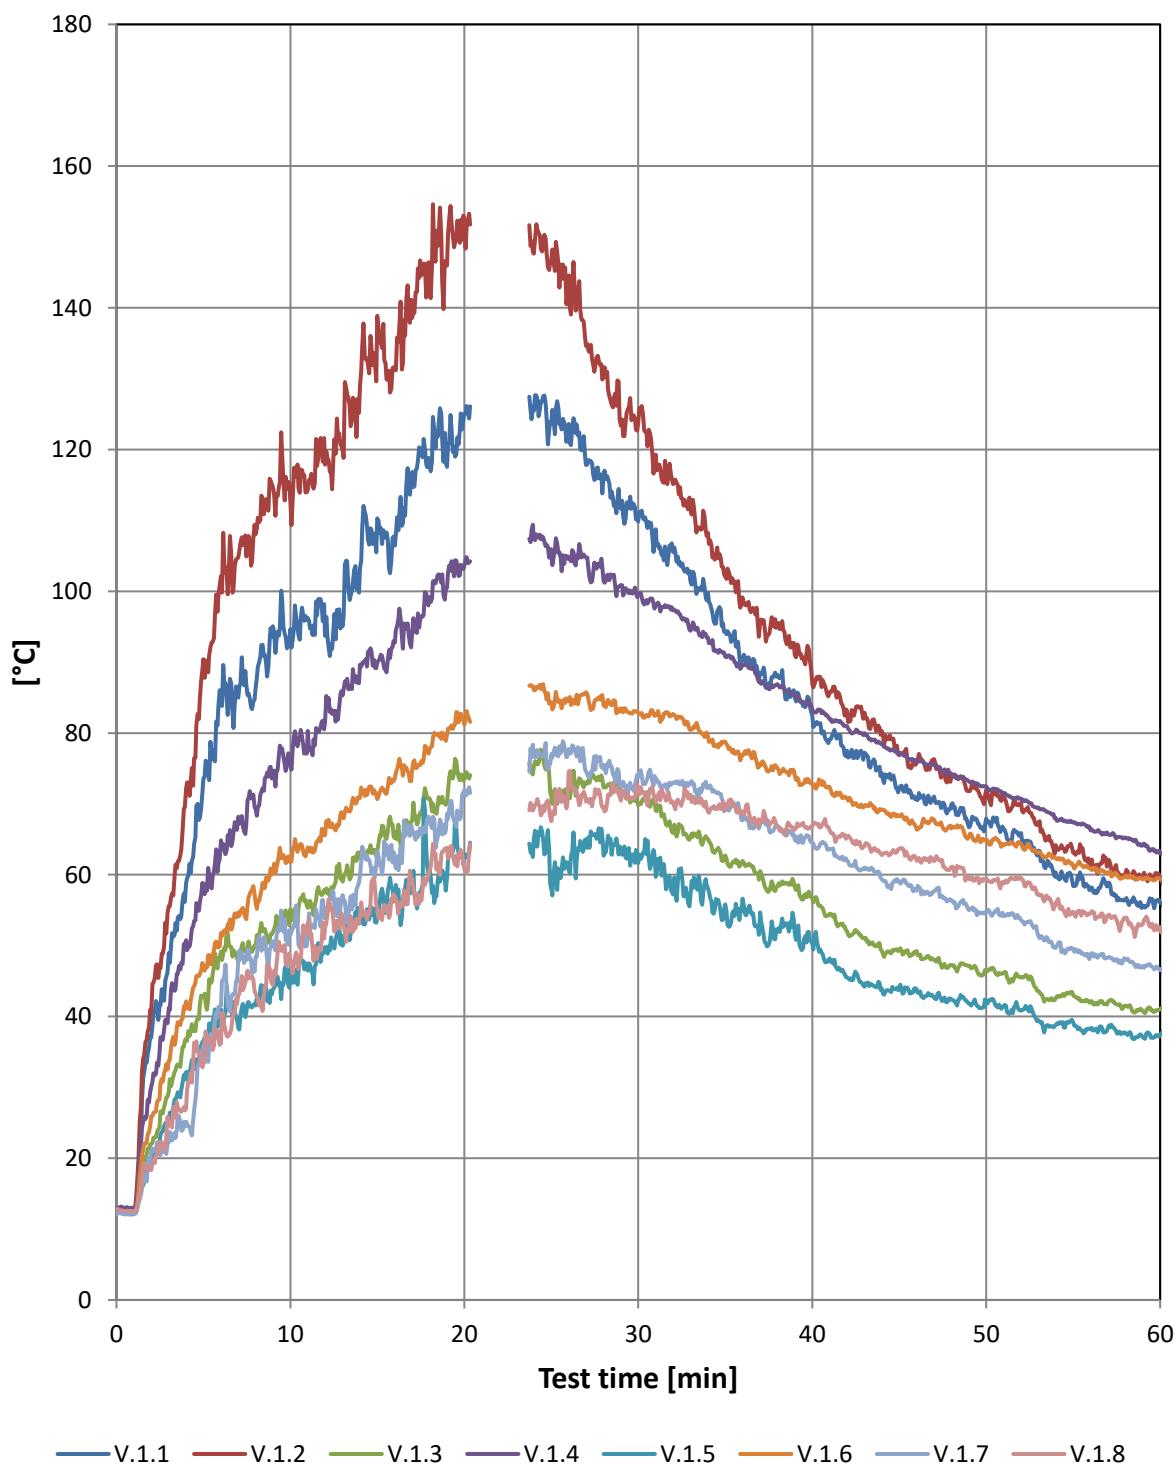
## Temperature measured in the ventilated cavity

A 3-minute mechanical failure caused all thermocouples to fail between 20 and 23

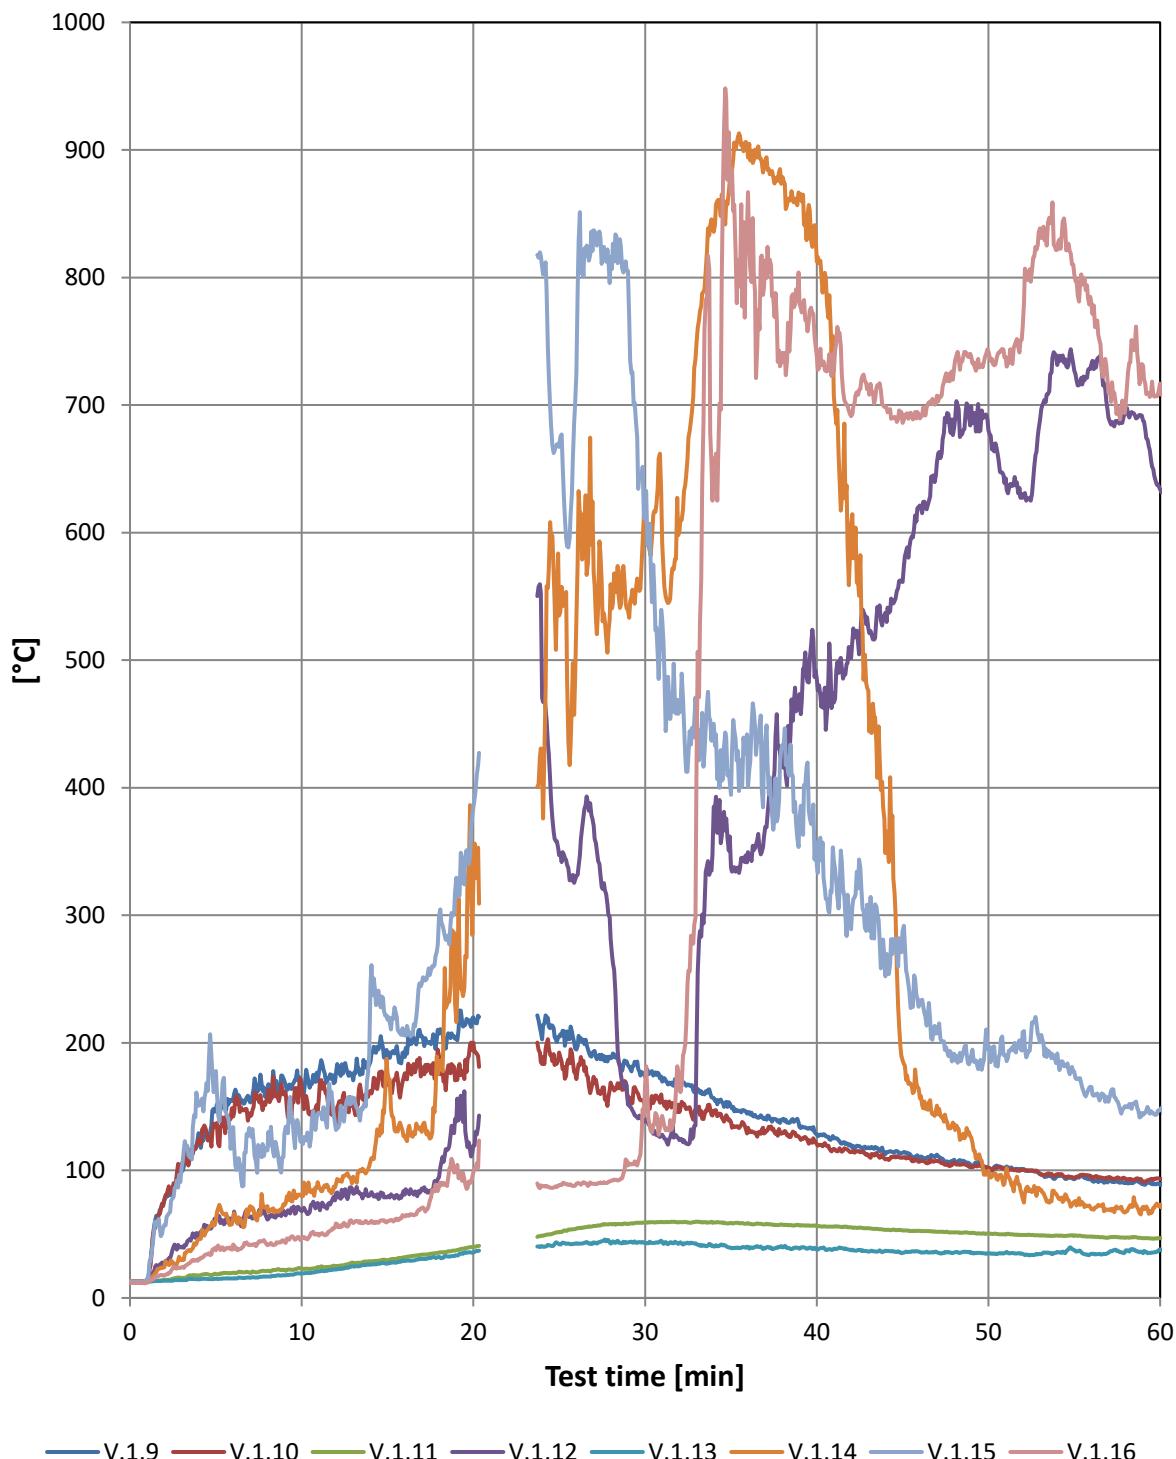
## Temperature measured in the ventilated cavity

*A 3-minute mechanical failure caused all thermocouples to fail between 20 and 23*

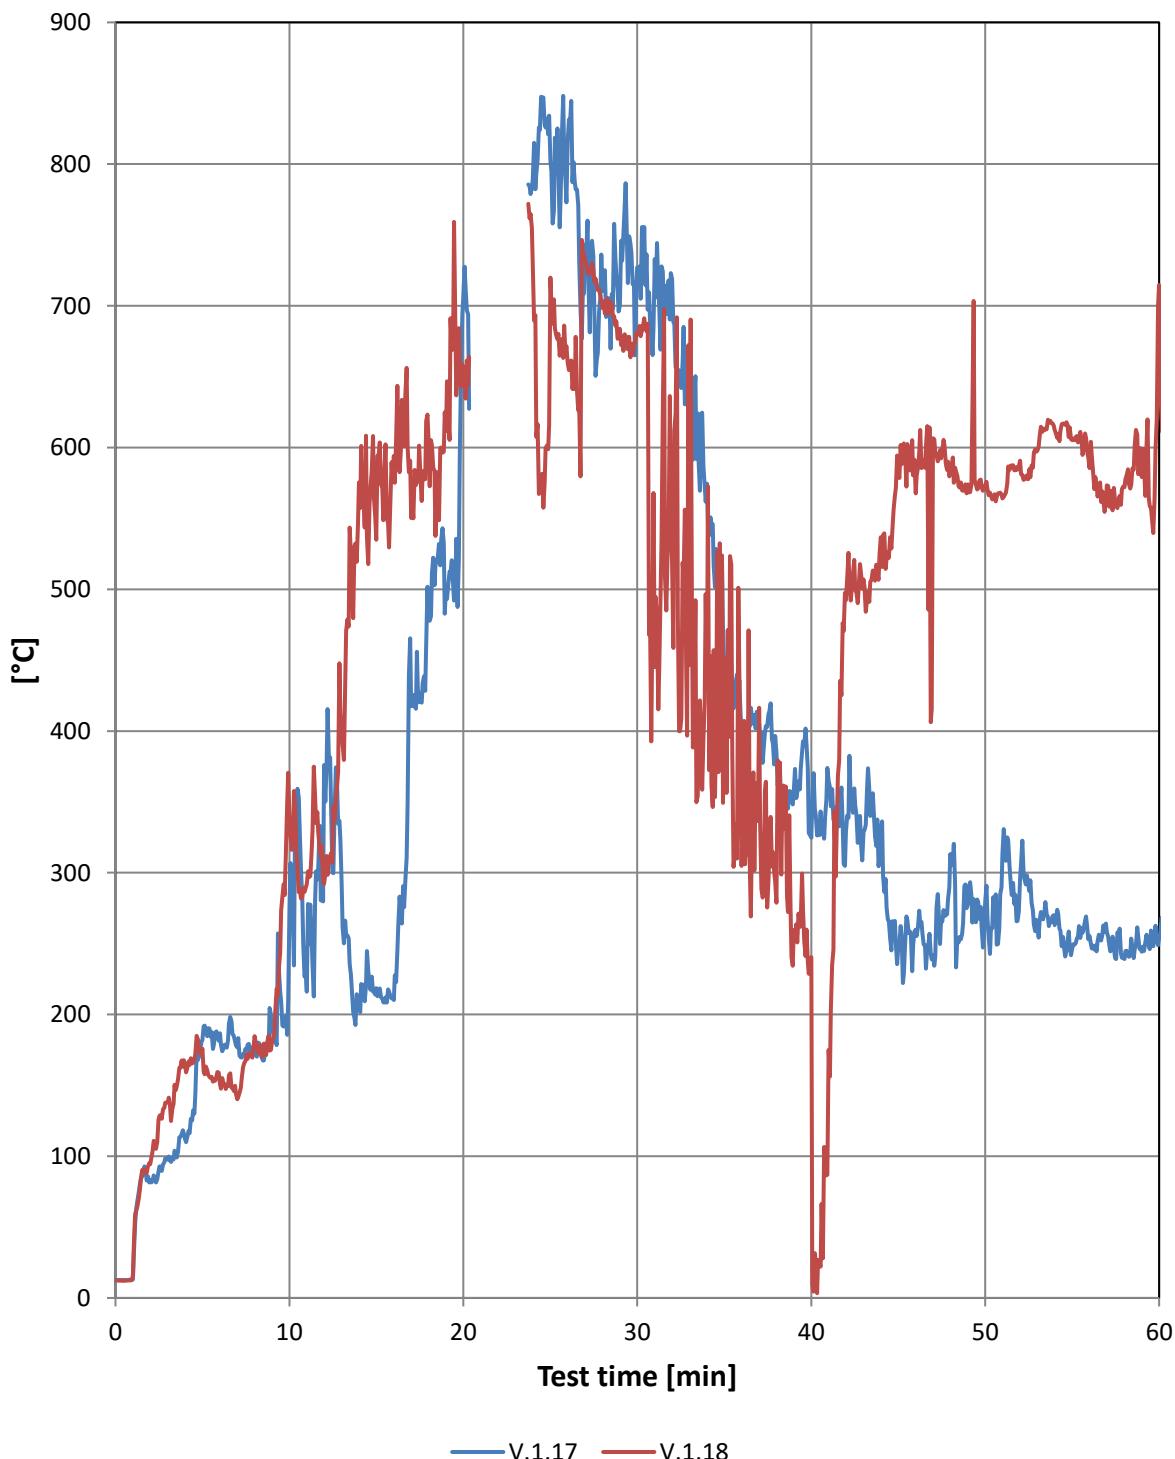
**Temperature measured in the ventilated cavity**

A 3-minute mechanical failure caused all thermocouples to fail between 20 and 23

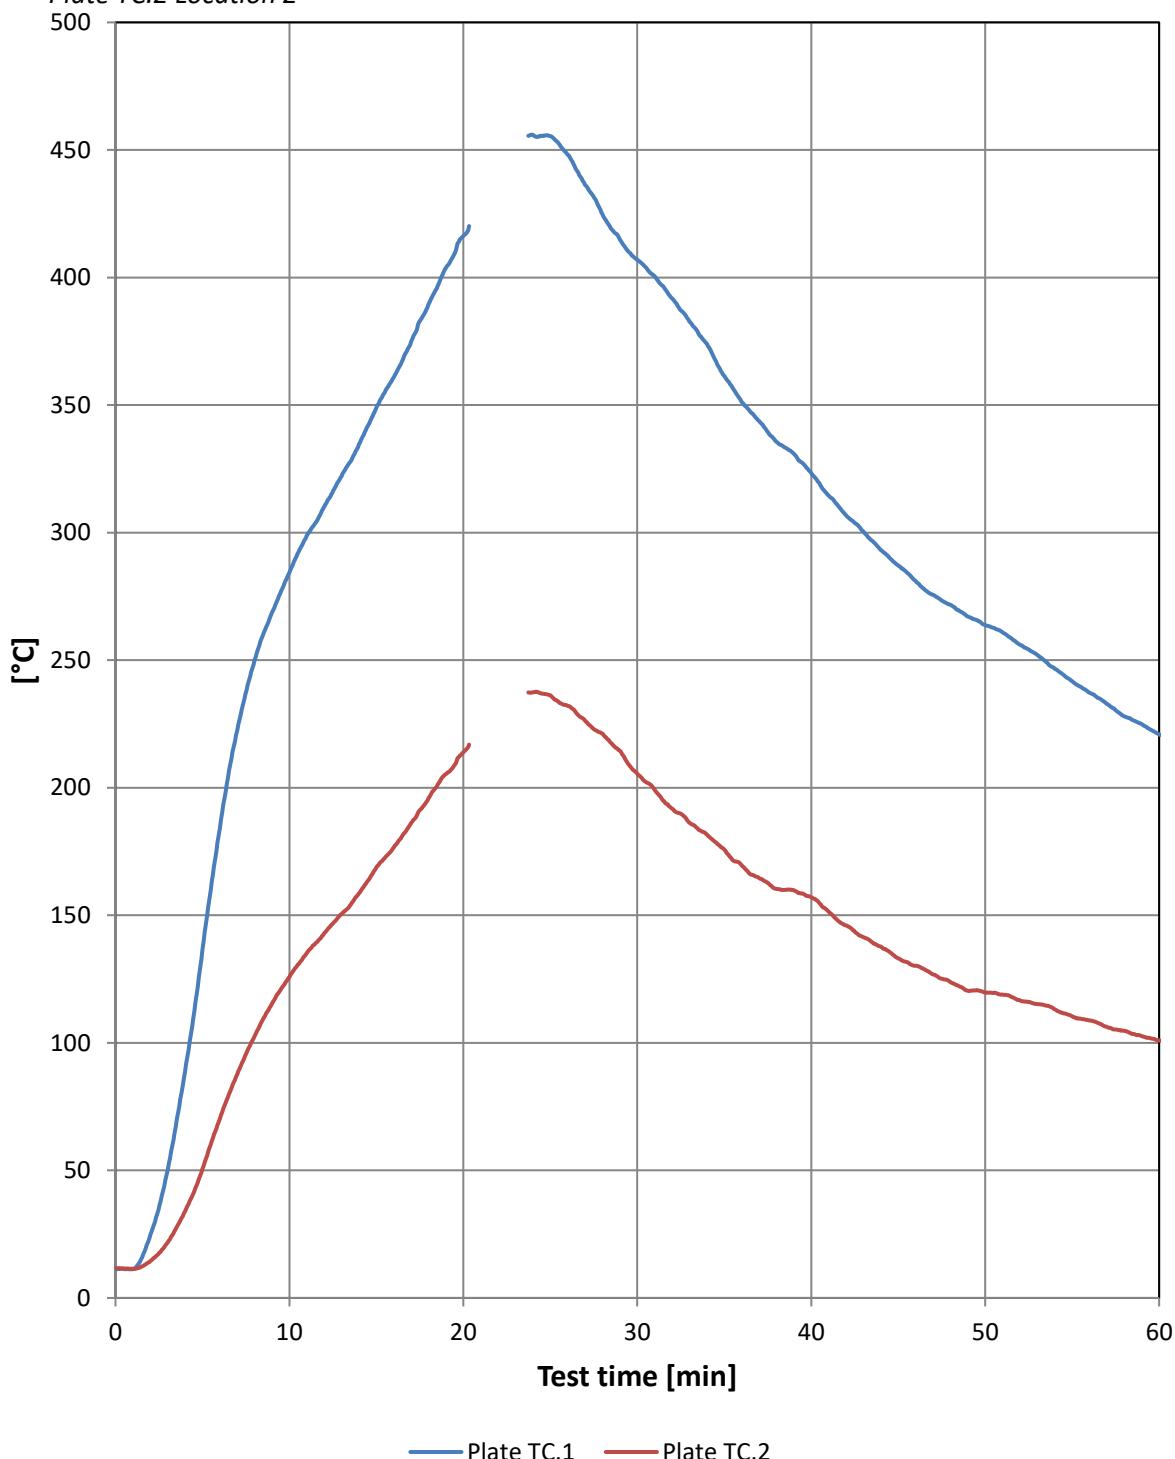
## Plate thermocouple

Plate TC.1 Location 1

Plate TC.2 Location 2

A 3-minute mechanical failure caused all thermocouples to fail between 20 and 23

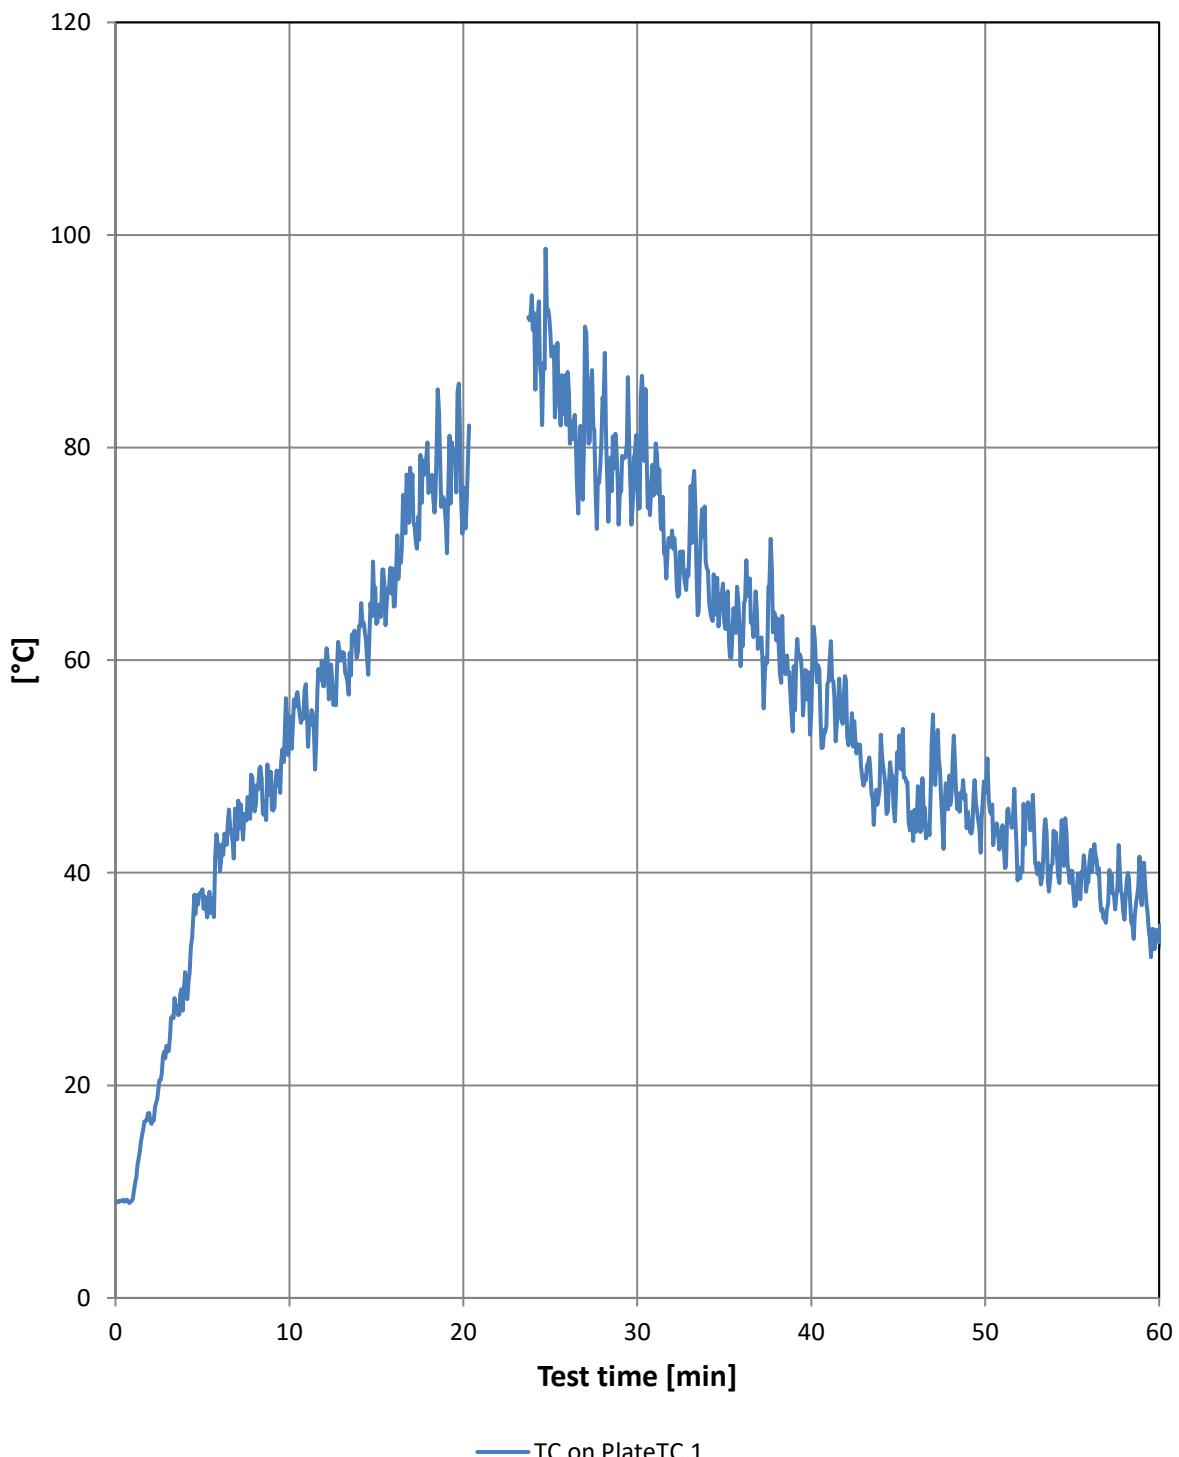
**Location 1 - TC on PlateTC**

*A 3-minute mechanical failure caused all thermocouples to fail between 20 and 23*

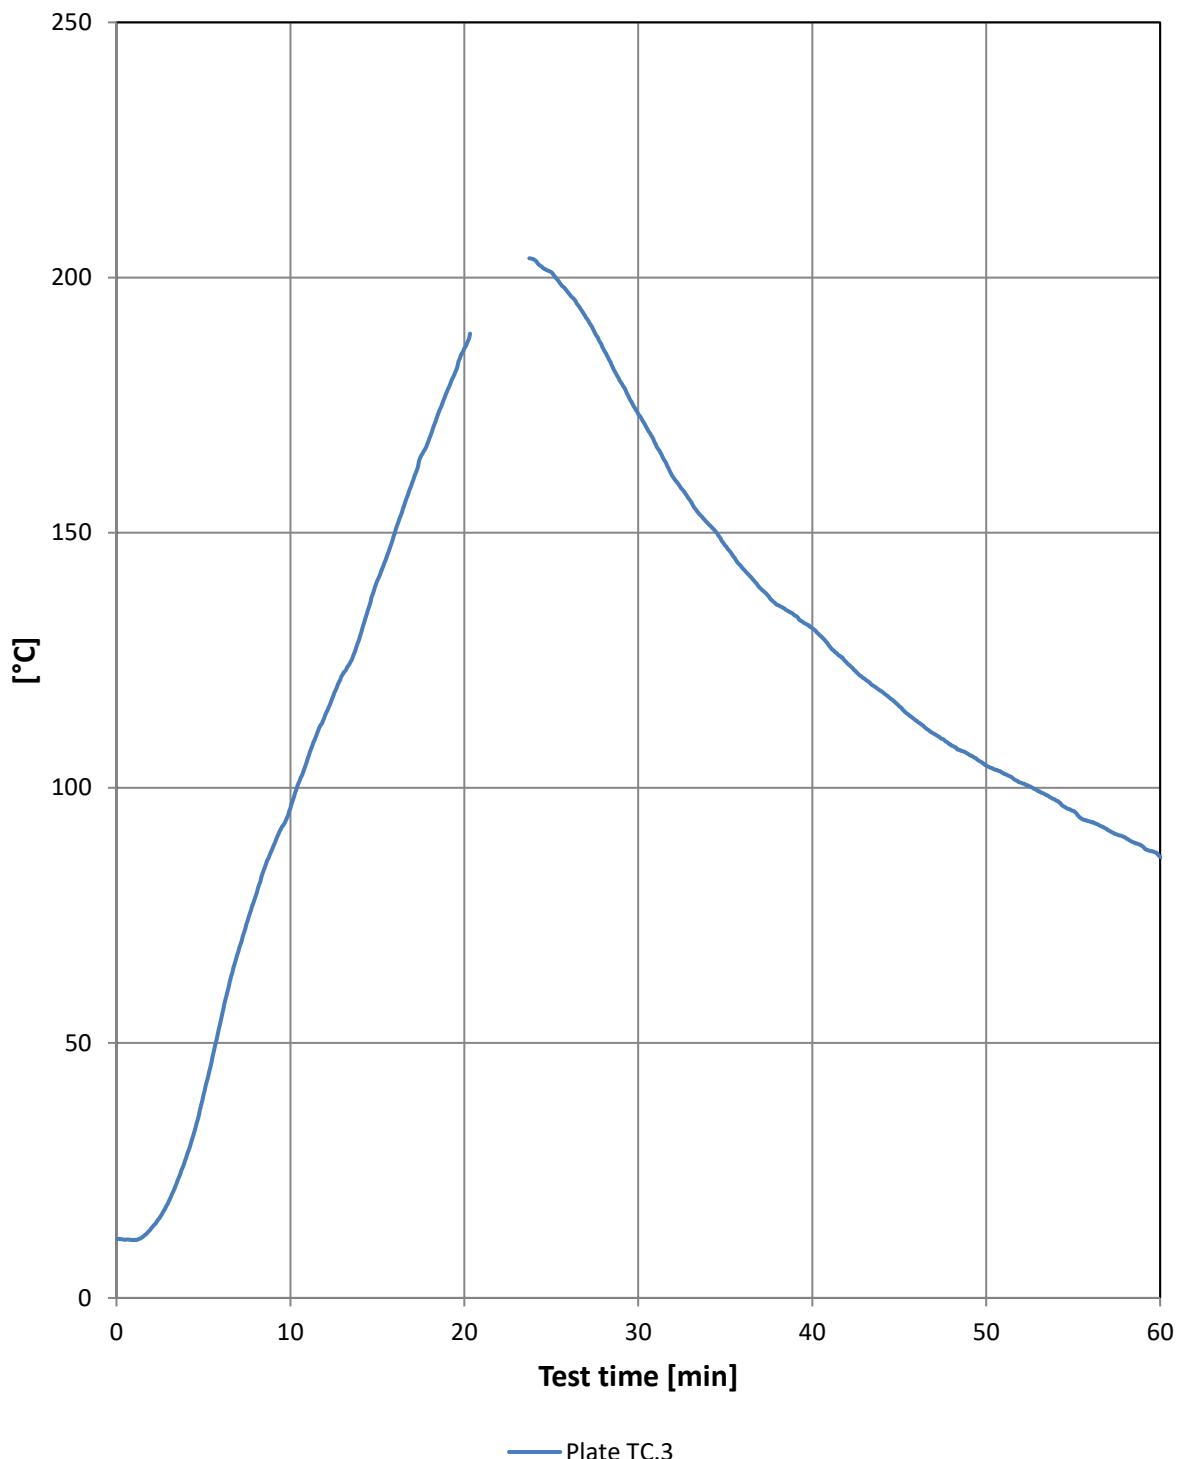
**Location 2. 5 m from facade 4.5 m height.**

*A 3-minute mechanical failure caused all thermocouples to fail between 20 and 23*

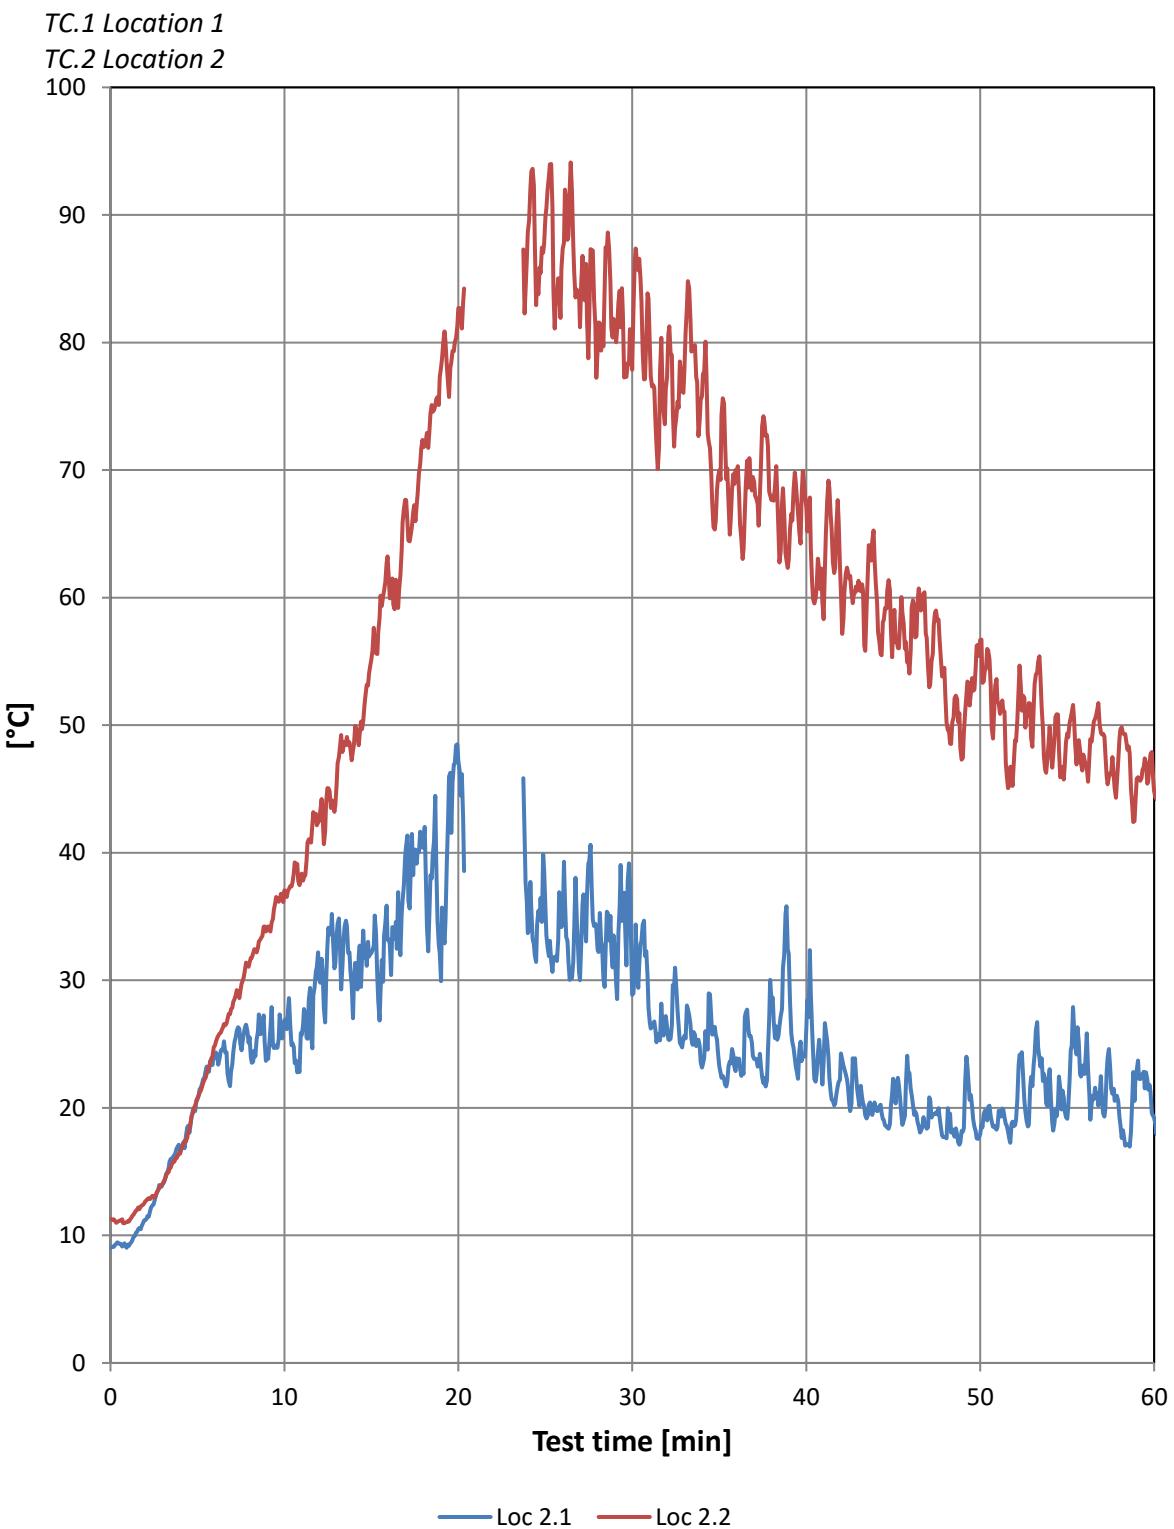
## Thermocouple

A 3-minute mechanical failure caused all thermocouples to fail between 20 and 23

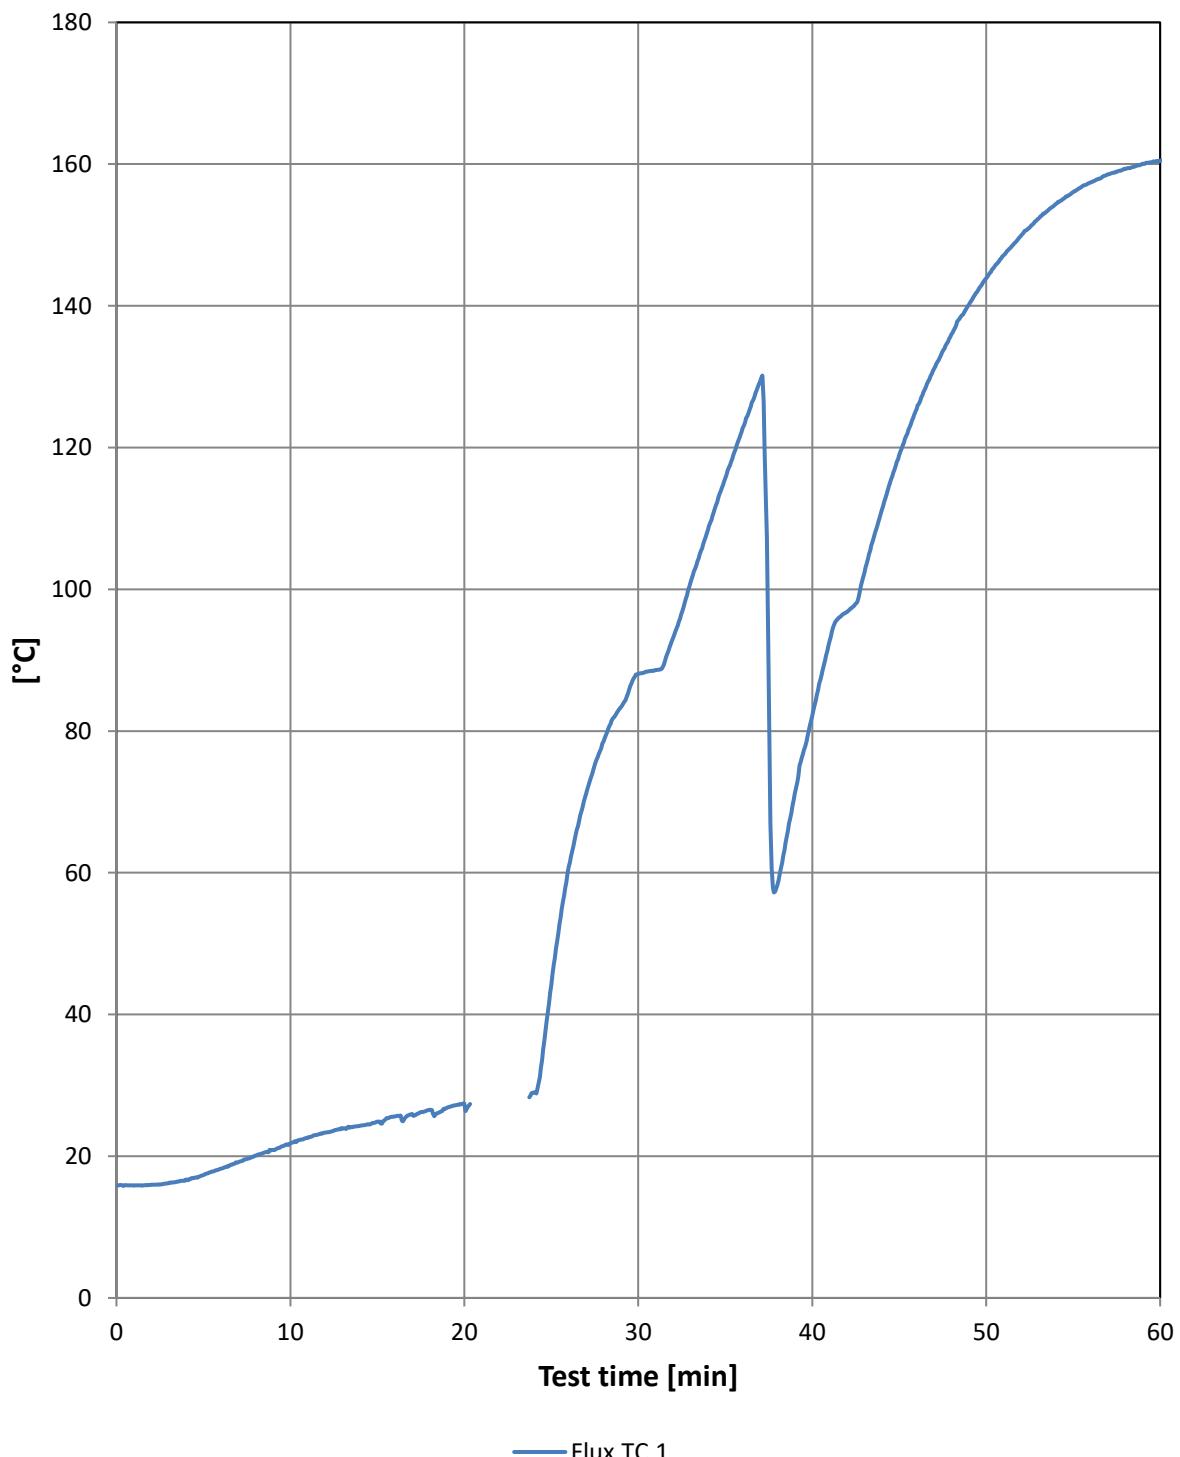
## Flux TC

*Flux.TC.2 located 3 m from fire chamber*

*A 3-minute mechanical failure caused all thermocouples to fail between 20 and 23*
