# TEST REPORT EU FACADE TEST 3

<b>Name of sponsor:</b>	CPH Village Holding ApS		
<b>Product name:</b>	EU facade test draft 6		
<b>File no.:</b>	PGC10027A	<b>Revision no.:</b>	0
<b>Test date:</b>	27-10-2023	<b>Date:</b>	07-12-2023
<b>Pages:</b>	13	<b>Encl.:</b>	92
<b>Ref:</b>	CHD	/	CHB

Examination of the fire performance of a façade using the large fire exposure.

ASSESSMENT OF FIRE PERFORMANCE OF FACADES USING LARGE FIRE EXPOSURE

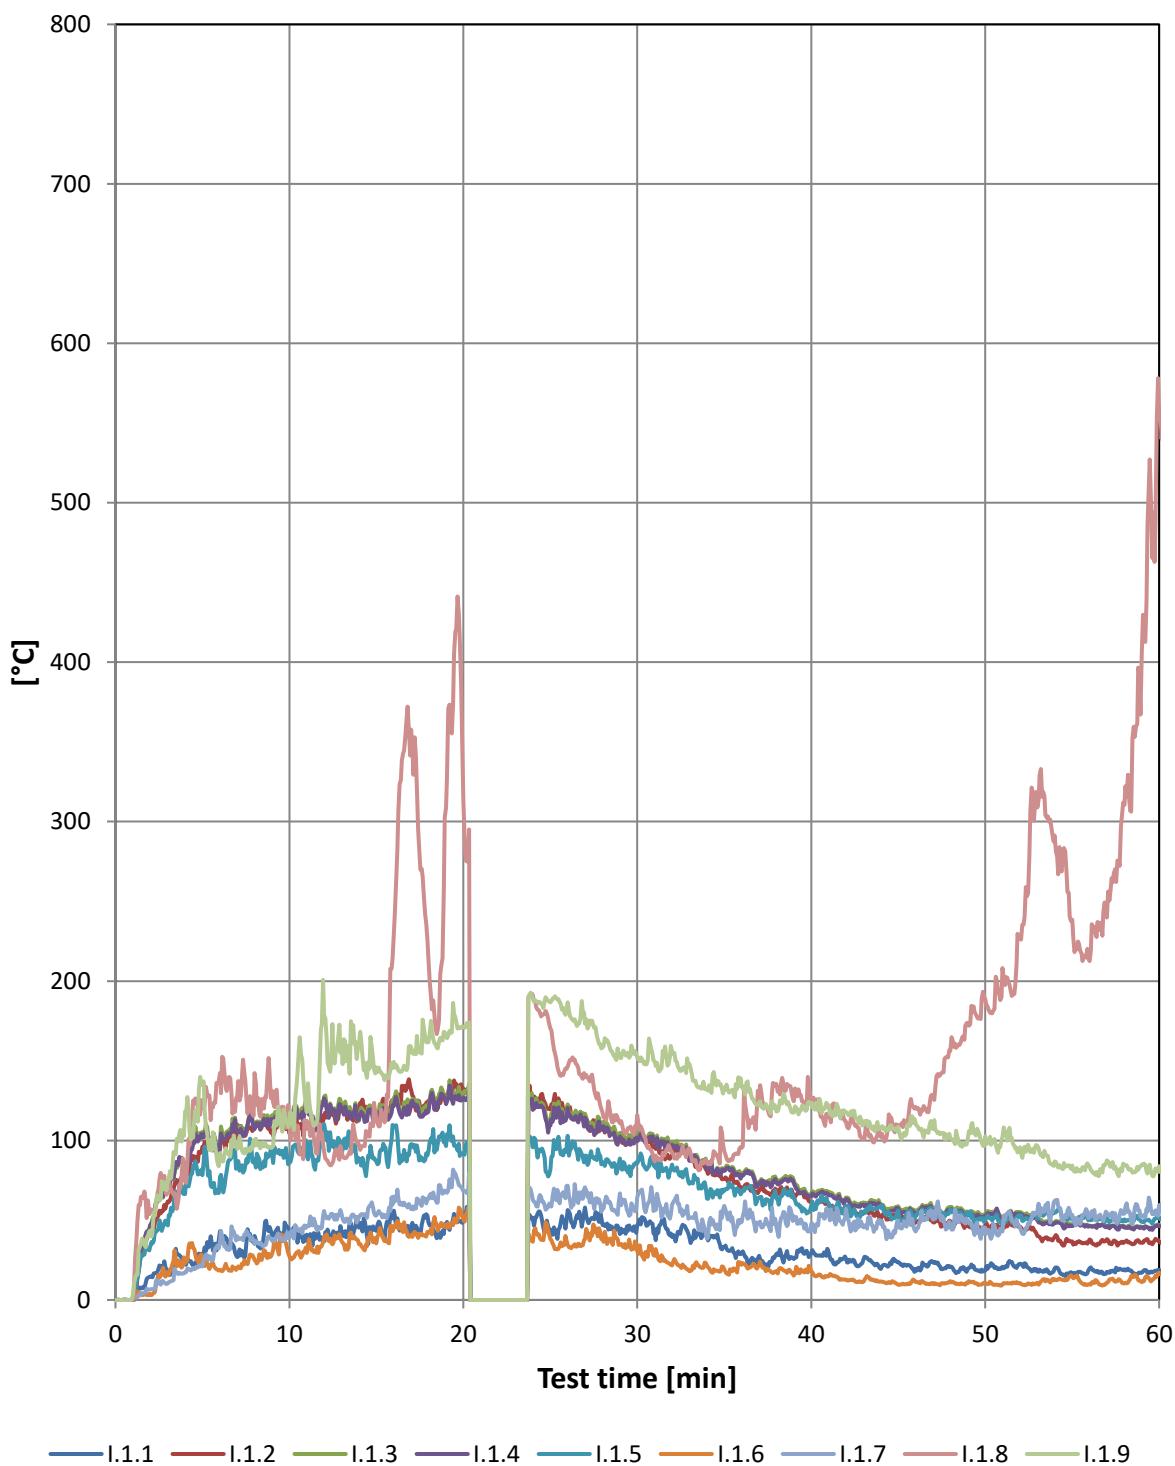
## Temperature rise measured 50mm from the facade

A 3-minute mechanical failure caused all thermocouples to fail between 20 and 23

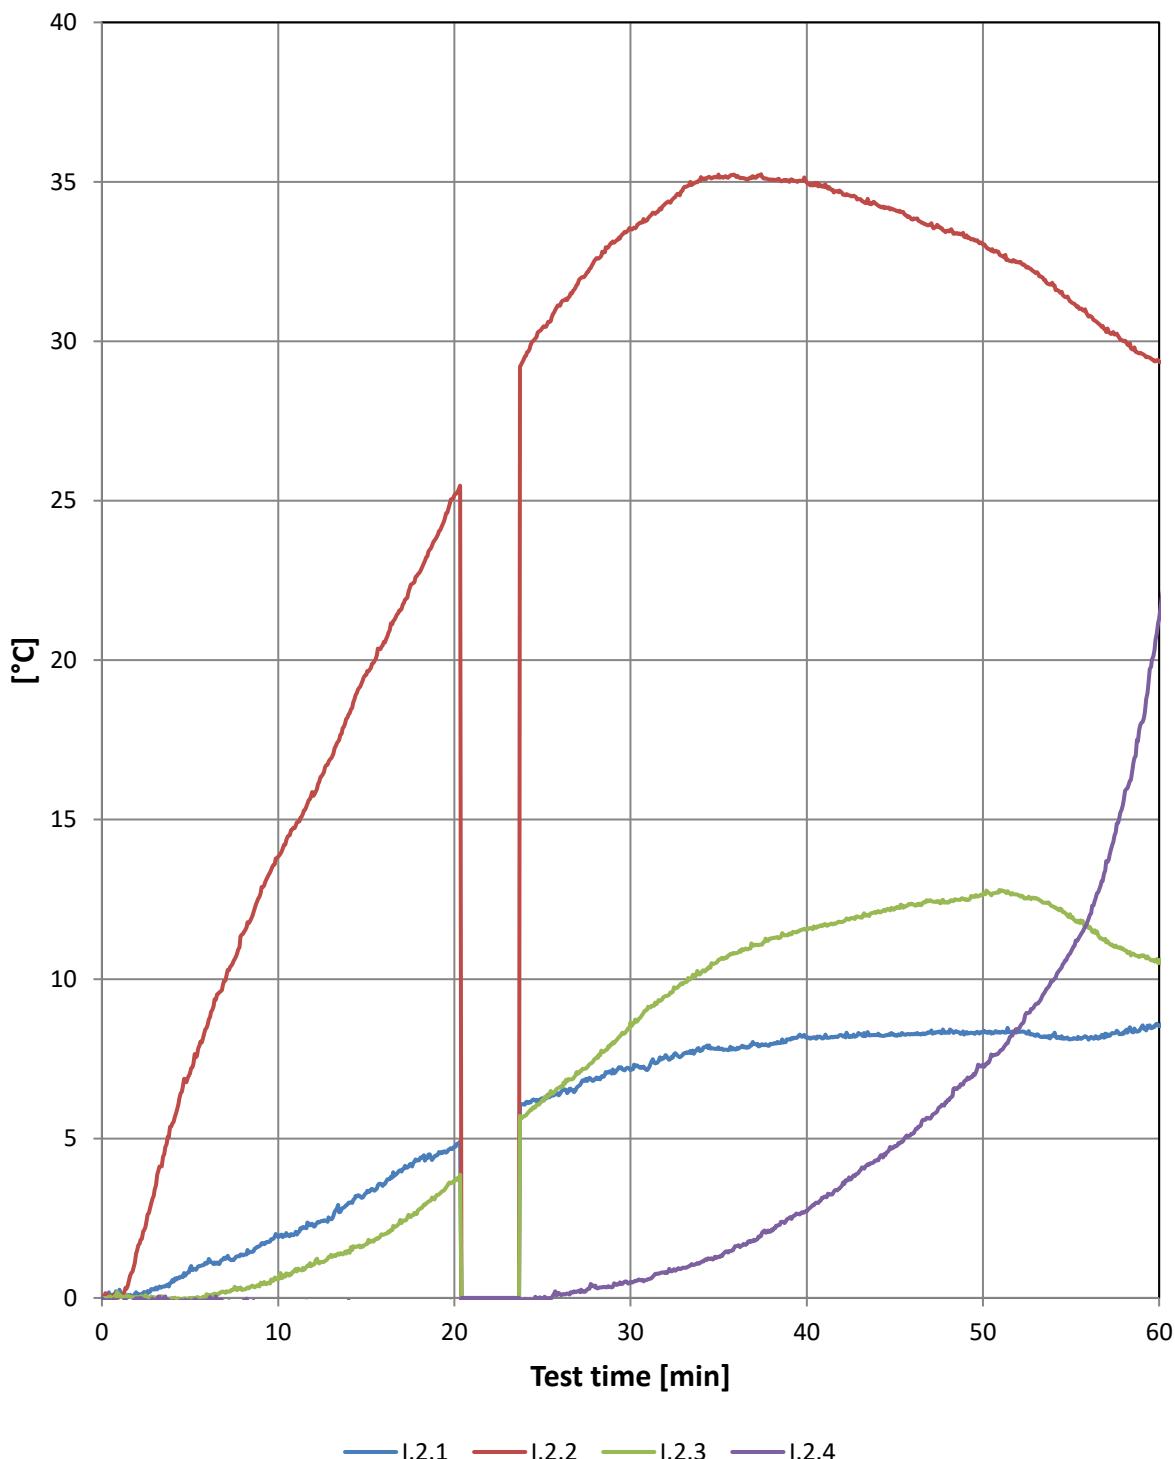
## Temperature rise measured in ventilation layer

A 3-minute mechanical failure caused all thermocouples to fail between 20 and 23

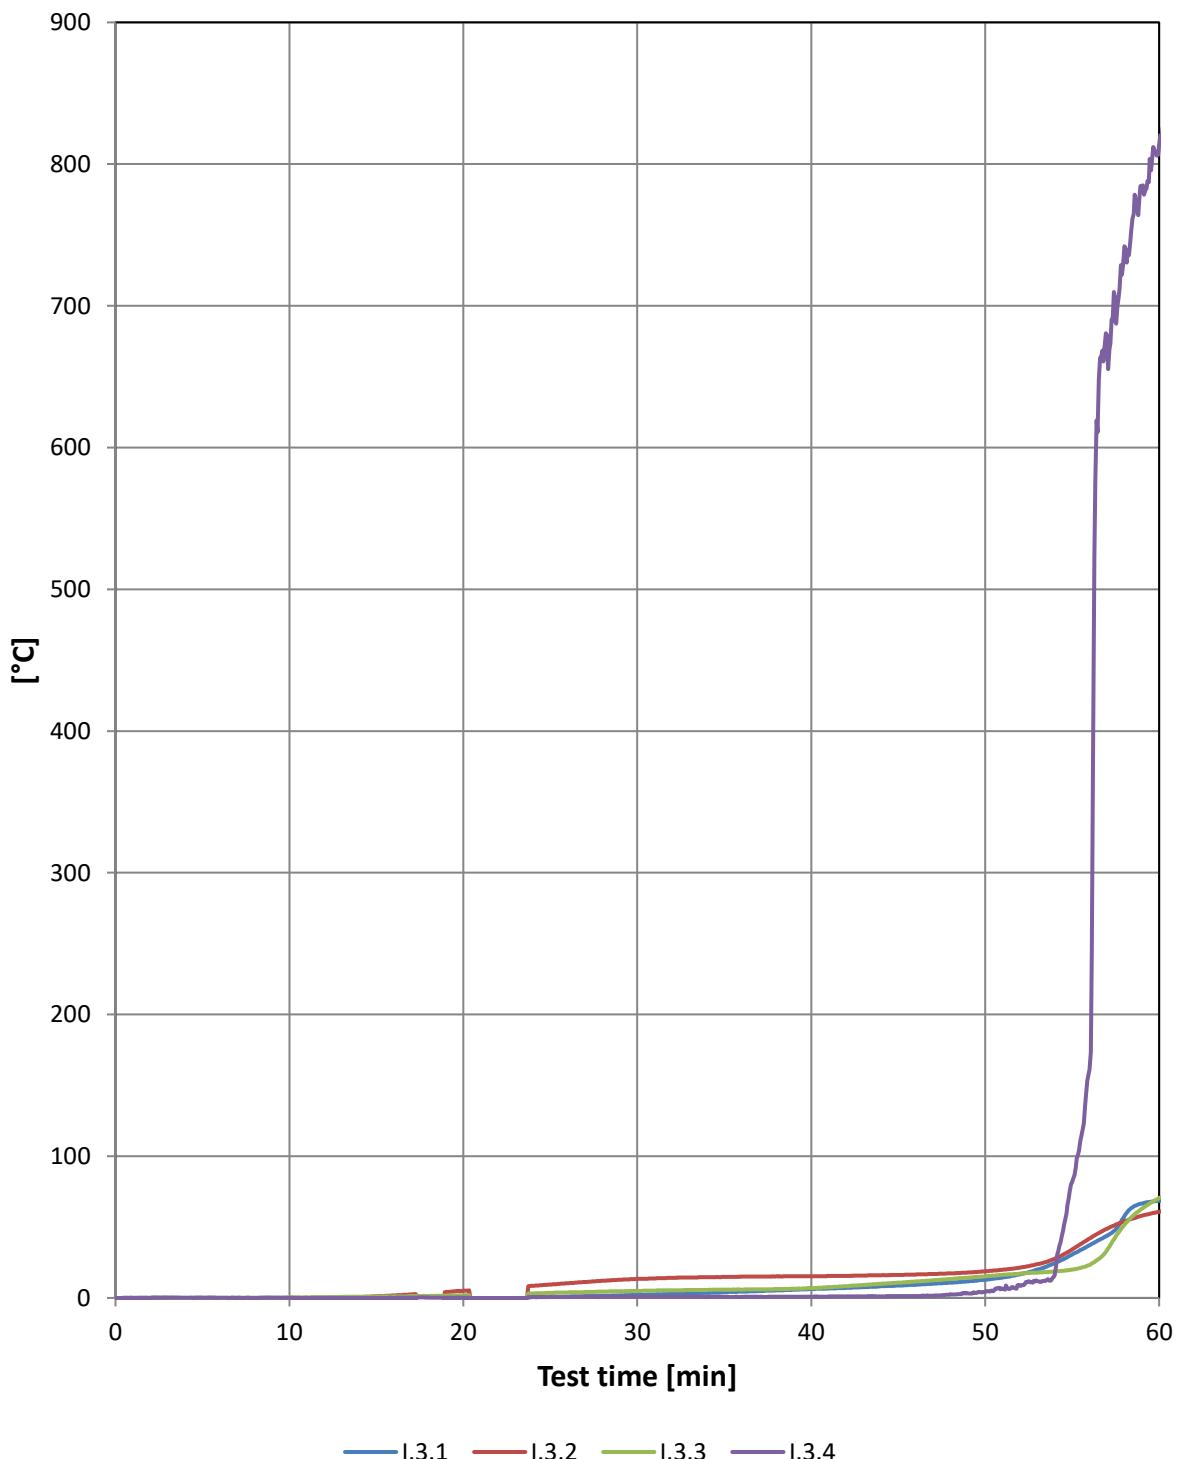
**Temperature rise measured in middle of insulation**

A 3-minute mechanical failure caused all thermocouples to fail between 20 and 23

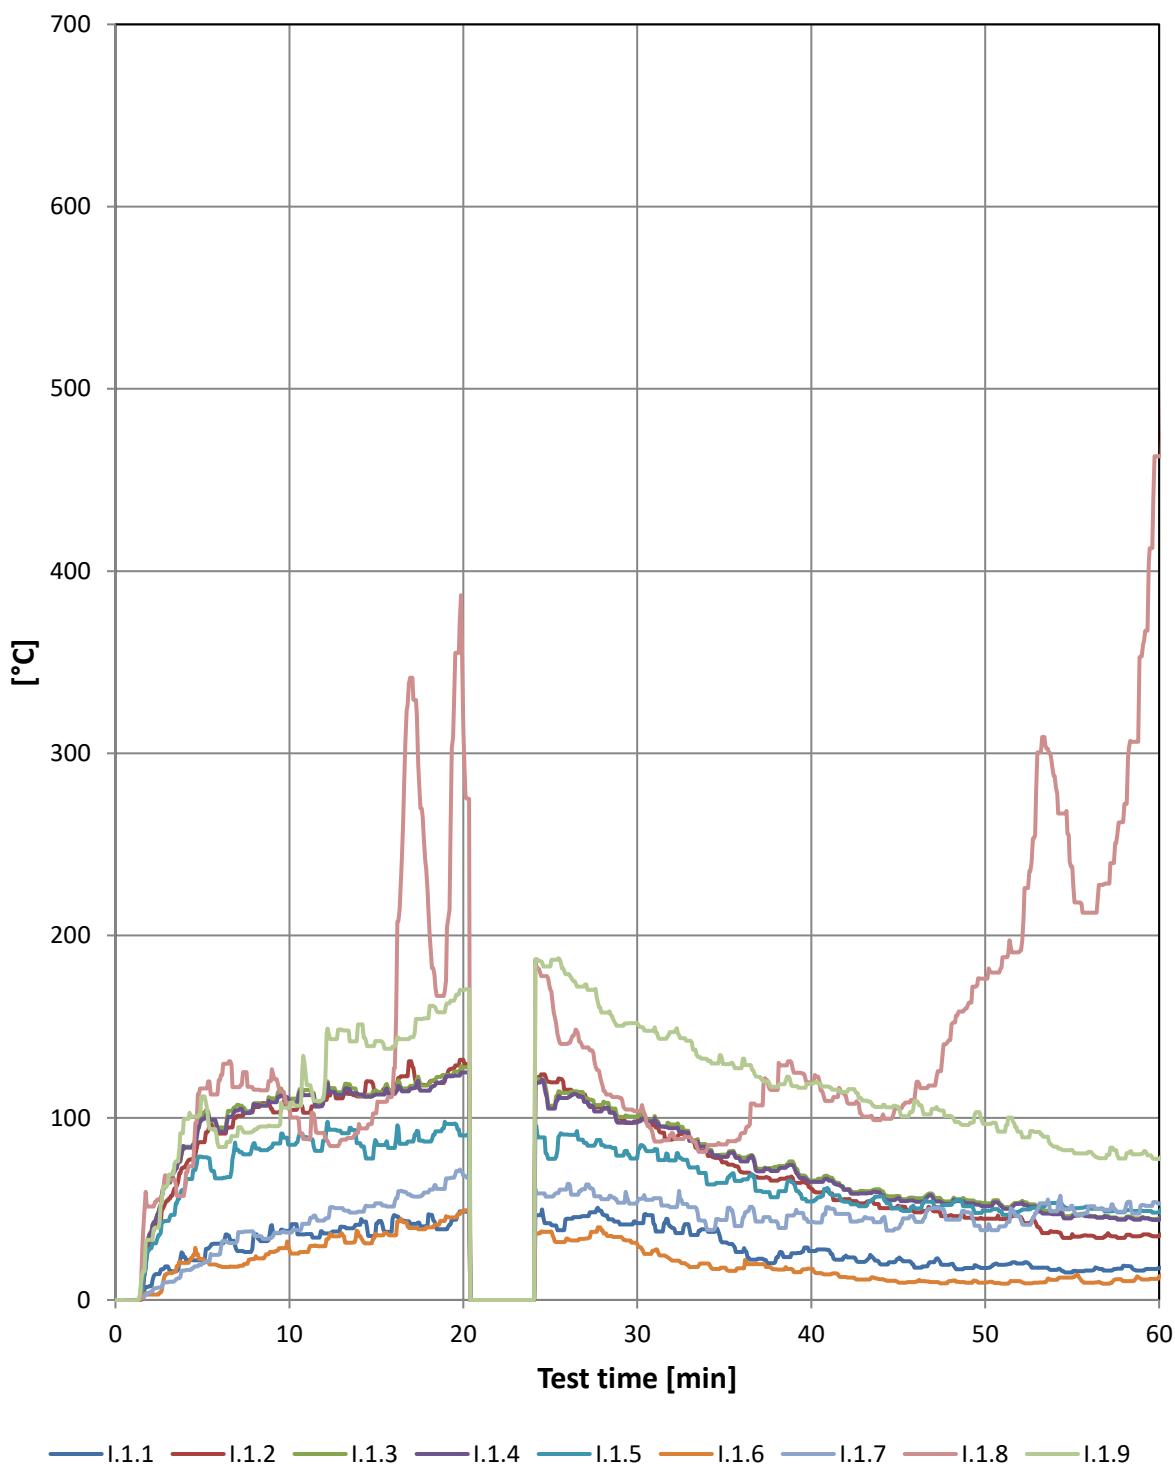
**Temperature rise measured according to the standard - 50 mm from facade. Minimum of 30 sec**

A 3-minute mechanical failure caused all thermocouples to fail between 20 and 23

Failure [min]	-	-	-	-	-	-	-	60.20	-	60.20
Failure°C	500	500	500	500	500	500	500	500	500	500

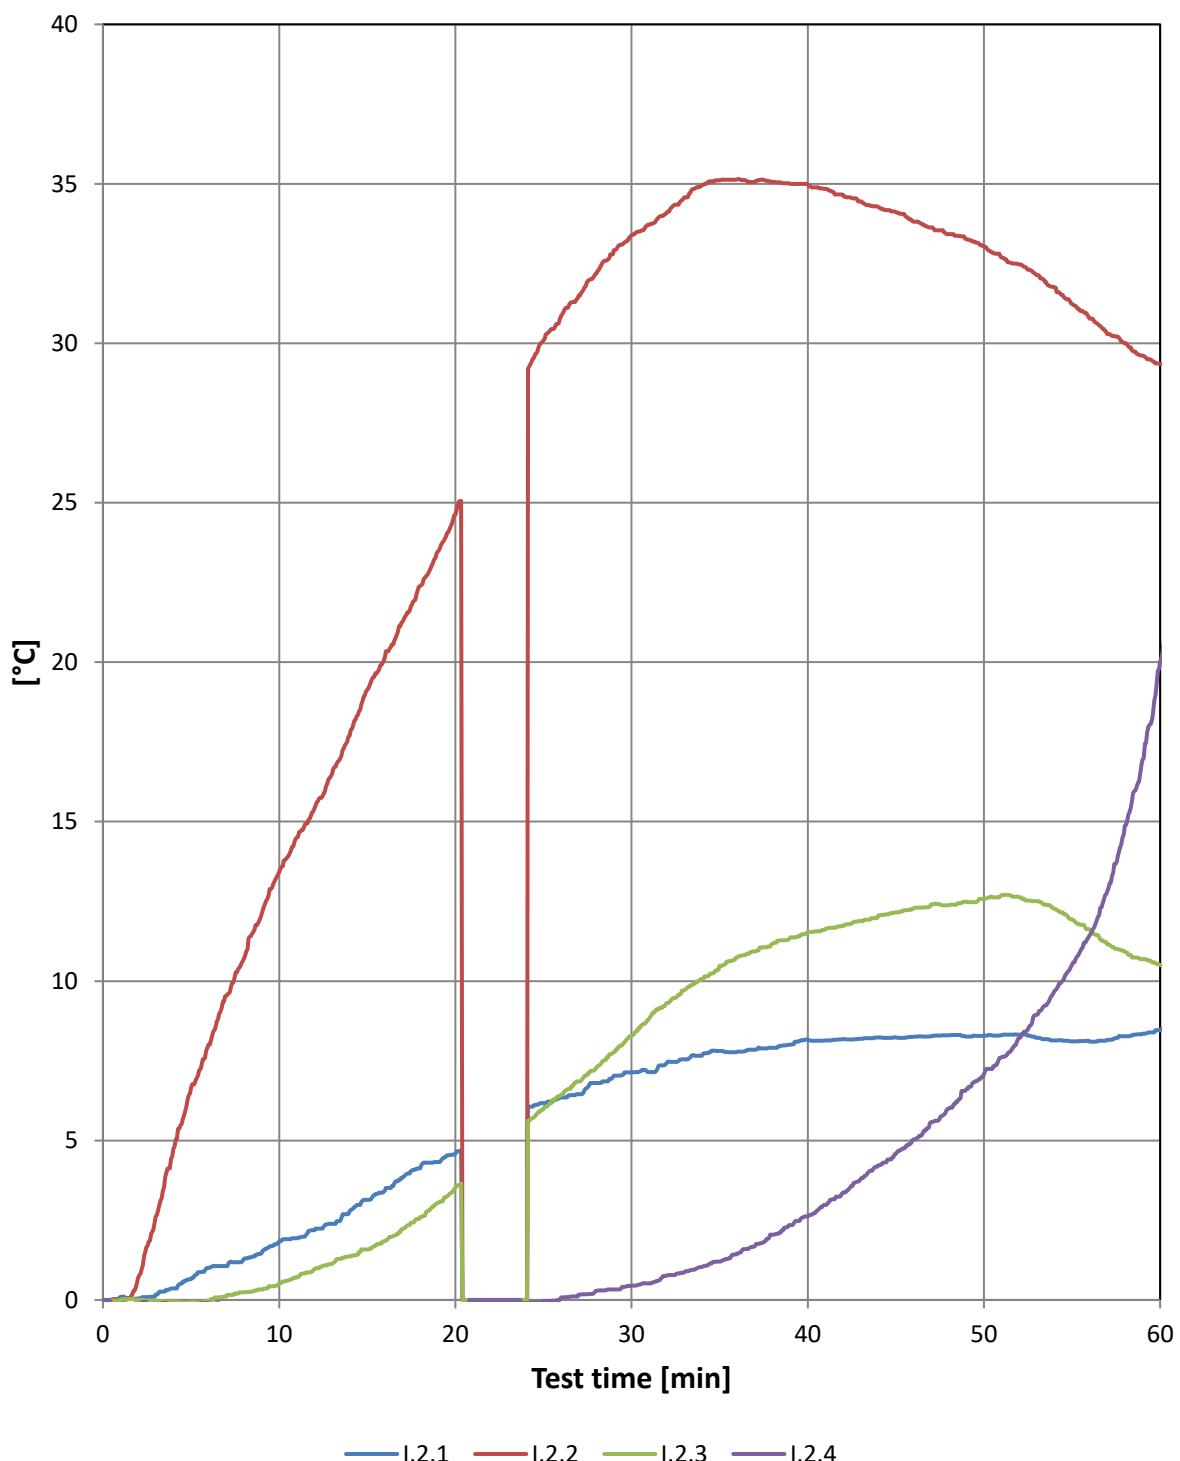
**Temperature rise measured according to the standard - ventilation layer.  
Minimum of 30 sec**

*A 3-minute mechanical failure caused all thermocouples to fail between 20 and 23*

Failure [min]	-	-	-	-	-
Failure°C	500	500	500	500	500

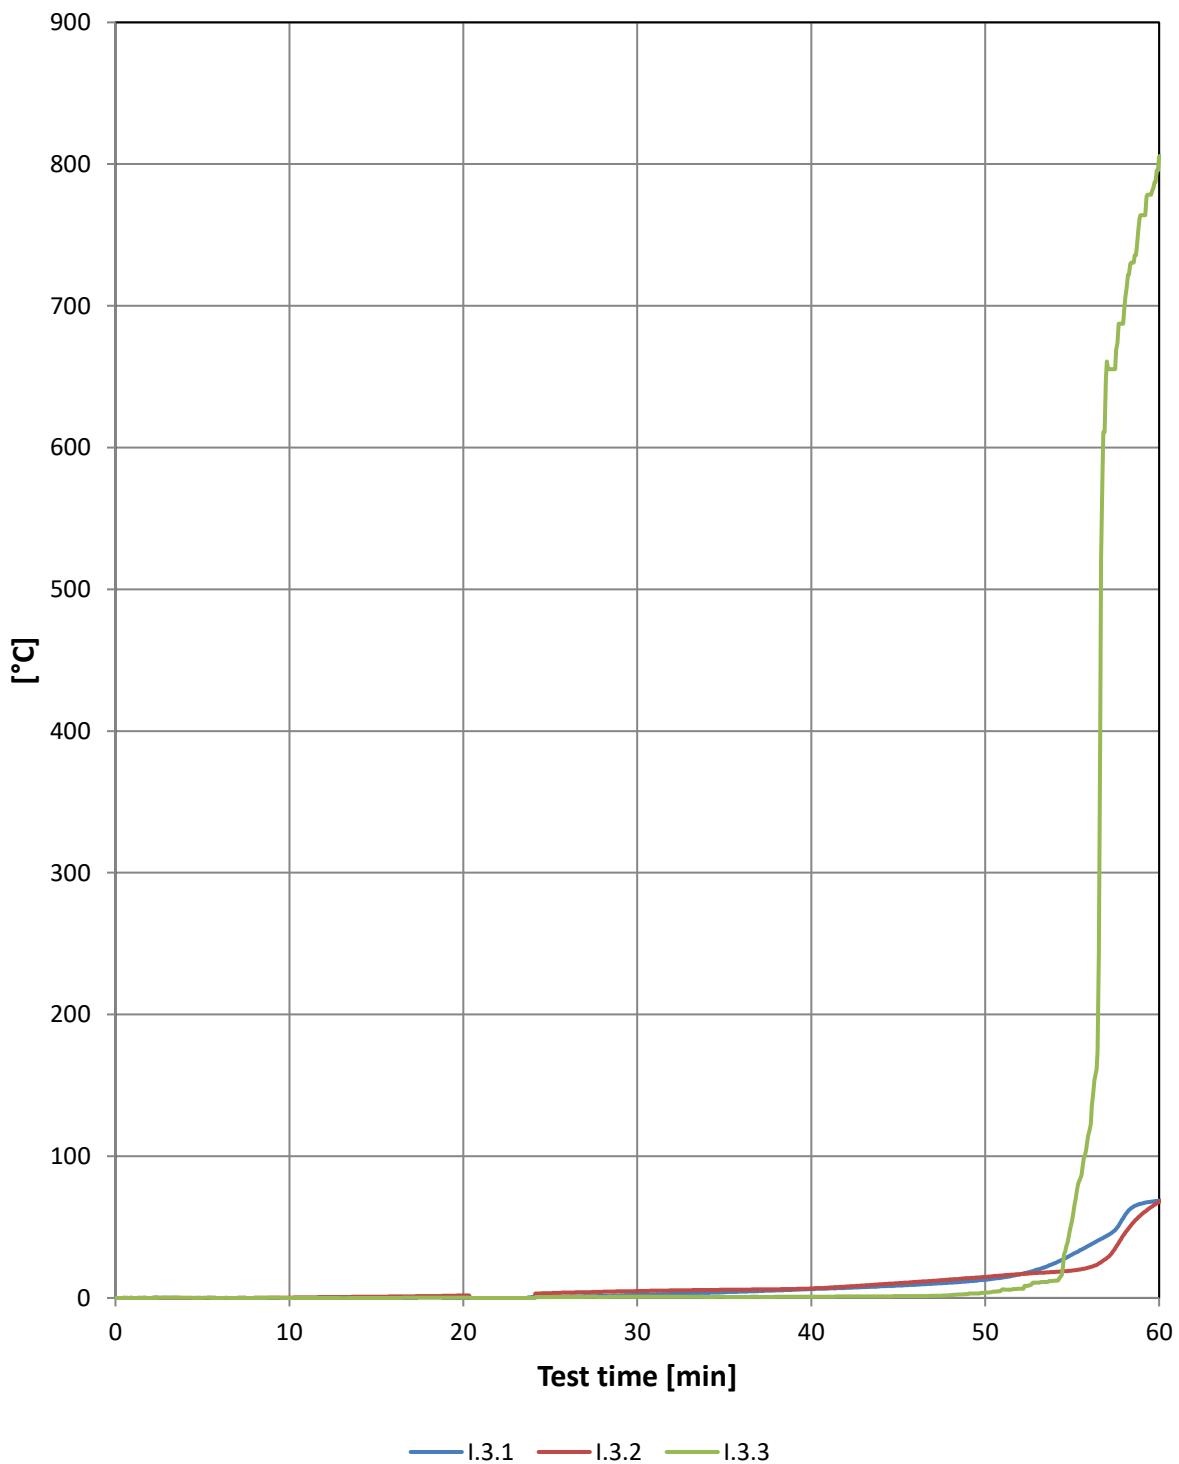
**Temperature rise measured according to the standard - in the middle of the insulation. Minimum of 30 sec**

*A 3-minute mechanical failure caused all thermocouples to fail between 20 and 23*

Failure [min]	-	-	56.60	56.60
Failure°C	500	500	500	500

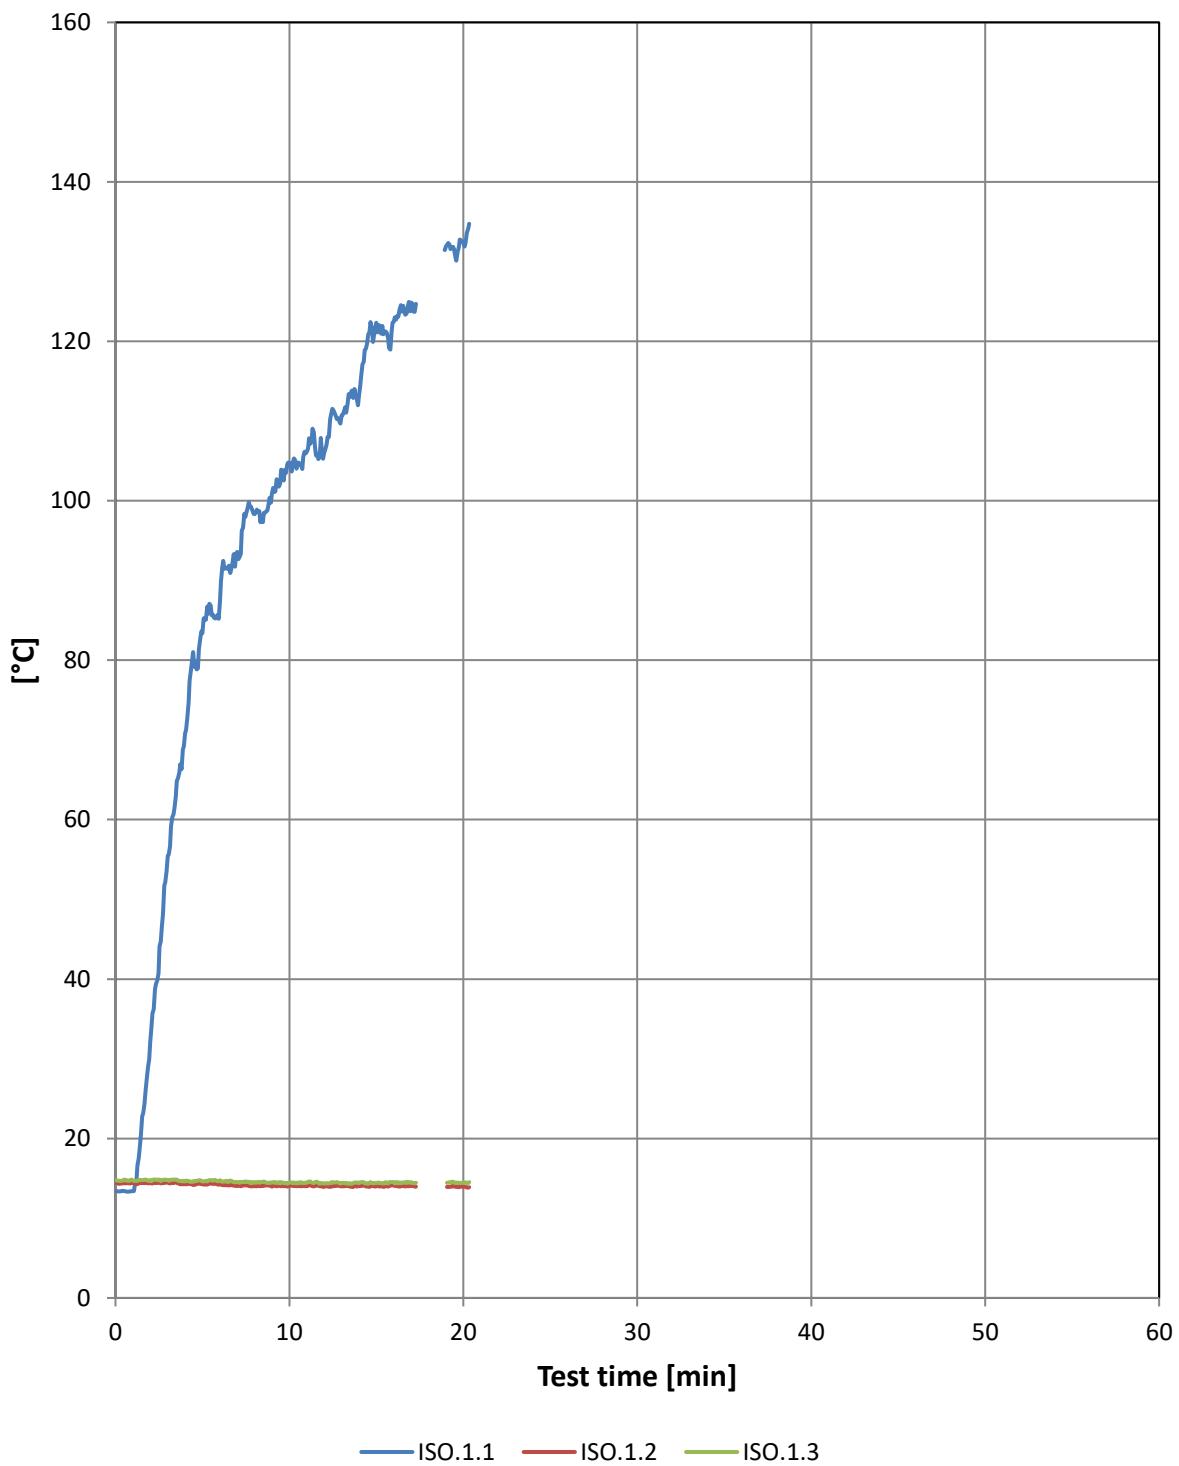
**Temperature measured behind windbreaker**

*All ISO failed due to mechanical failure after 16 minutes of testing*

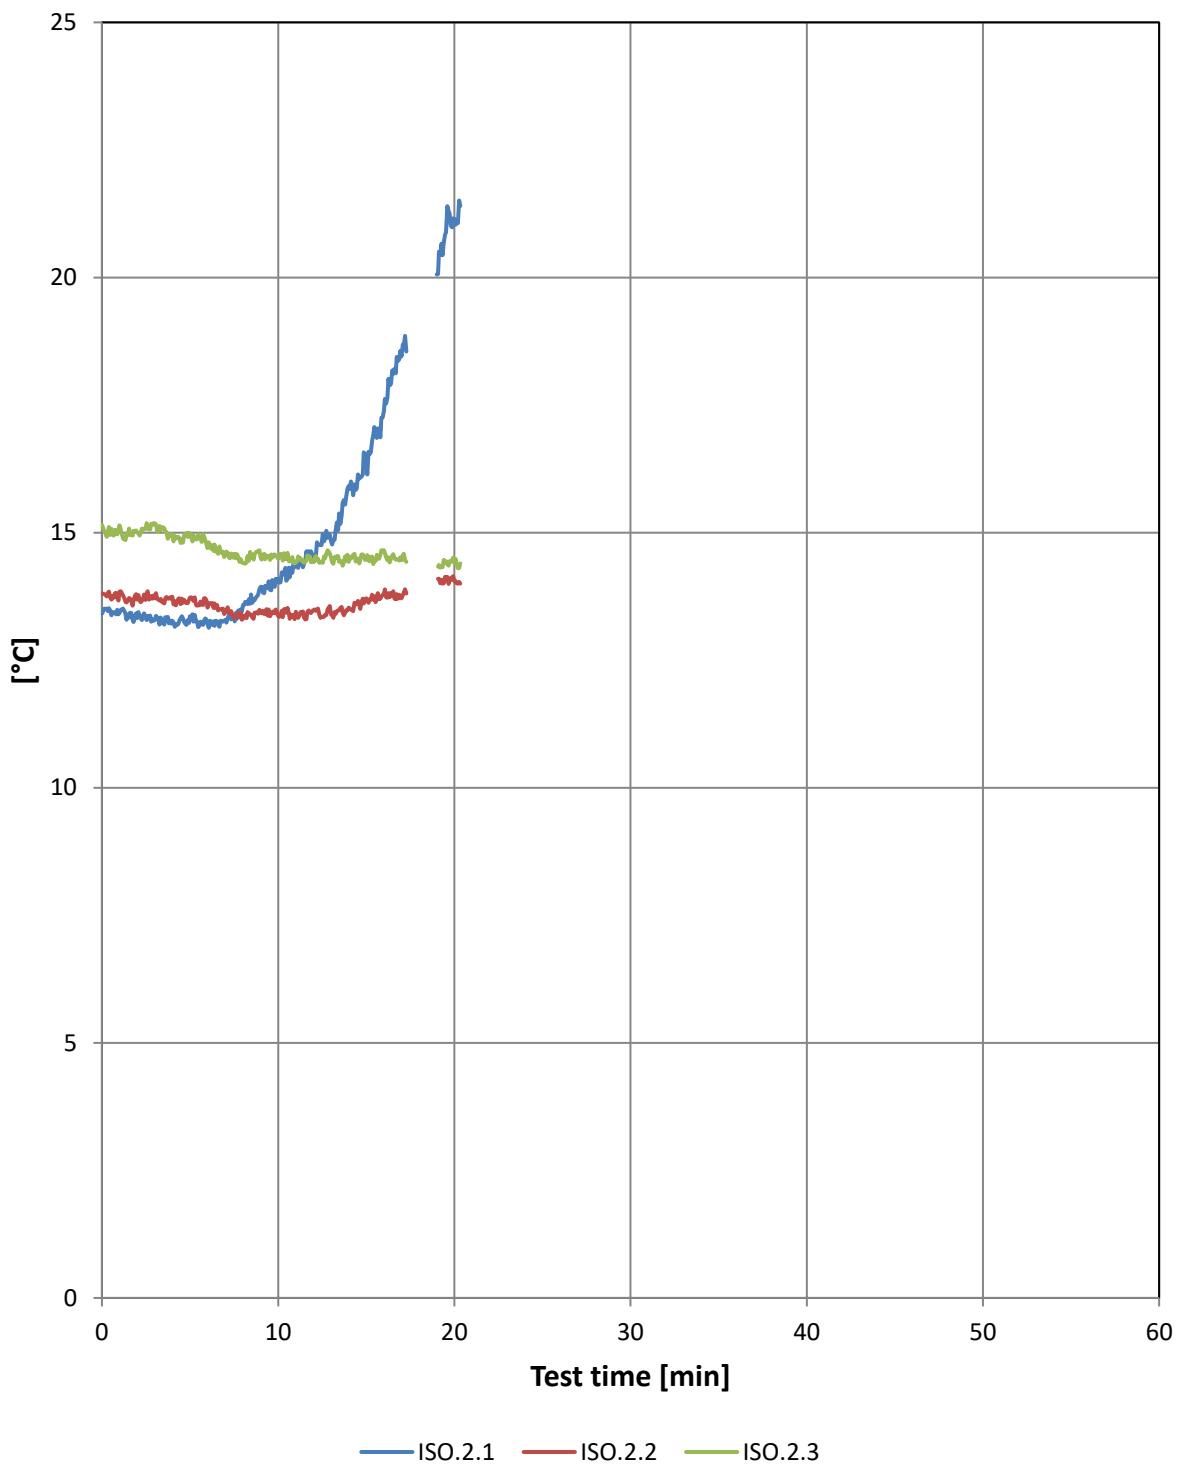
**Temperature measured back side of insulation**

*All ISO failed due to mechanical failure after 16 minutes of testing*

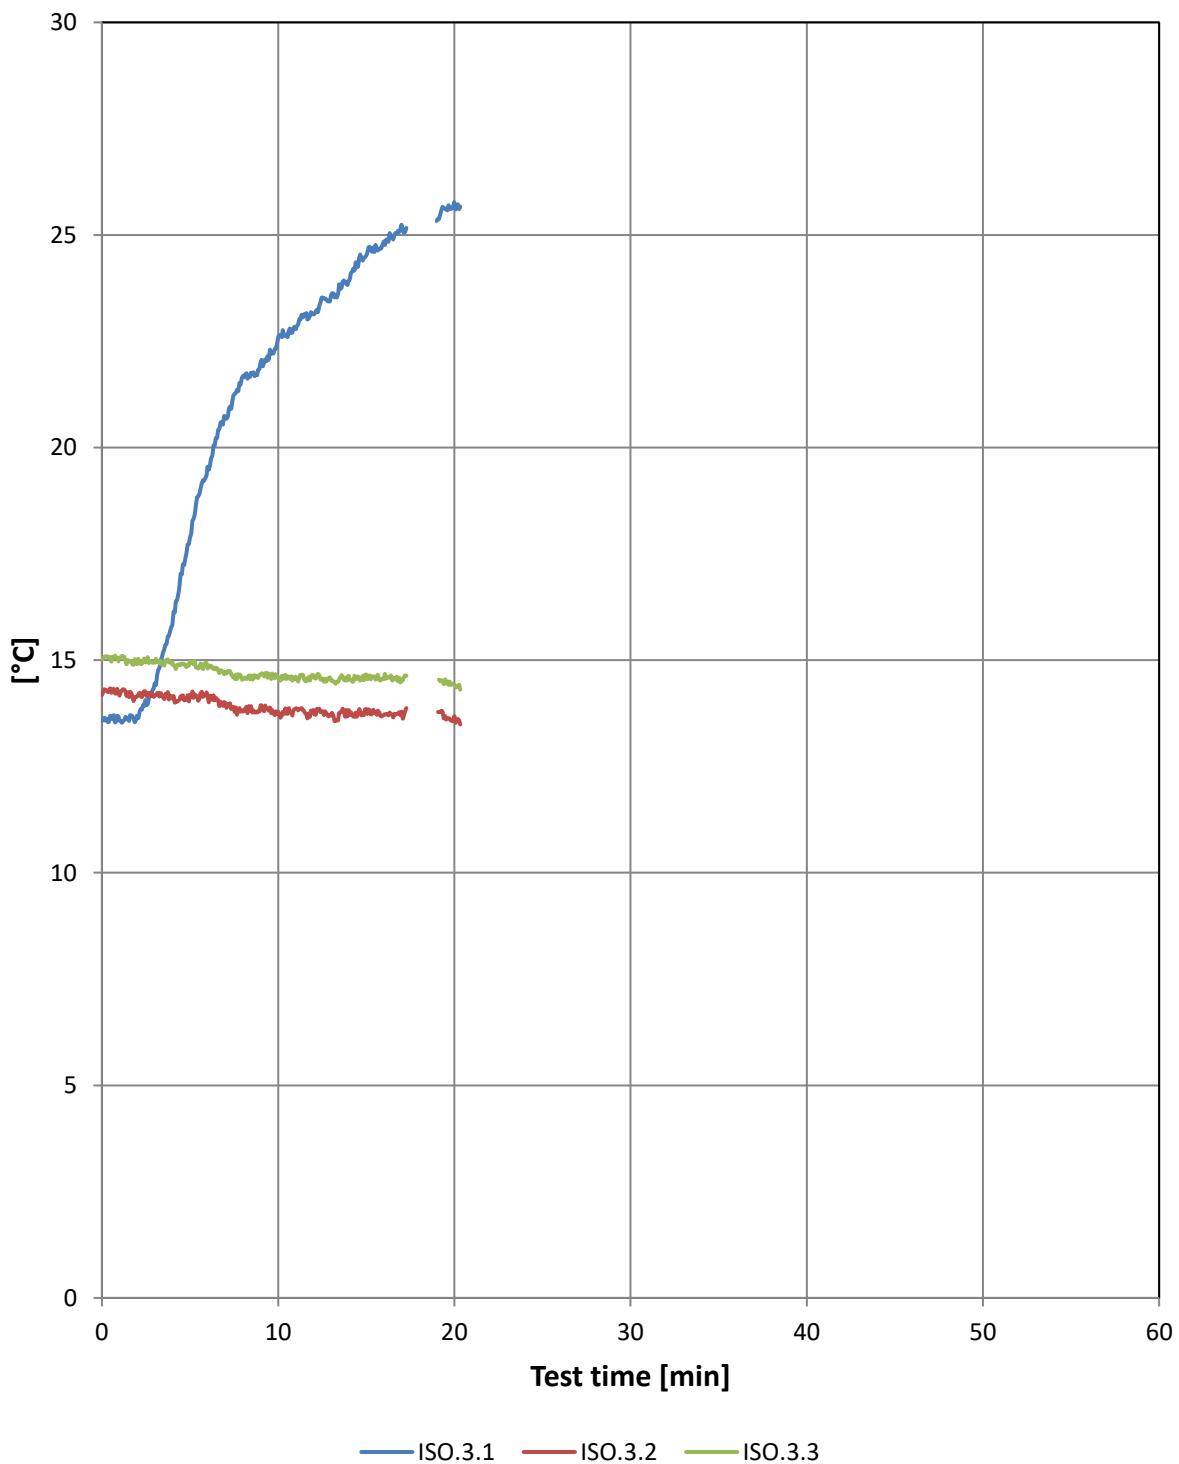
**Temperature measured middle of insulation**

*All ISO failed due to mechanical failure after 16 minutes of testing*

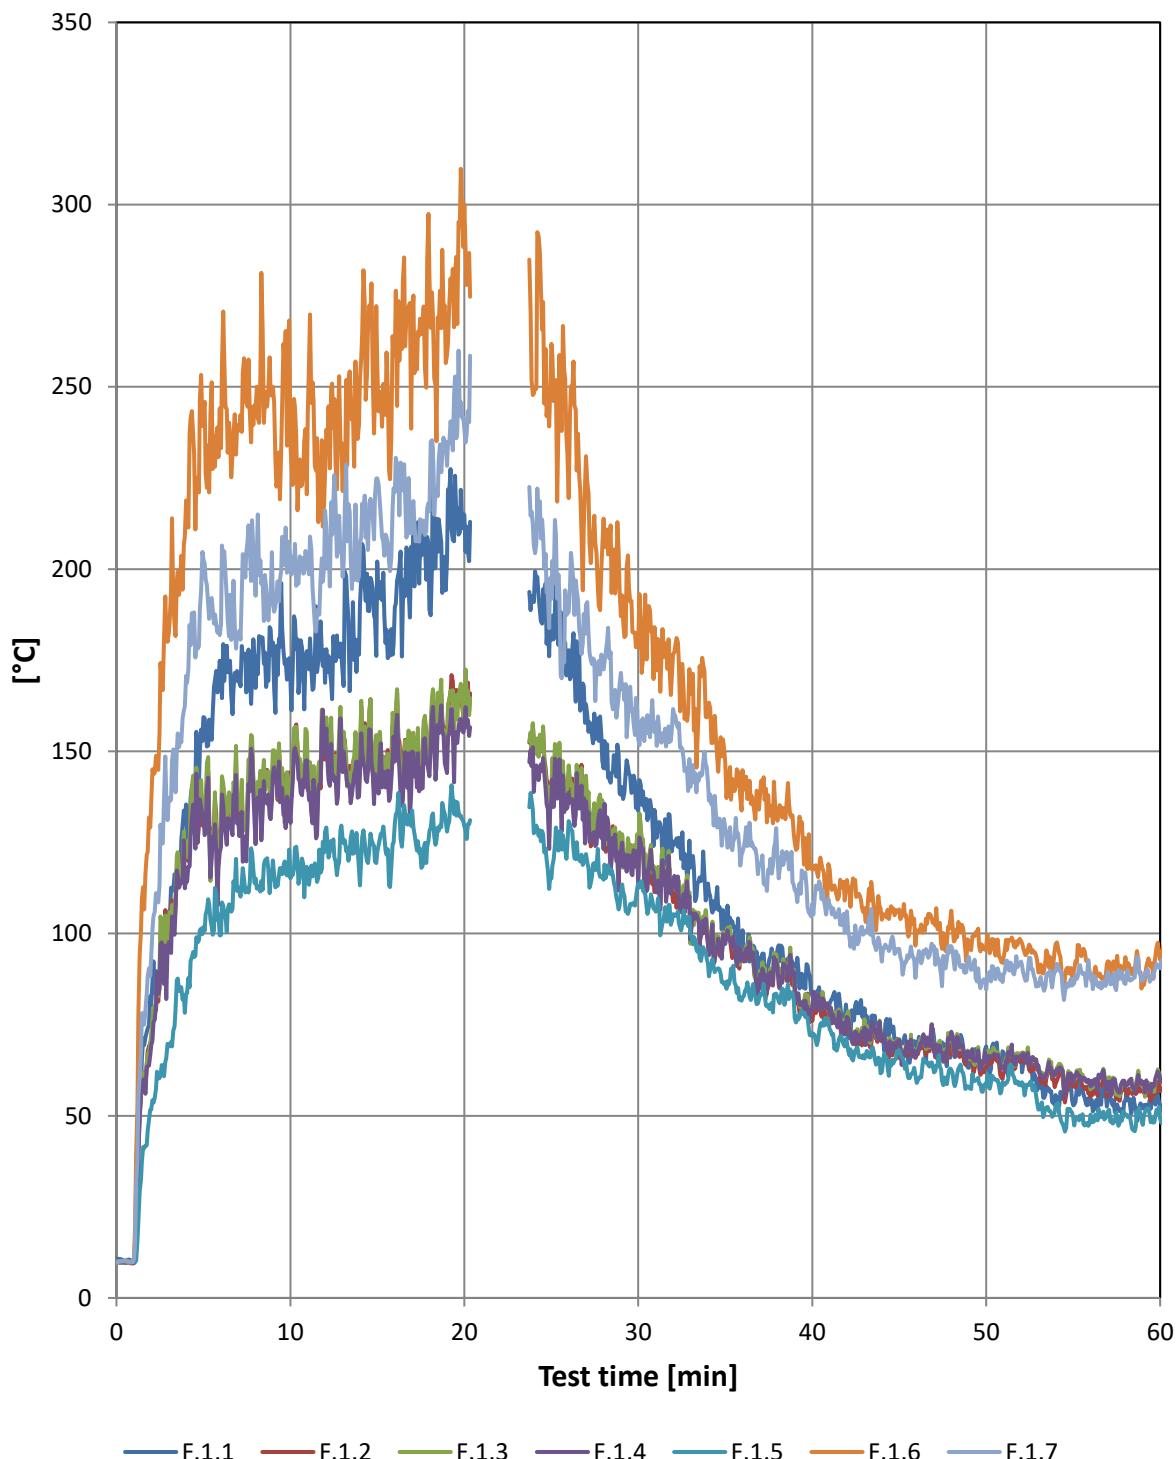
## Vertical measurements on main facade

A 3-minute mechanical failure caused all thermocouples to fail between 20 and 23

Enclosures 22.0 and 22.1	Vertical measurements on main facade
Enclosures 23.0 and 23.1	Vertical measurements on main facade
Enclosures 24.0 and 24.1	Vertical measurements on the wing
Enclosures 25.0 and 25.1	Vertical measurements on the wing
Enclosures 26.0 and 26.1	Horizontal measurements
Enclosures 27.0 and 27.1	Horizontal measurements
Enclosures 28.0 and 28.1	Plate thermocouple on facade Plate thermocouple on facade A 3-minute mechanical failure caused all thermocouples to fail between 20 and 23

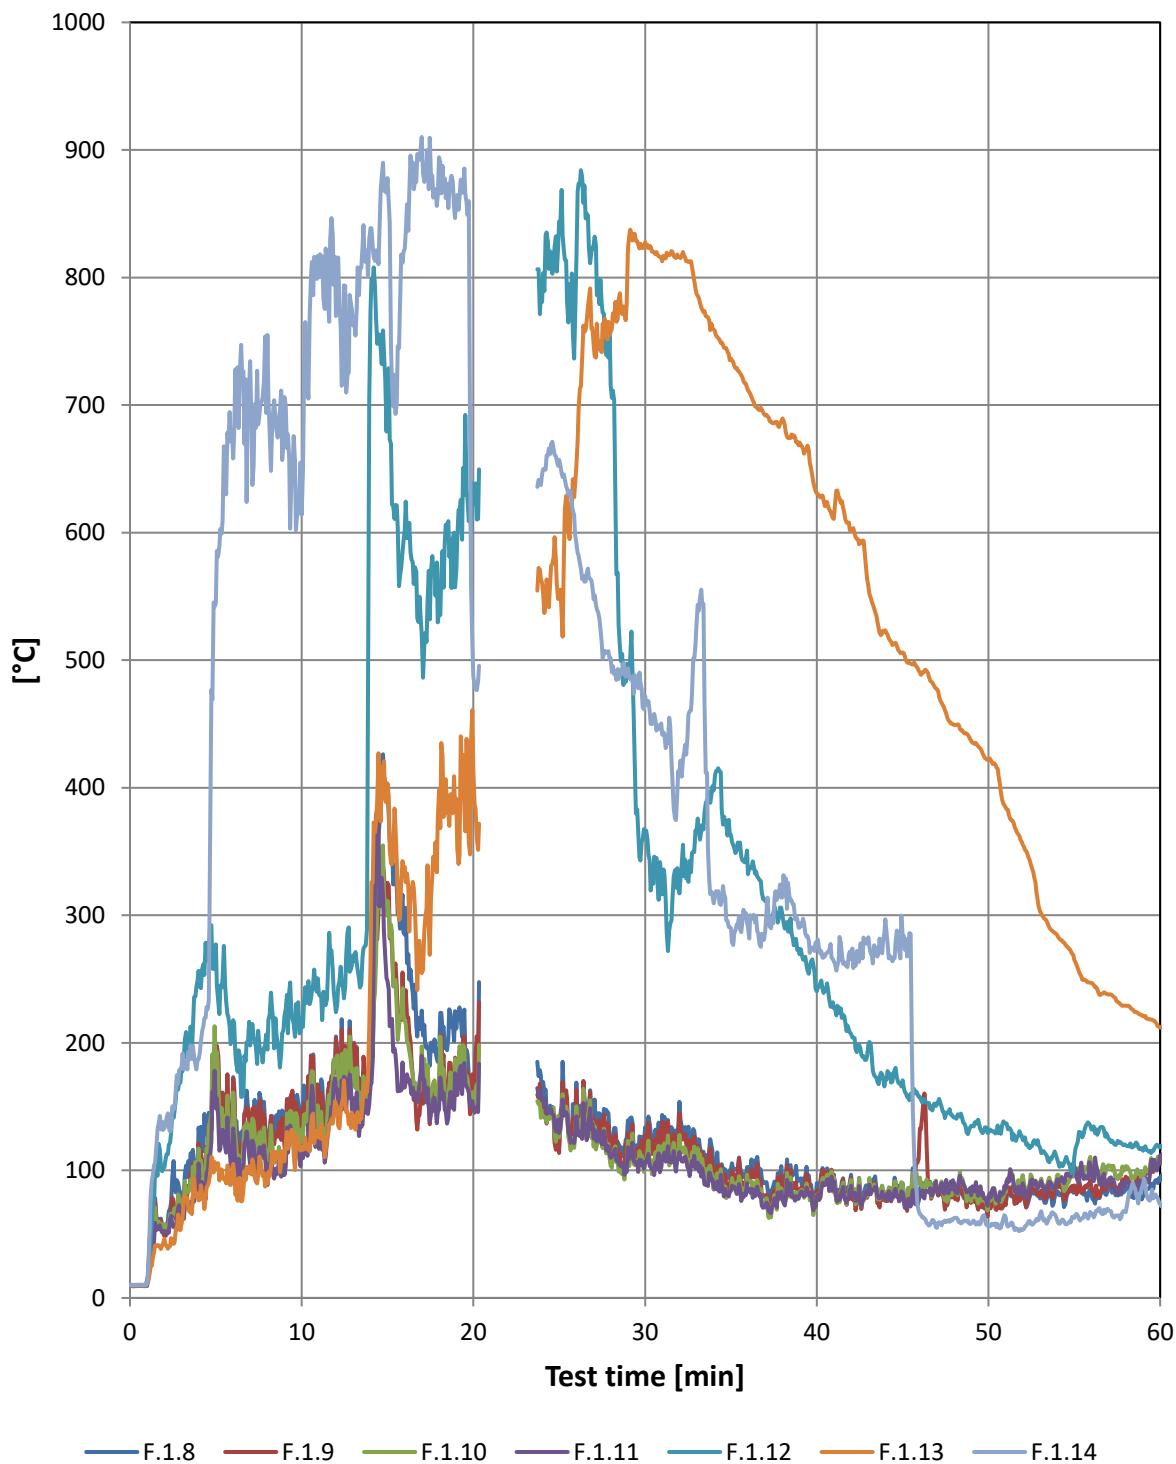
## Vertical measurements on main facade

A 3-minute mechanical failure caused all thermocouples to fail between 20 and 23

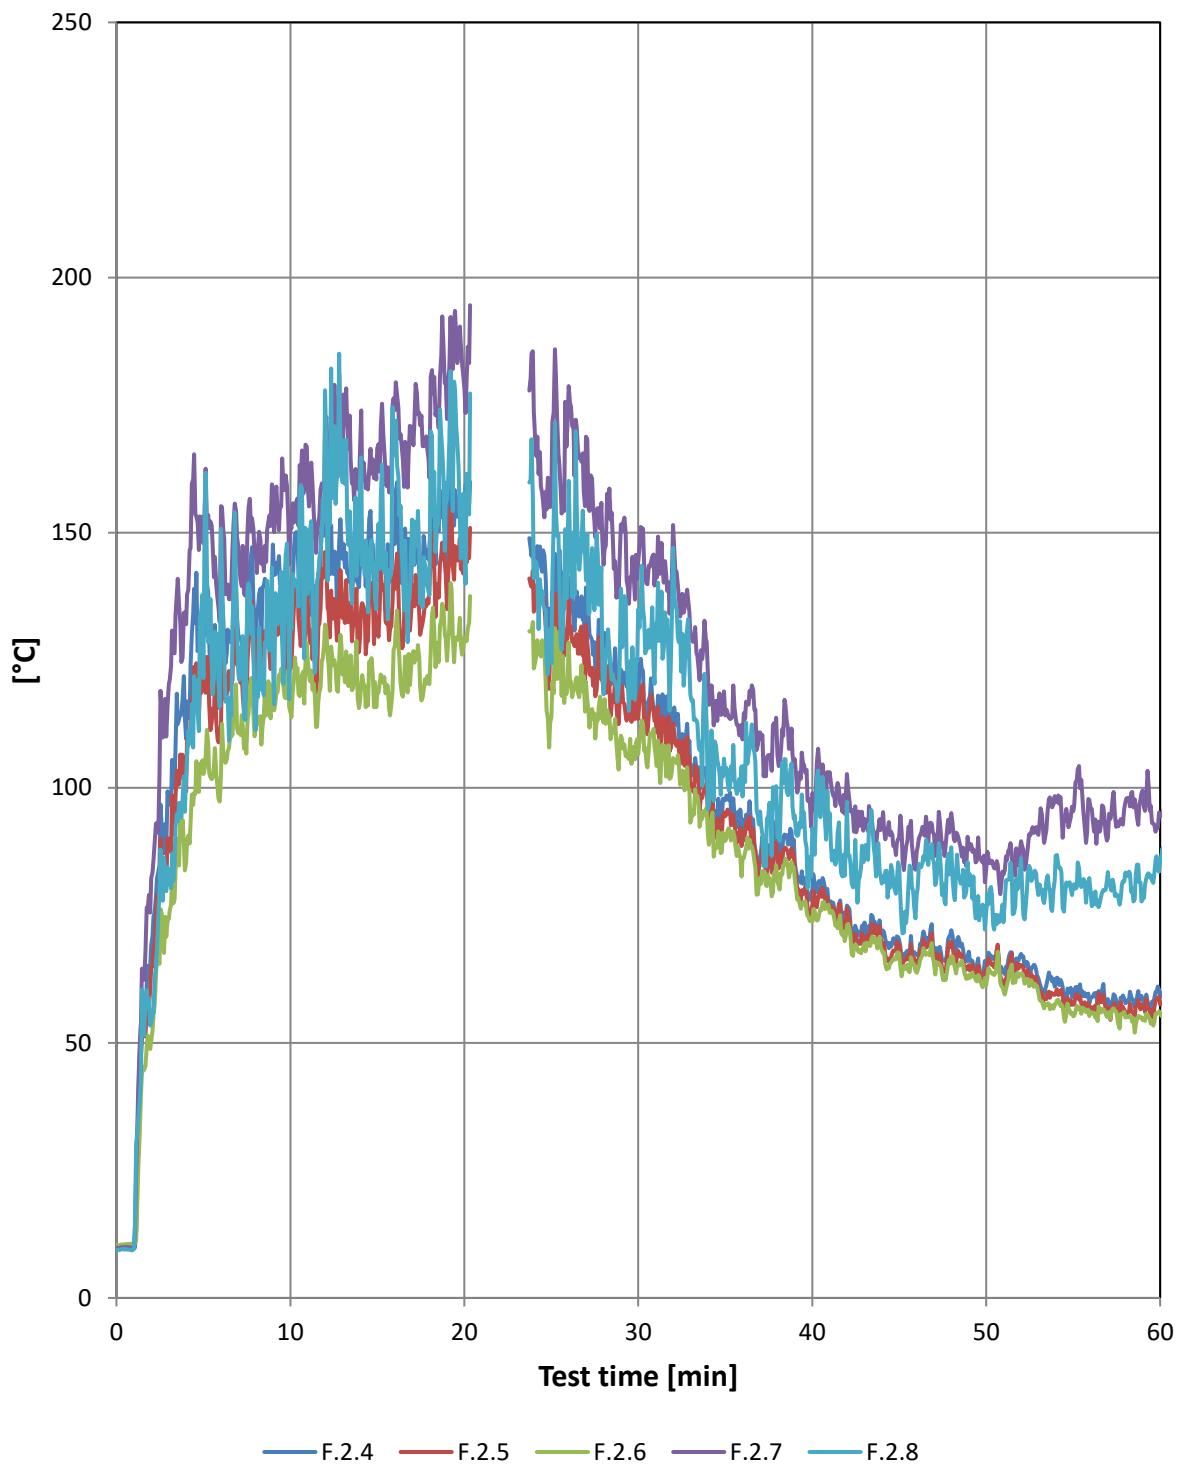
## Vertical measurements on the wing

A 3-minute mechanical failure caused all thermocouples to fail between 20 and 23

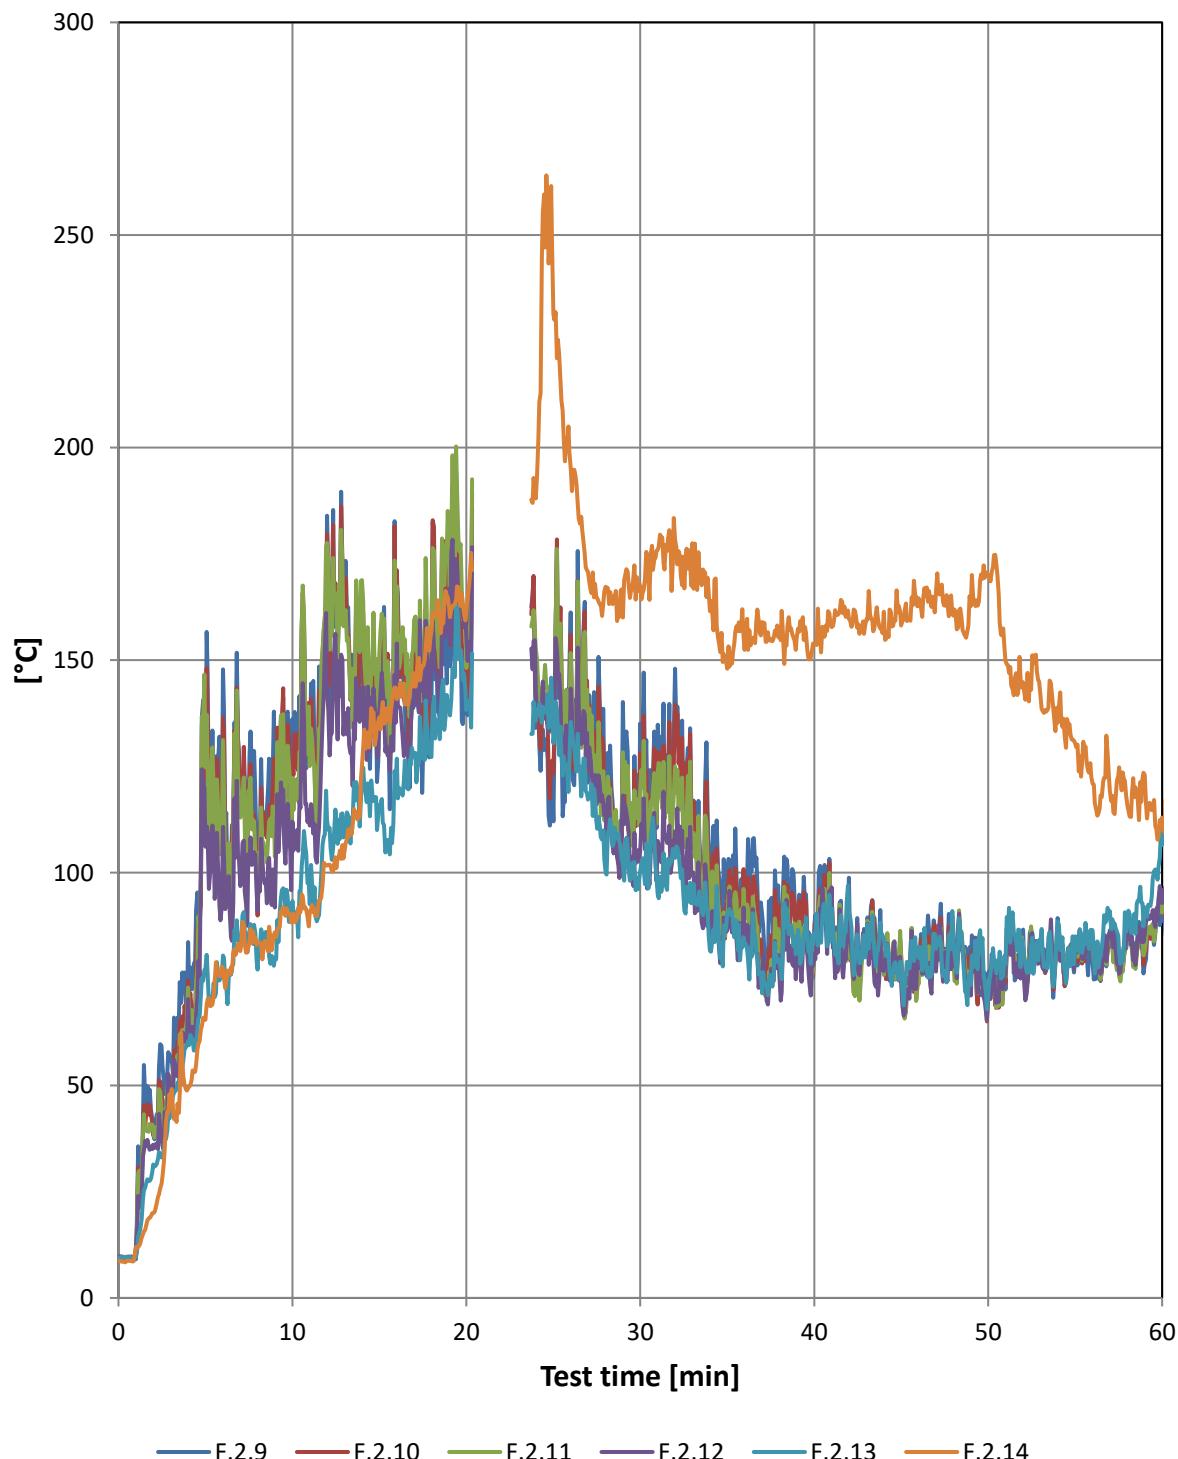
## Vertical measurements on the wing

A 3-minute mechanical failure caused all thermocouples to fail between 20 and 23
