# TEST REPORT EU FACADE TEST 3

<b>Name of sponsor:</b>	CPH Village Holding ApS		
<b>Product name:</b>	EU facade test draft 6		
<b>File no.:</b>	PGC10027A	<b>Revision no.:</b>	0
<b>Test date:</b>	27-10-2023	<b>Date:</b>	07-12-2023
<b>Pages:</b>	13	<b>Encl.:</b>	92
<b>Ref:</b>	CHD	/	CHB

Examination of the fire performance of a façade using the large fire exposure.

ASSESSMENT OF FIRE PERFORMANCE OF FACADES USING LARGE FIRE EXPOSURE

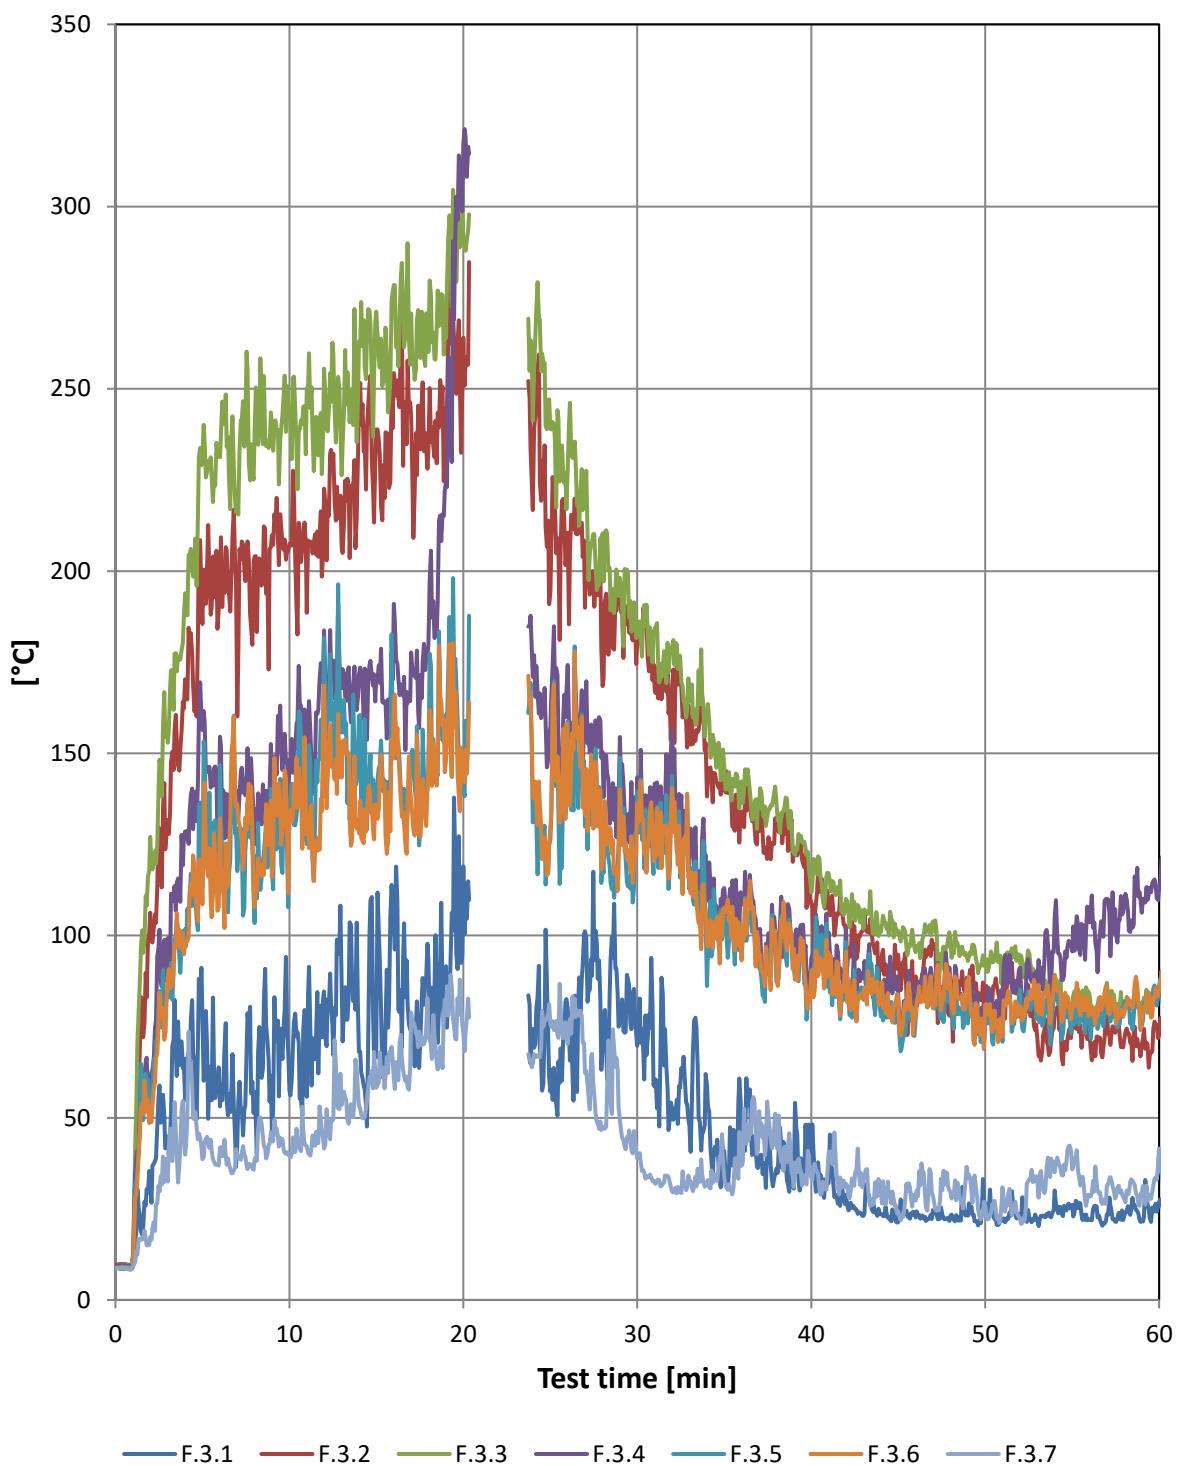
## Horizontal measurements

A 3-minute mechanical failure caused all thermocouples to fail between 20 and 23

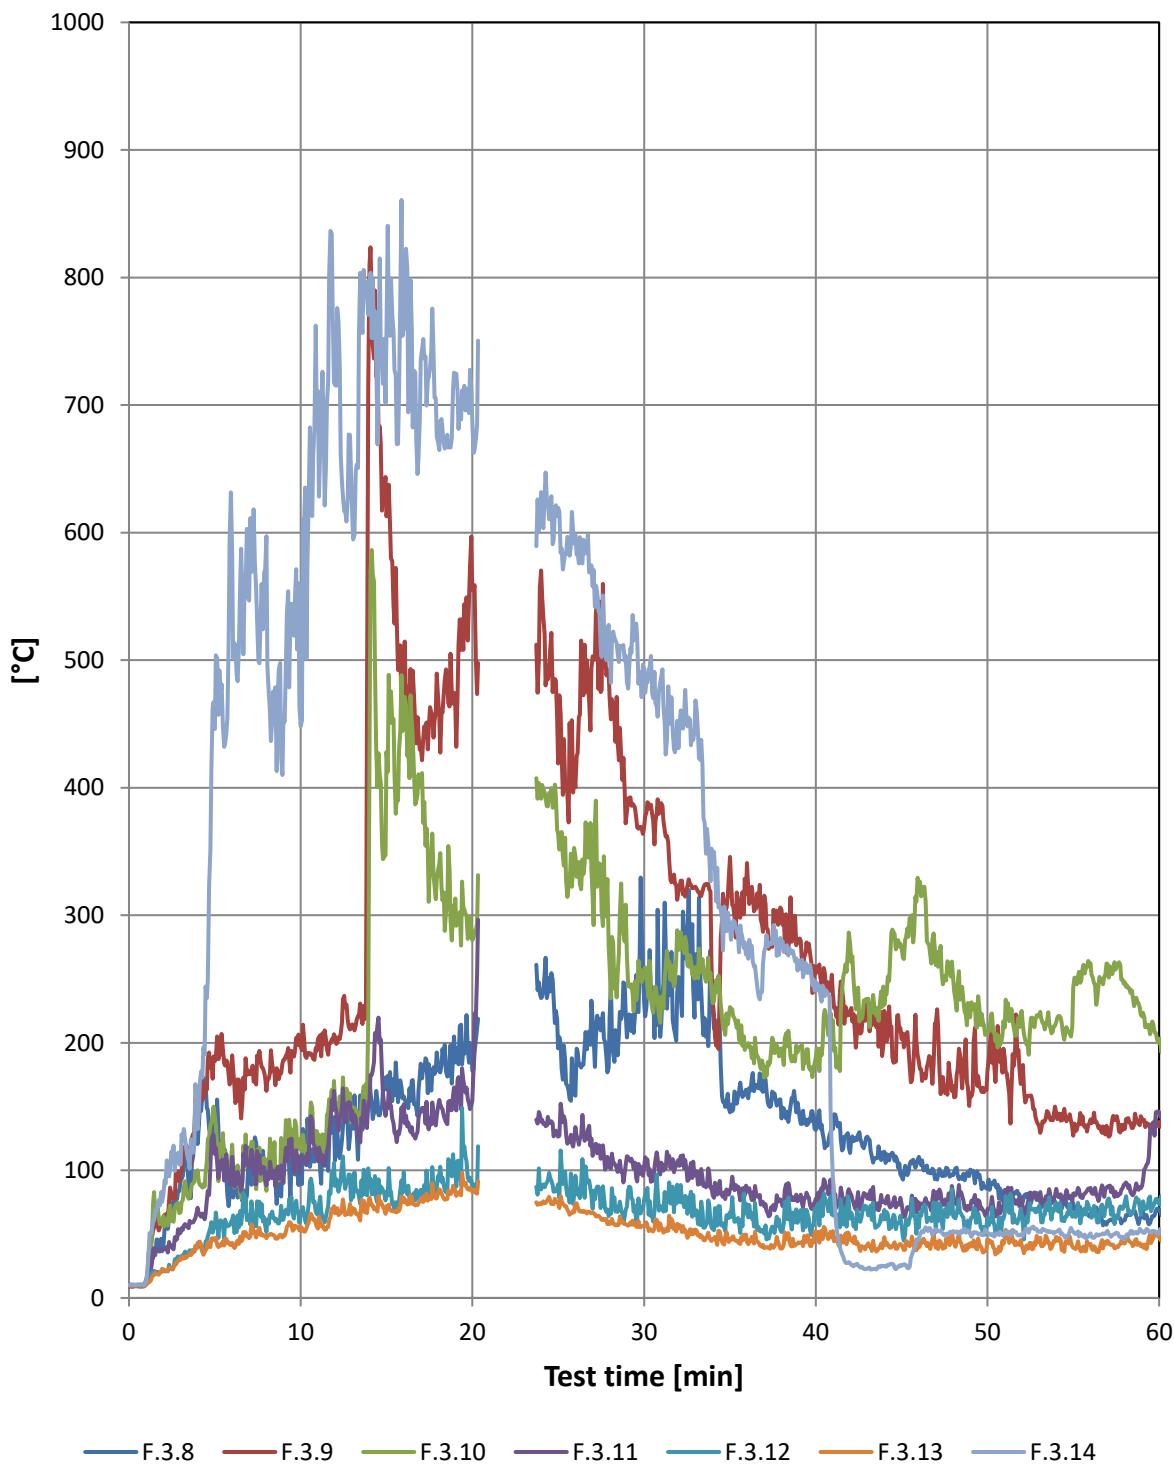
## Horizontal measurements

A 3-minute mechanical failure caused all thermocouples to fail between 20 and 23

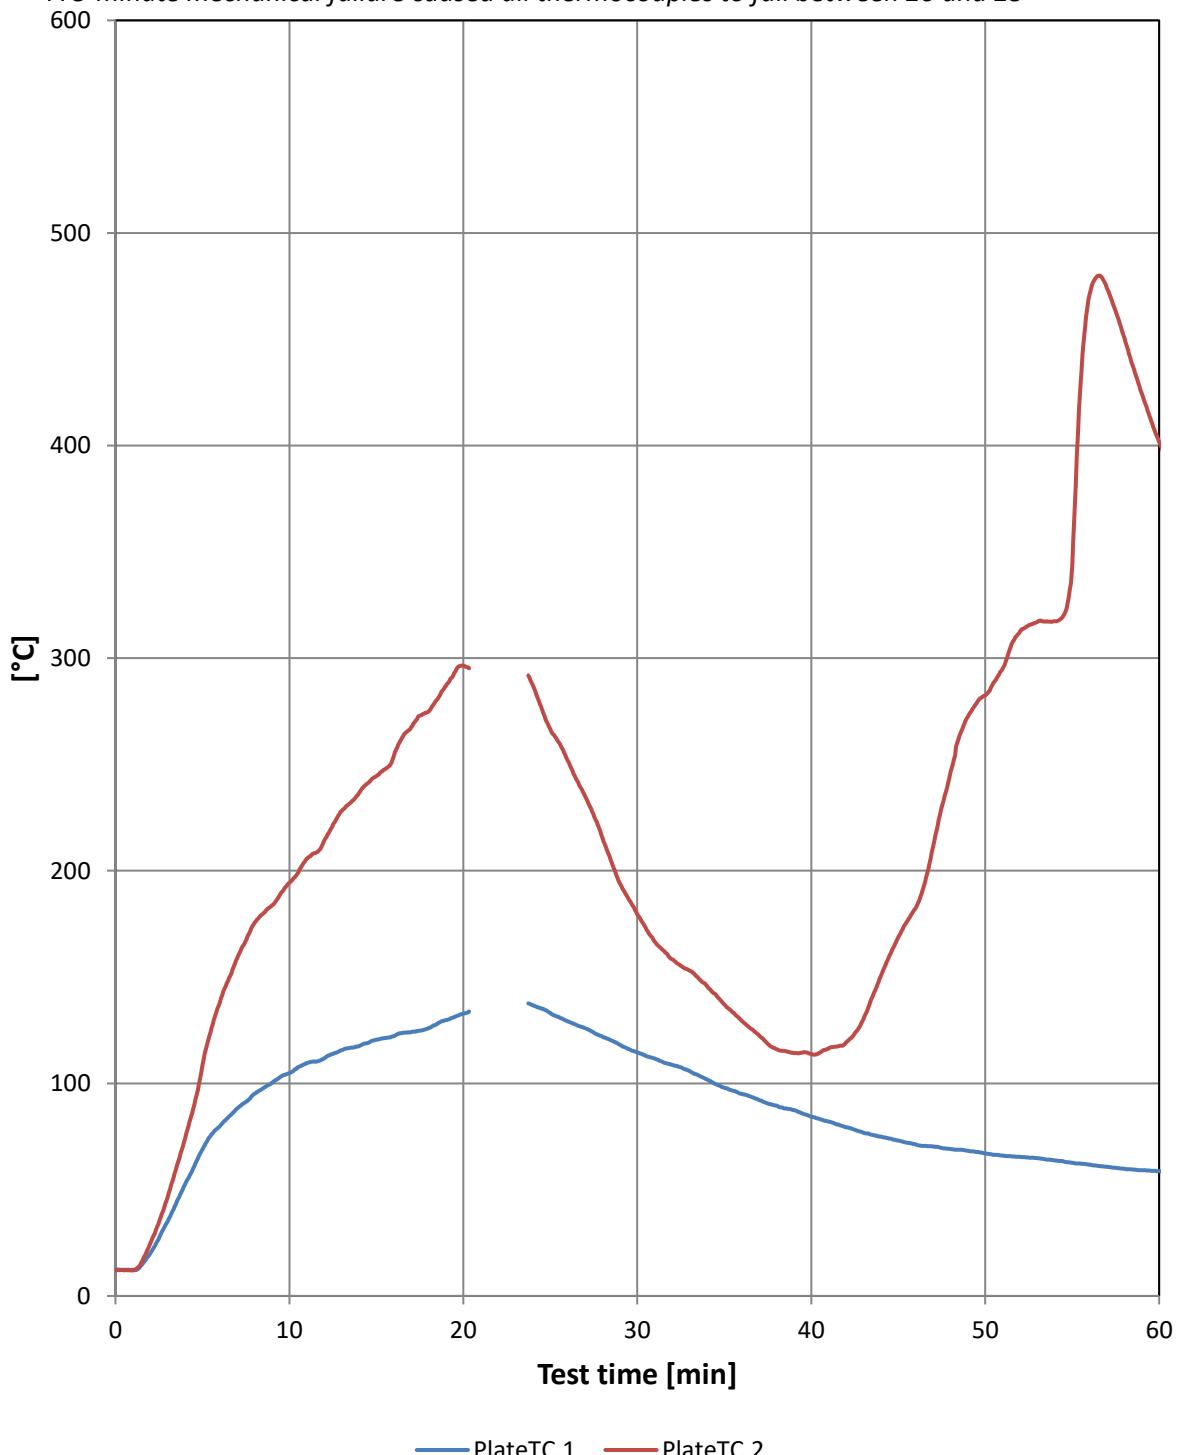
## Plate thermocouple on facade

A 3-minute mechanical failure caused all thermocouples to fail between 20 and 23

FacadePlateTC.1 Top

FacadePlateTC.2 Bottom

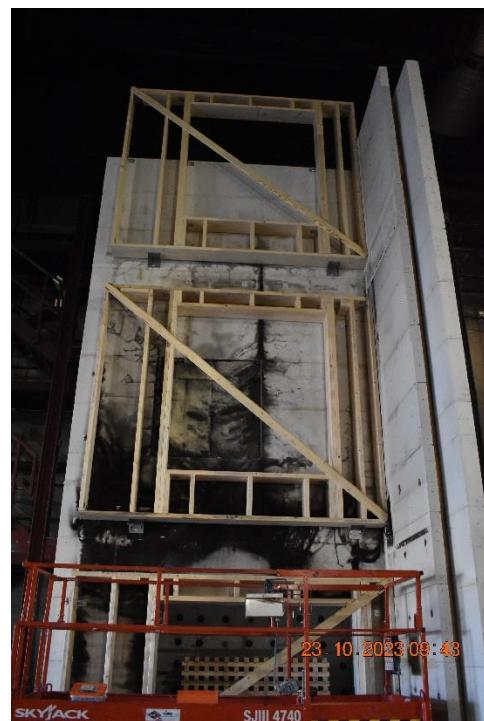
Photo No. 1 Prefabricated cassettes mounted on the façade rig.

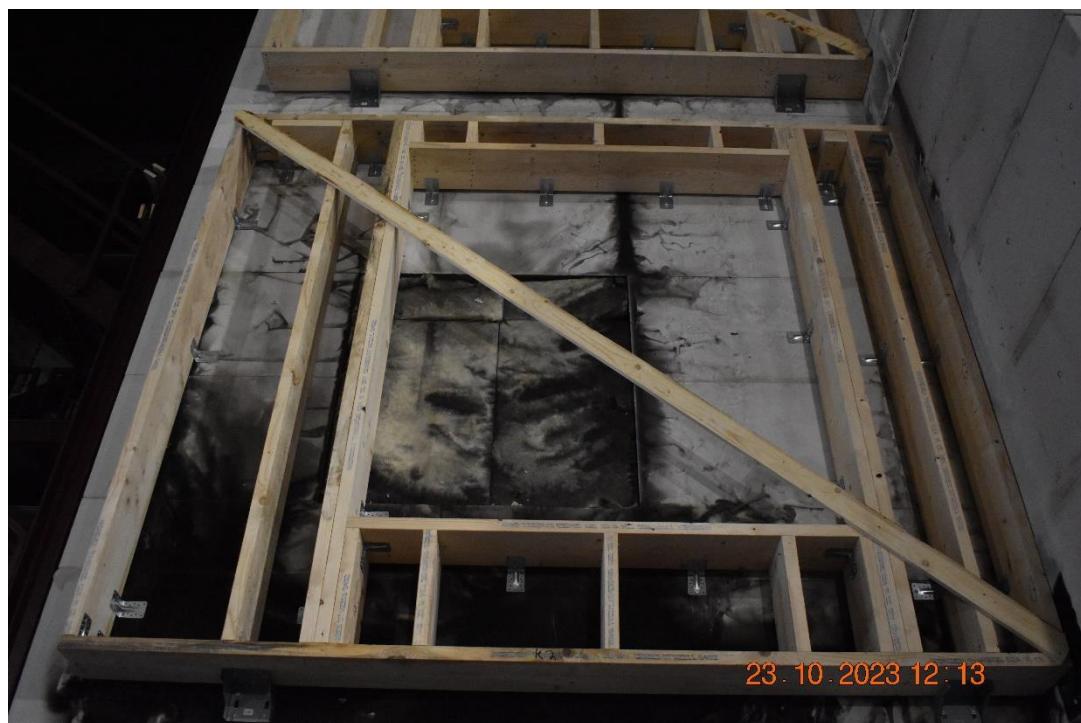
Photo No. 2 Fixing of prefabricated cassettes.

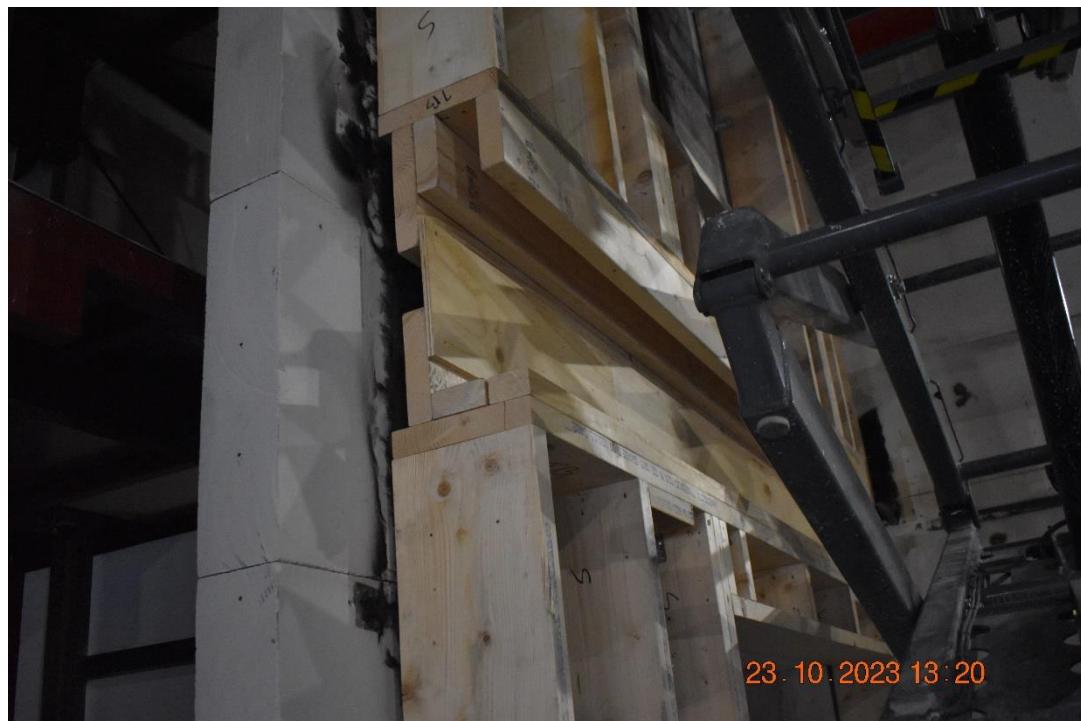
Photo No. 3 Gap between two cassettes.

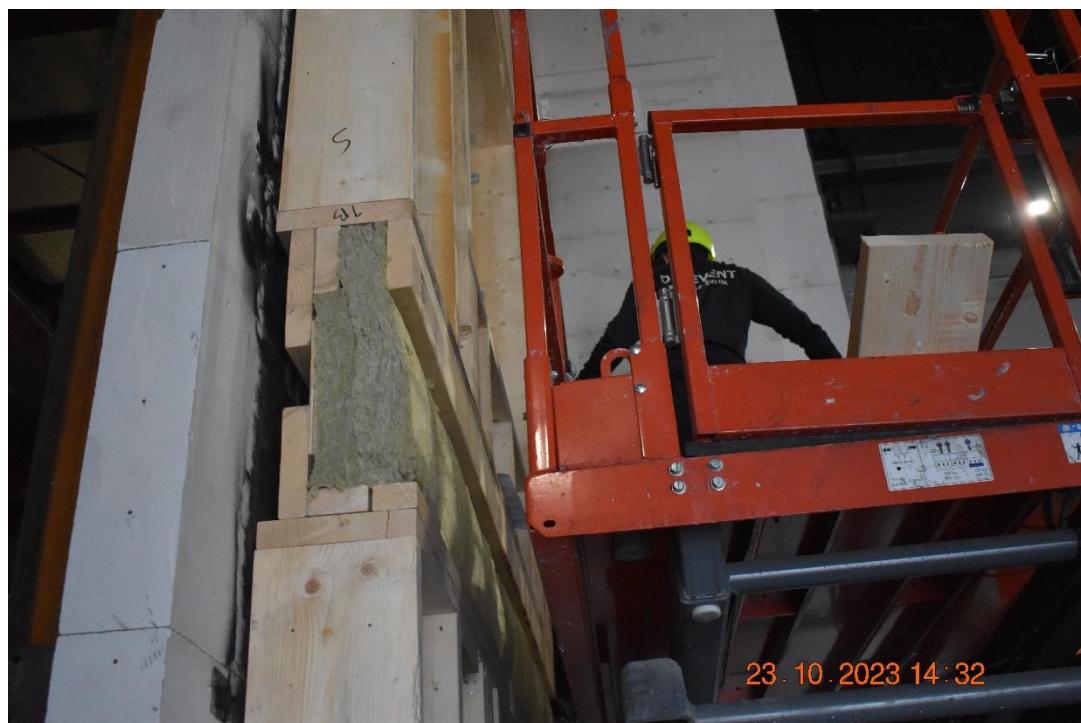
Photo No. 4 Insulation in the gap.

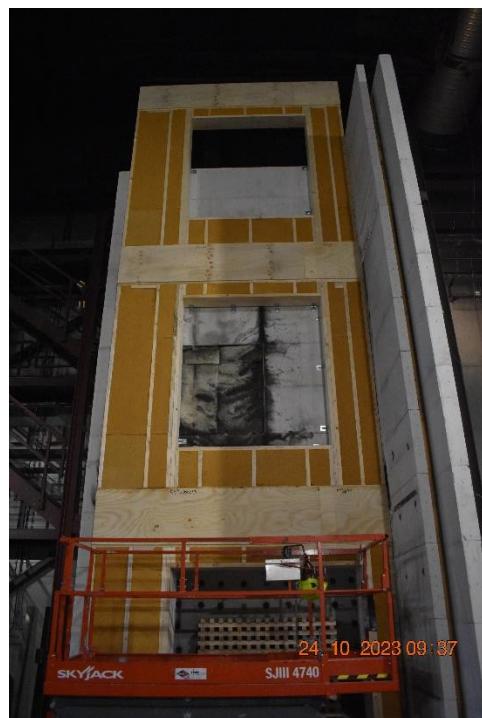
Photo No. 5 Isolation layer applied to the façade.

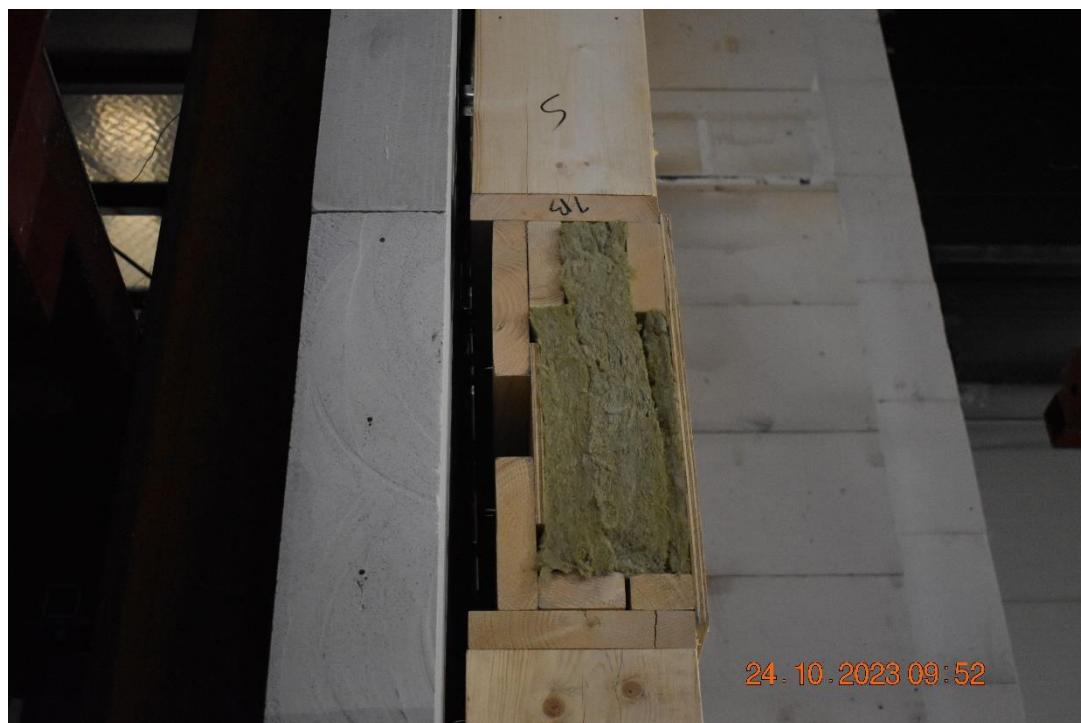
Photo No. 6 Plywood on the gap to keep the insulation.

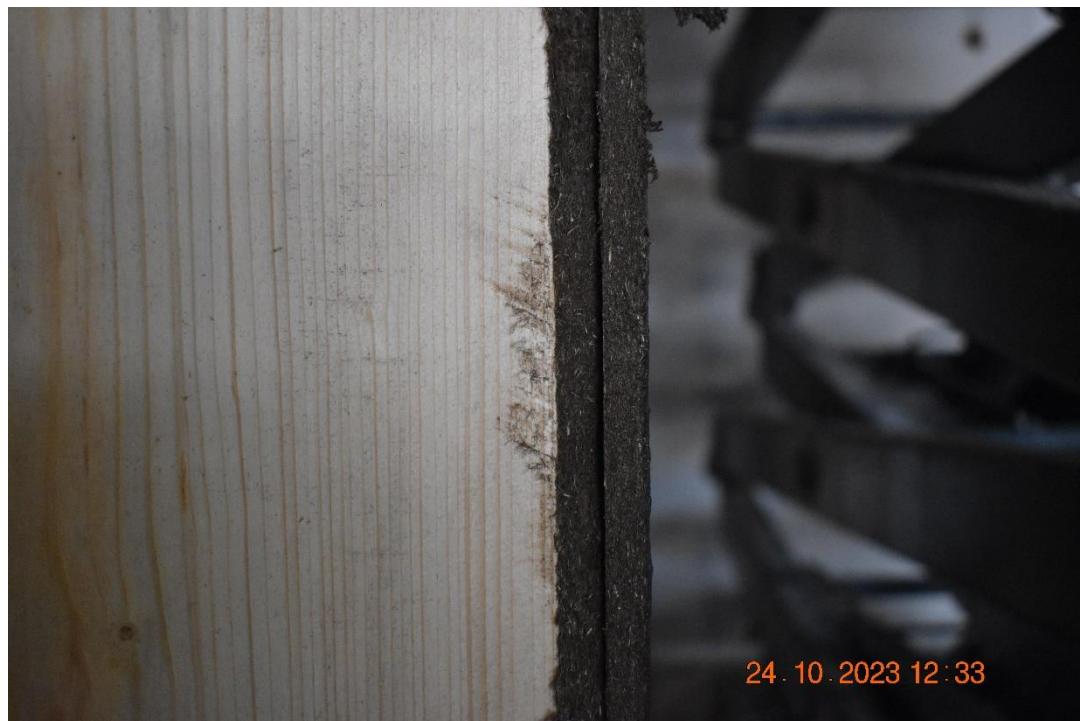
Photo No. 7 Two layers of Hunton windbreaker boards mounted to the prefabricated cassettes.

Two layers of Hunton wood fiber-based windbreaker boards 12 mm with a nominal density of 235 kg/m<sup>3</sup>, were mounted on the construction wood C24 of all three cassettes. See photo No. 7.

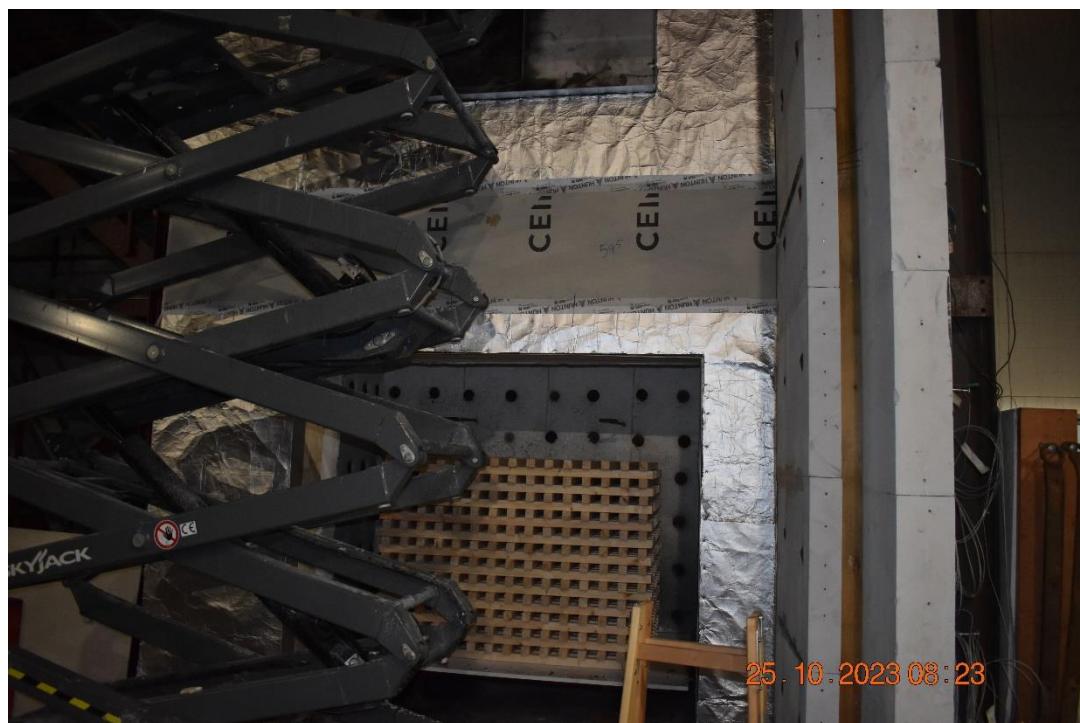
Photo No. 8 Cembrit boards mounted to the gap.

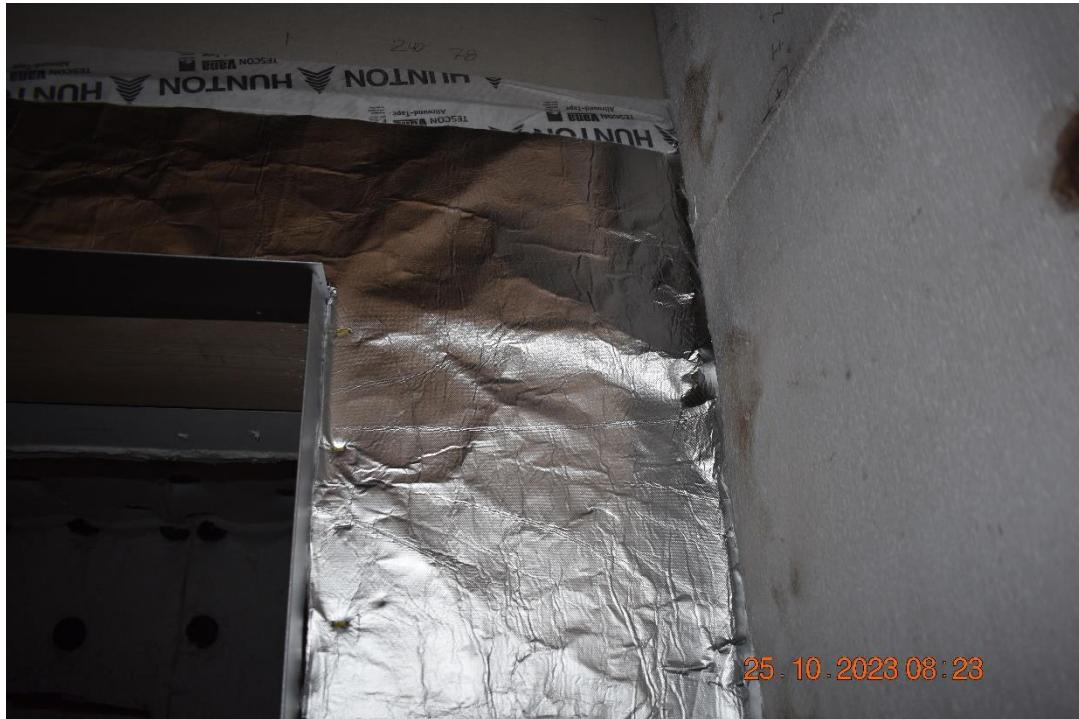
Photo No. 9 Traspir alu 430 mounted to the prefabricated cassettes.

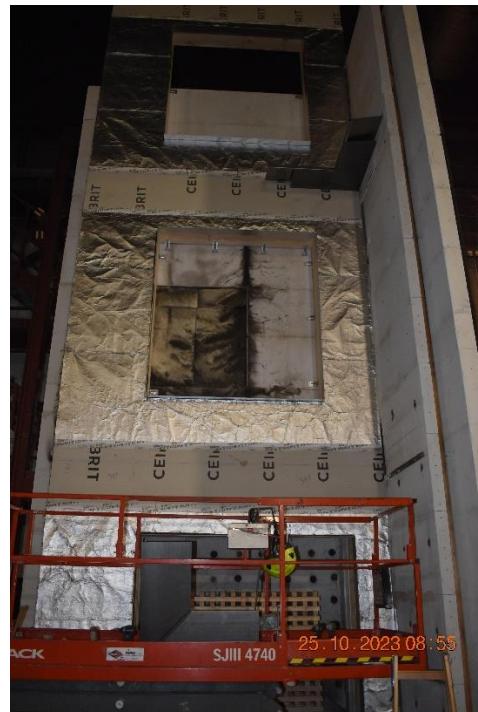
Photo No. 10 Traspir alu 420 has been mounted and steel profiles around window and fire chamber has been installed.

See photo No. 10.

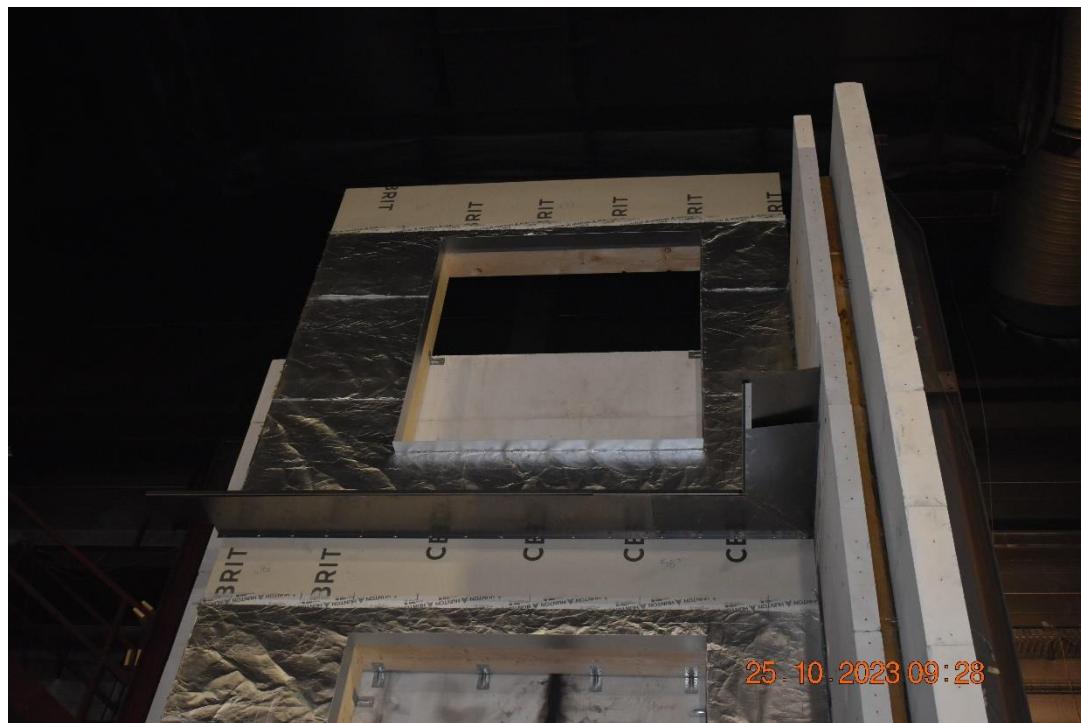
Photo No. 11 Flame deflectors are being mounted.

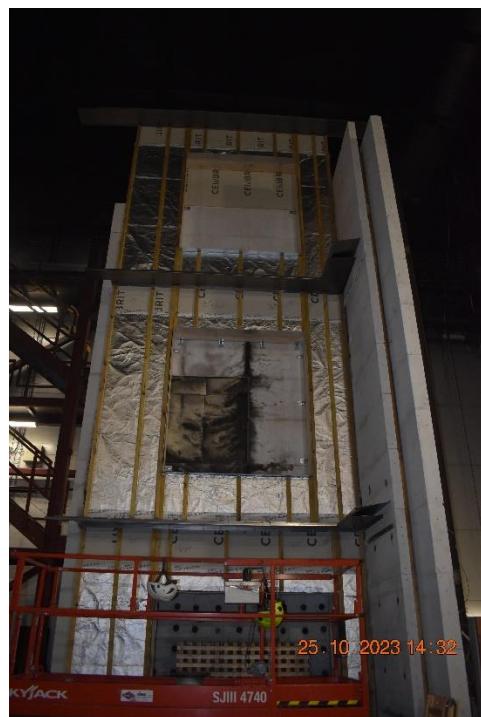
Photo No. 12 Vertical formworks have been mounted.

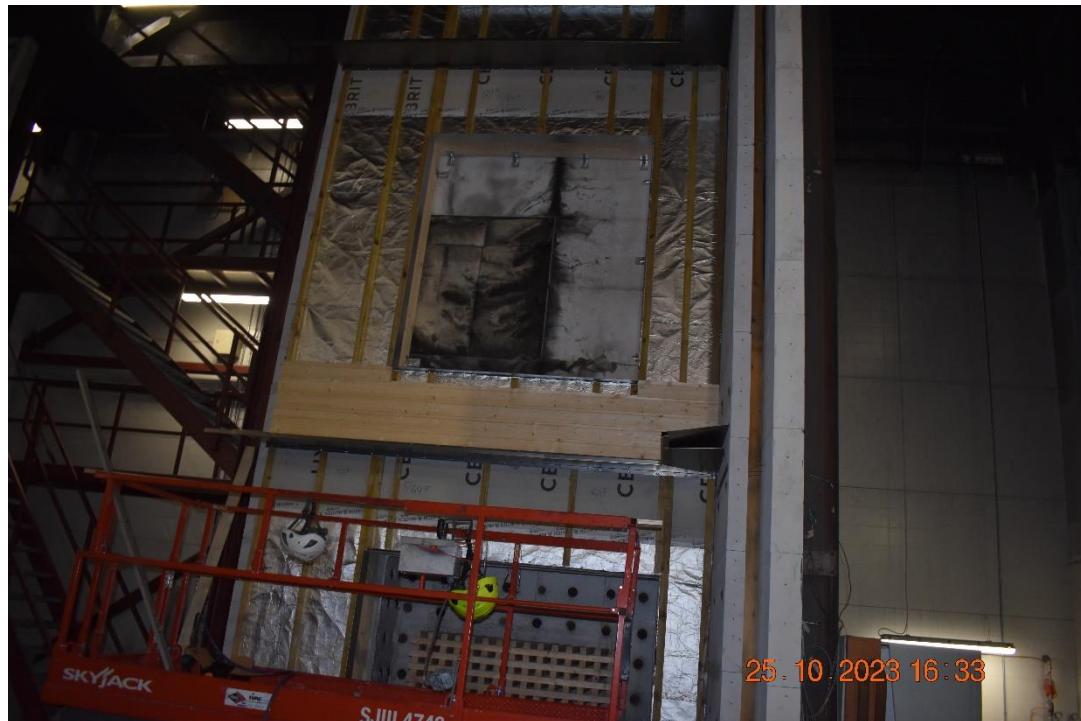
Photo No. 13 Horizontal cladding is being mounted.

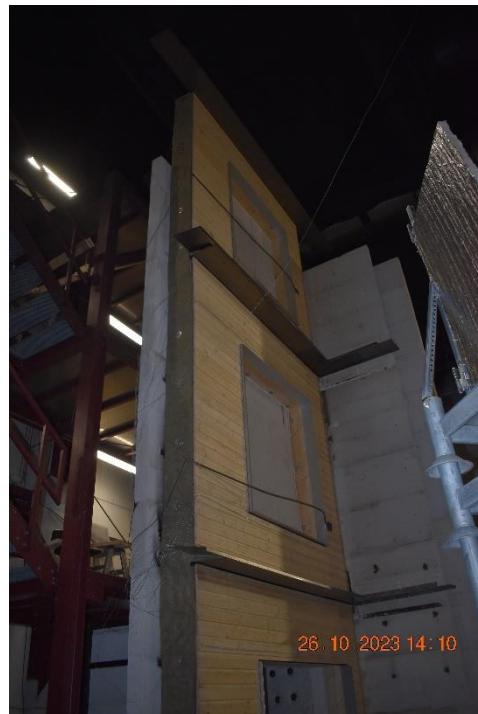
Photo No. 14 Mineral wool insulated on the side of the main façade.

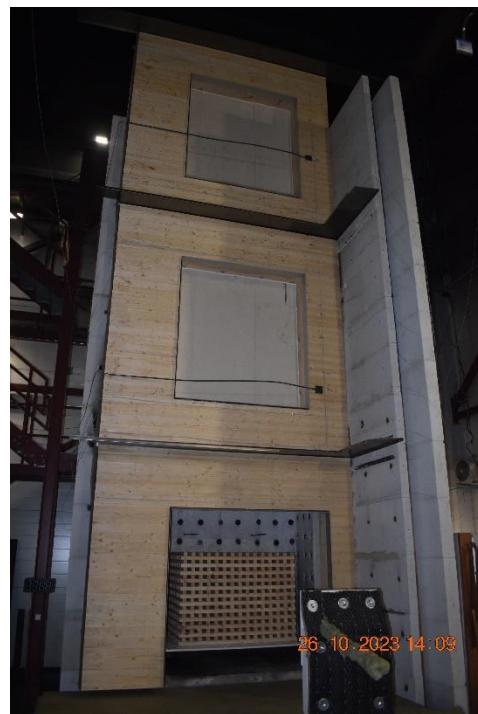
Photo No. 15 Façade before start test.

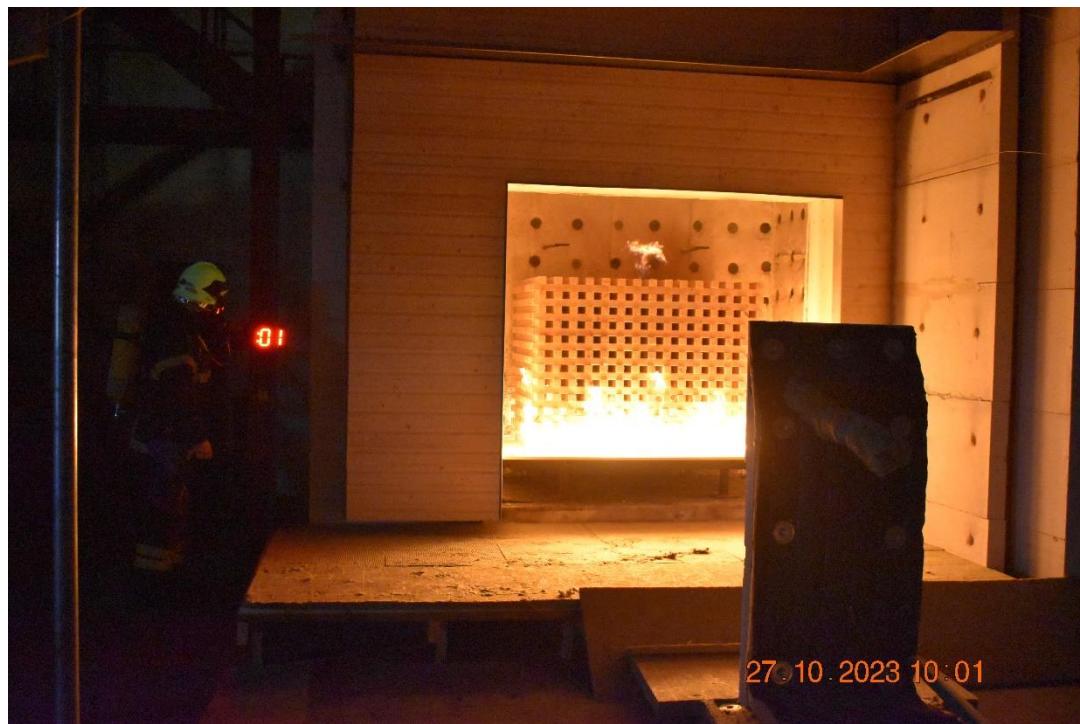
Photo No. 16 Test specimen at start test.

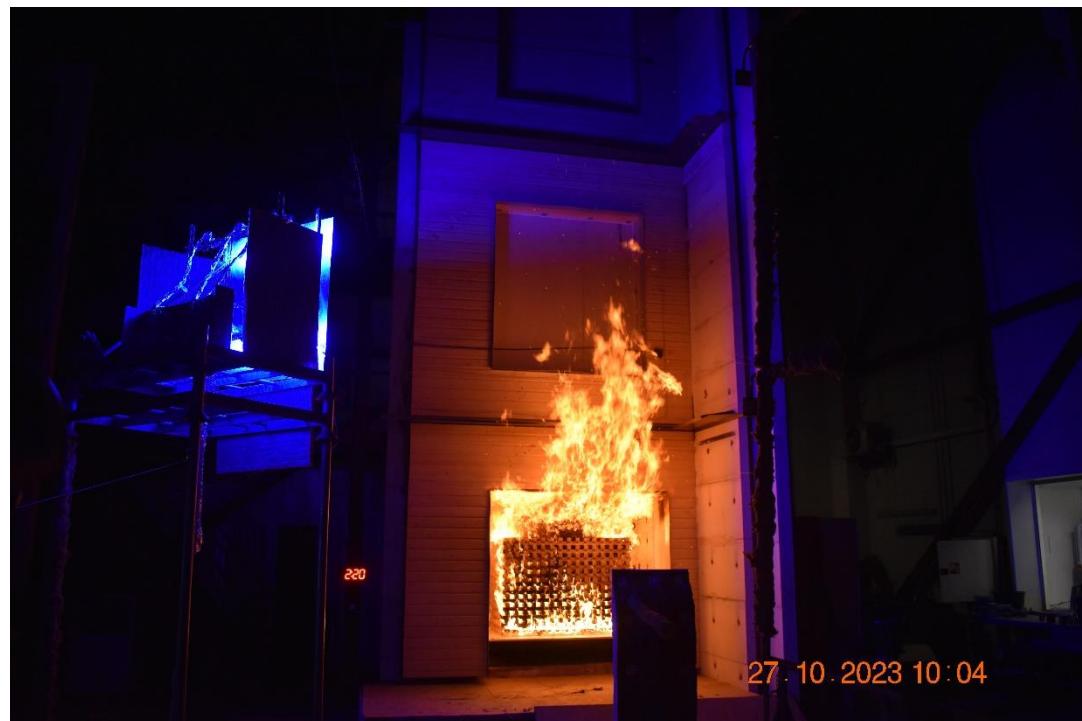
Photo No. 17 Test specimen 2 minutes into the test.

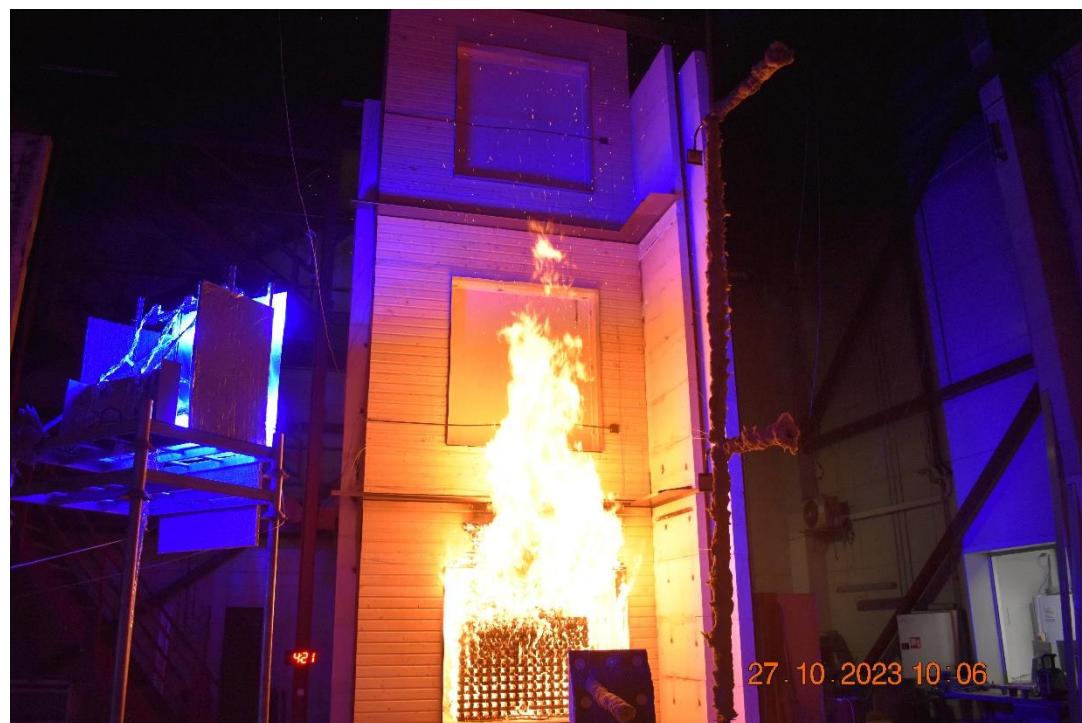
Photo No. 18 Test specimen 4 minutes into the test.

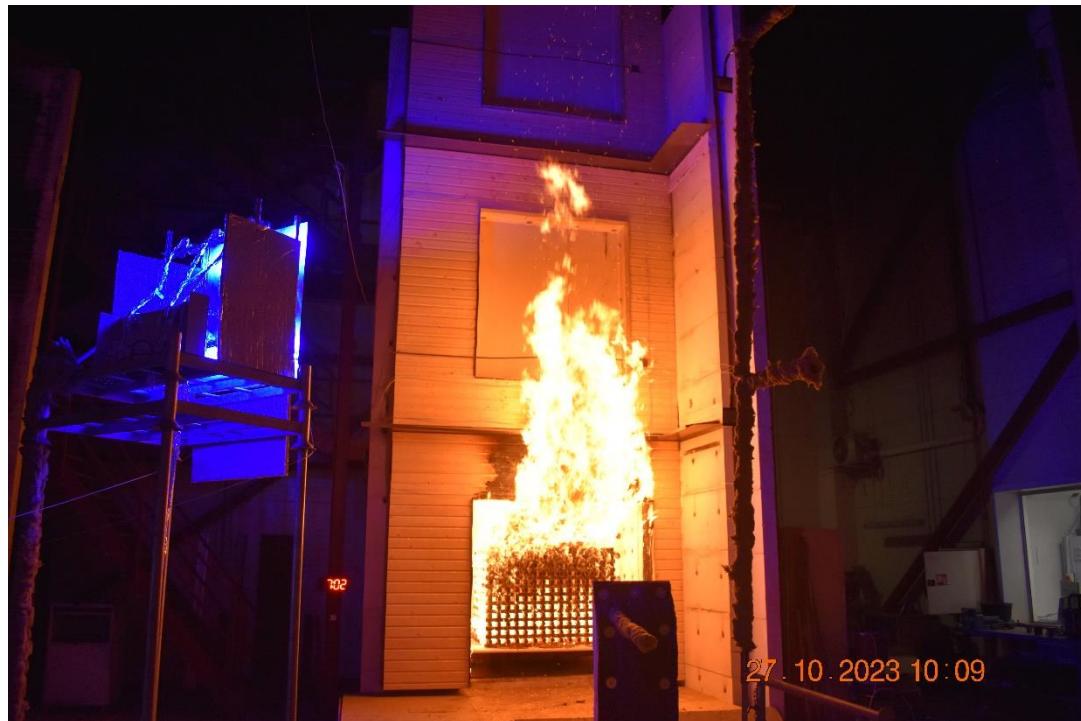
Photo No. 19 Test specimen 7 minutes into the test.

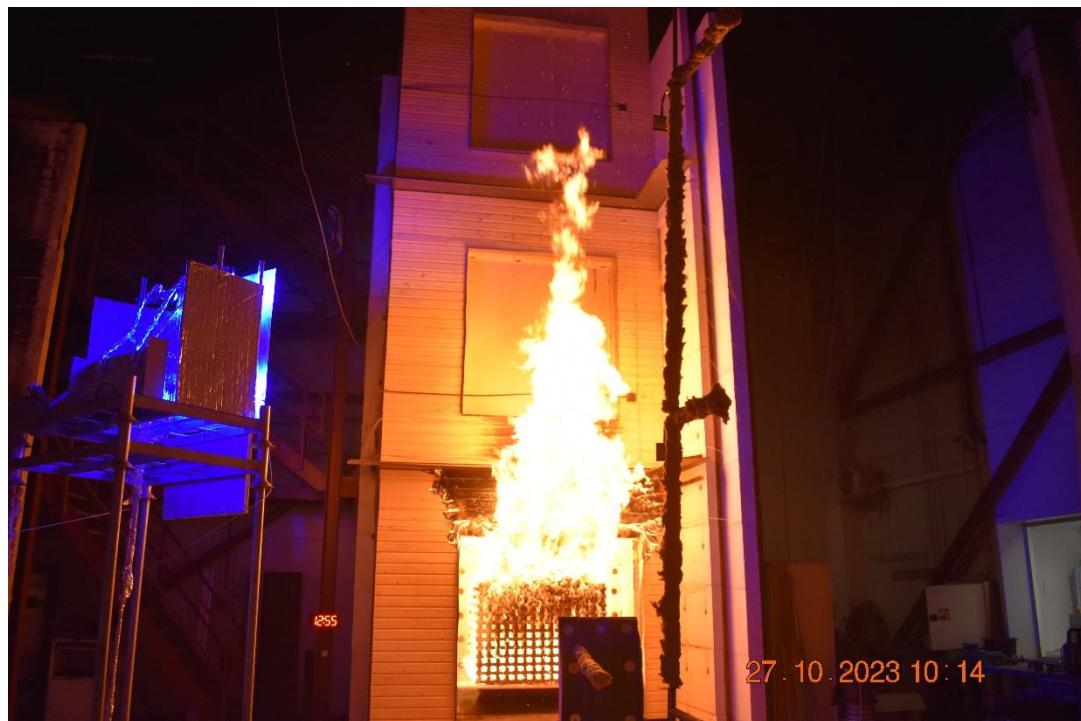
Photo No. 20 Test specimen 13 minutes into the test.

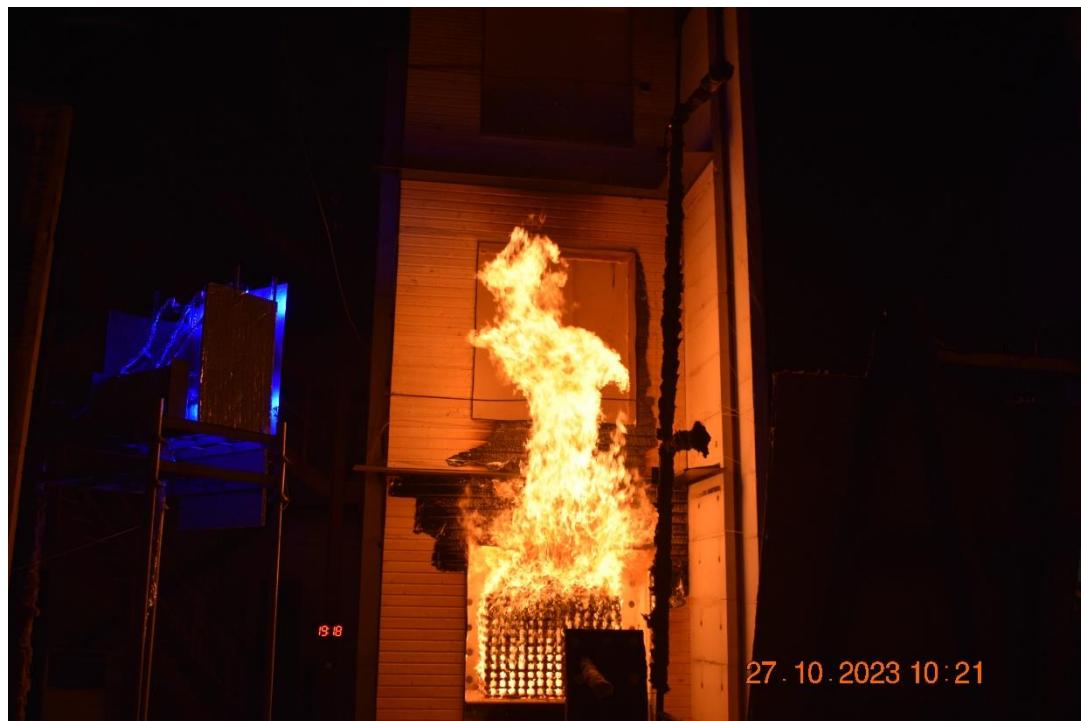
Photo No. 21 Test specimen 19 minutes into the test.

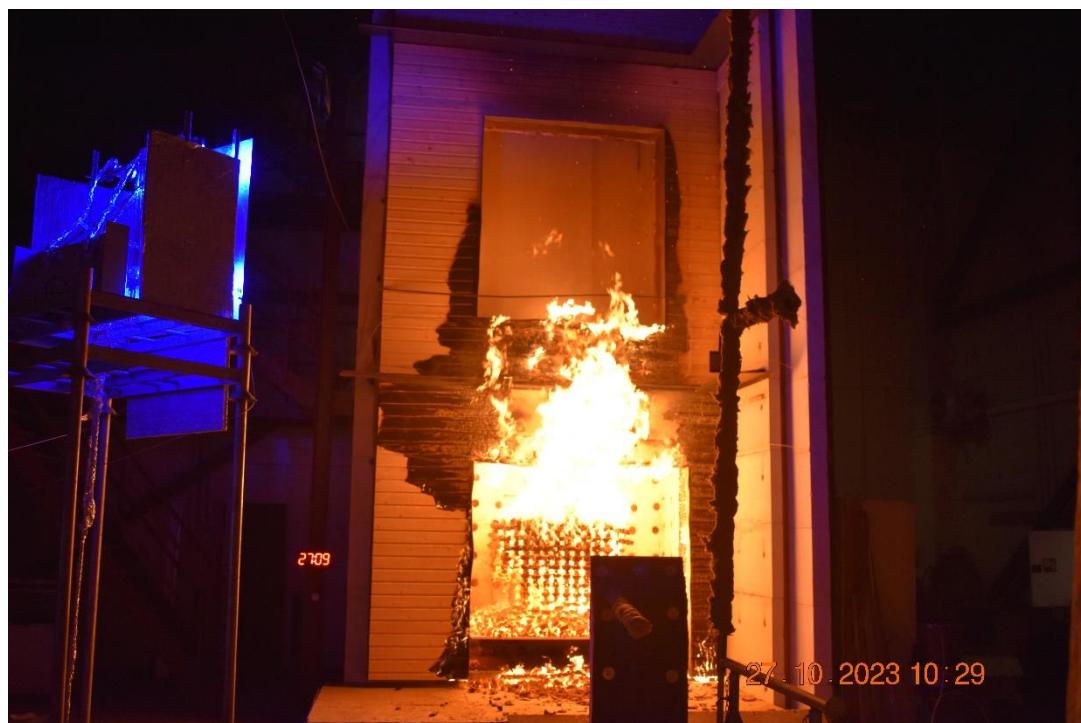
Photo No. 22 Test specimen 27 minutes into the test.

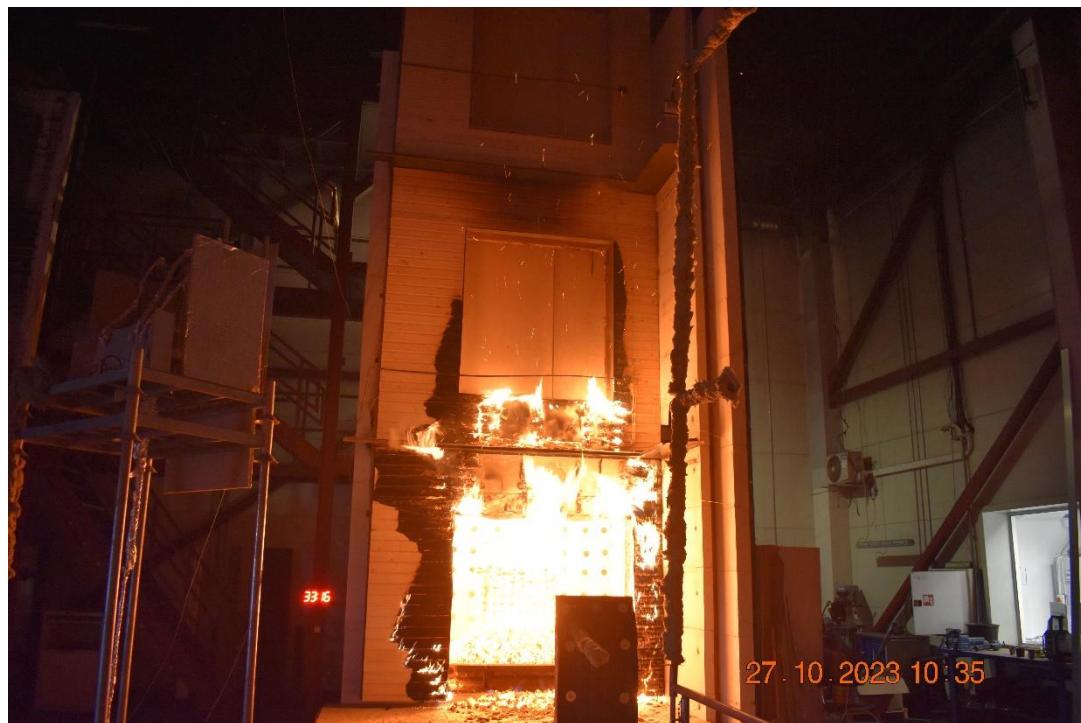
Photo No. 23 Test specimen 33 minutes into the test.

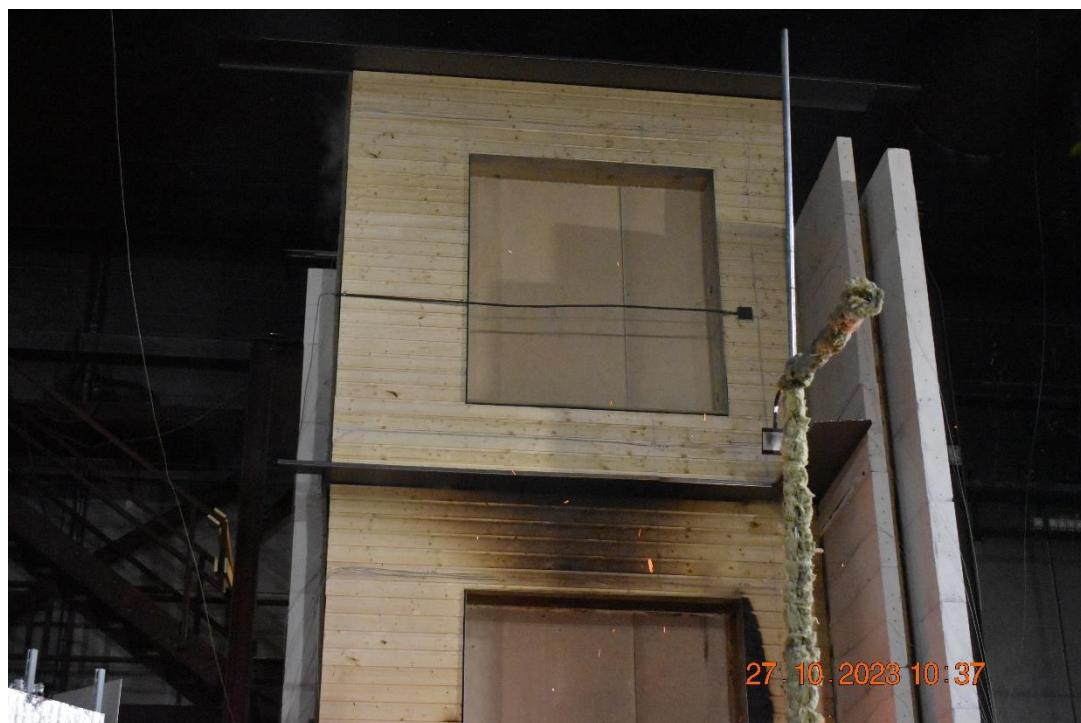
Photo No. 24 Test specimen 34 minutes into the test.

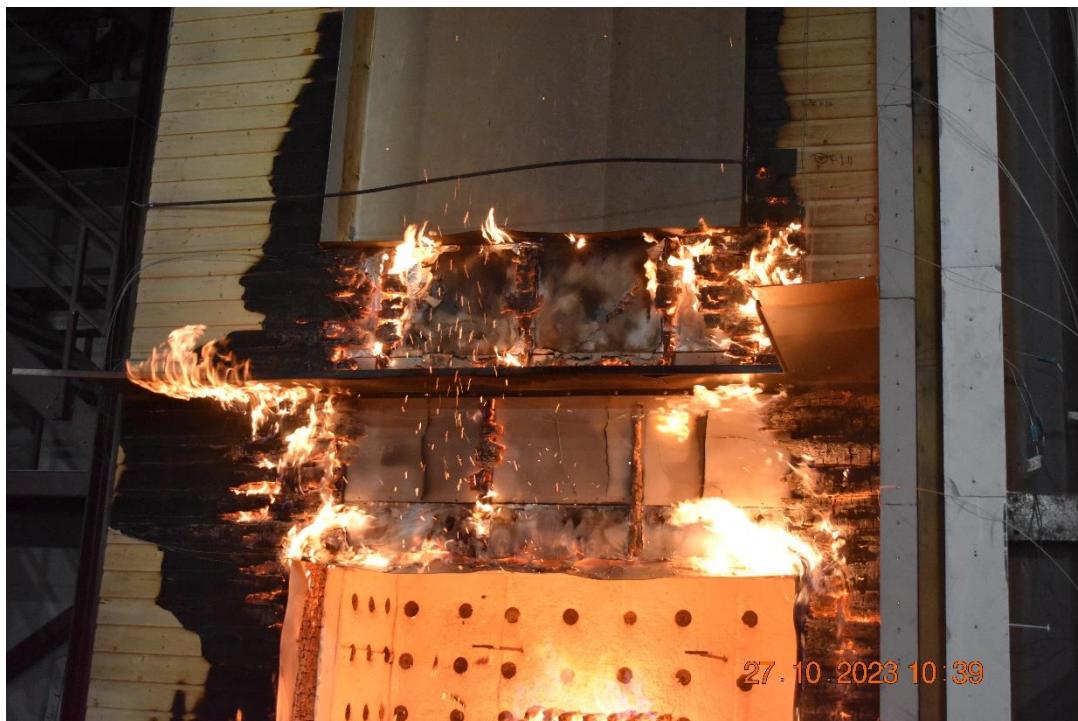
Photo No. 25 Test specimen 37 minutes into the test.

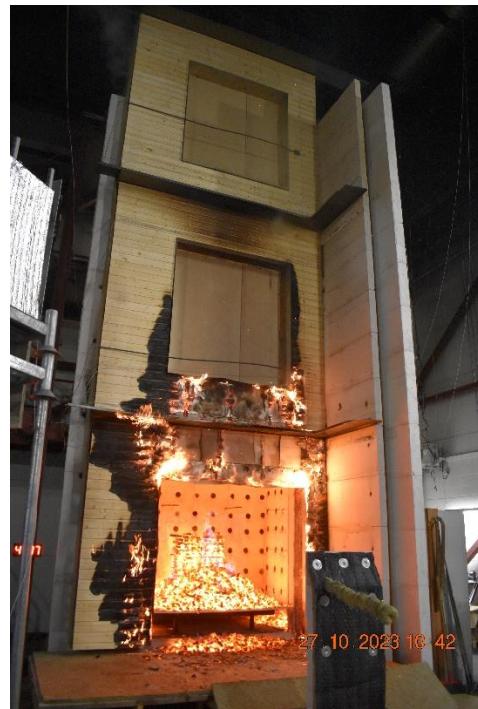
Photo No. 26 Test specimen 37 minutes into the test.
