# TEST REPORT EU FACADE TEST 3

<b>Name of sponsor:</b>	CPH Village Holding ApS		
<b>Product name:</b>	EU facade test draft 6		
<b>File no.:</b>	PGC10027A	<b>Revision no.:</b>	0
<b>Test date:</b>	27-10-2023	<b>Date:</b>	07-12-2023
<b>Pages:</b>	13	<b>Encl.:</b>	92
<b>Ref:</b>	CHD	/	CHB

Examination of the fire performance of a façade using the large fire exposure.

ASSESSMENT OF FIRE PERFORMANCE OF FACADES USING LARGE FIRE EXPOSURE

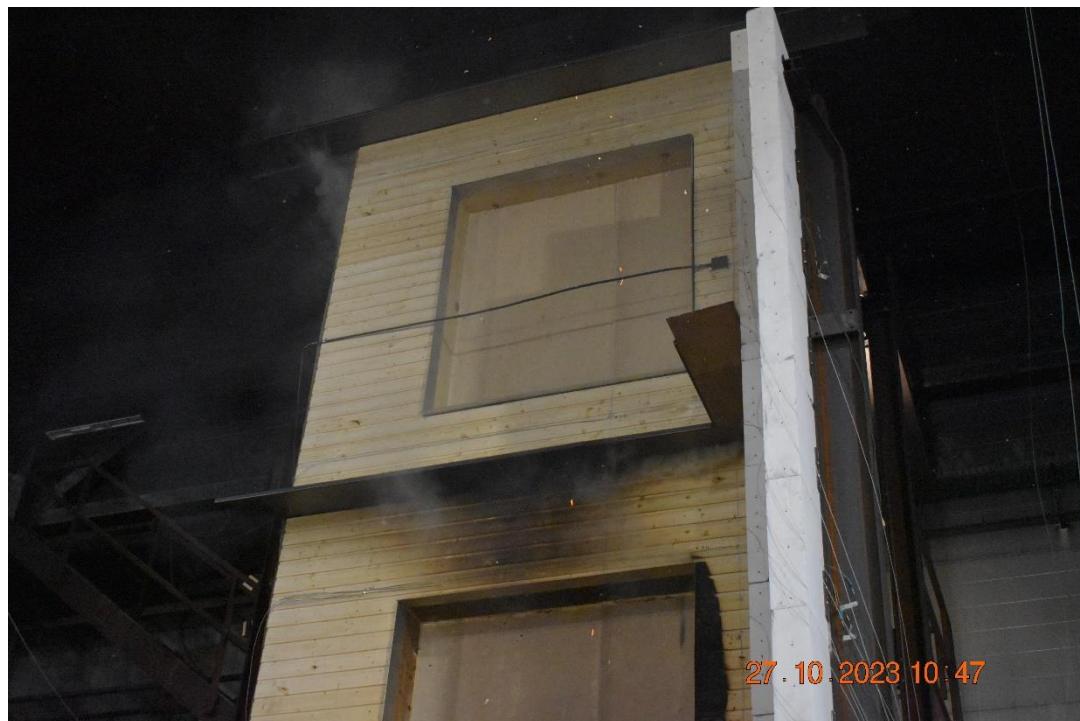
Photo No. 27 Test specimen 45 minutes into the test.

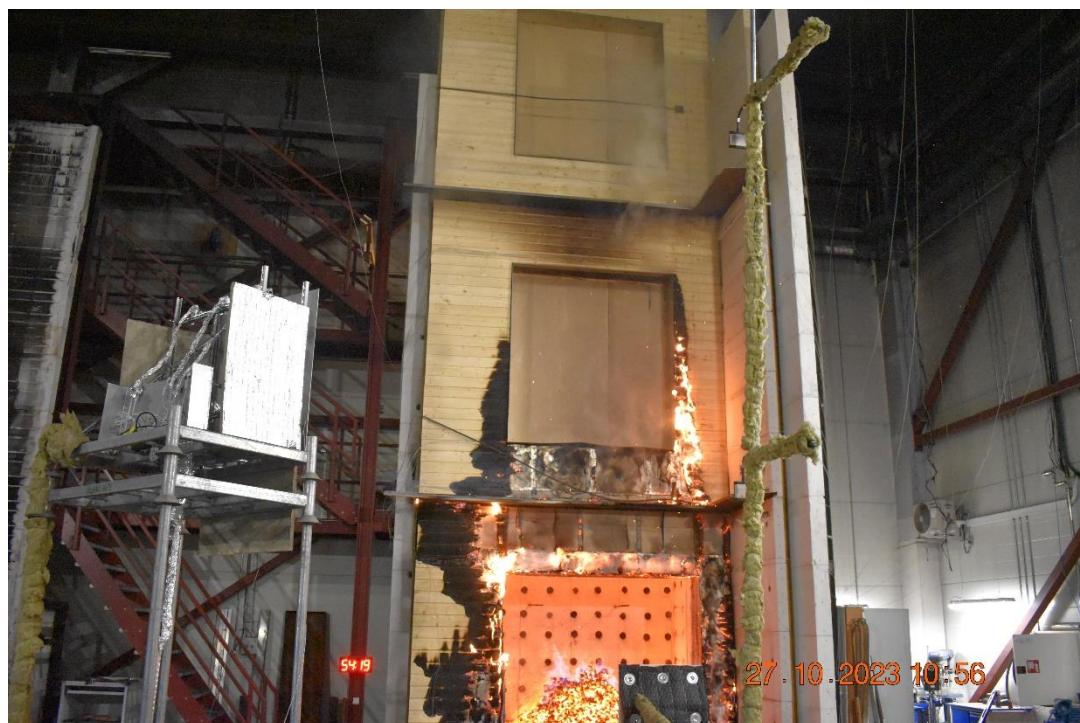
Photo No. 28 Test specimen 54 minutes into the test.

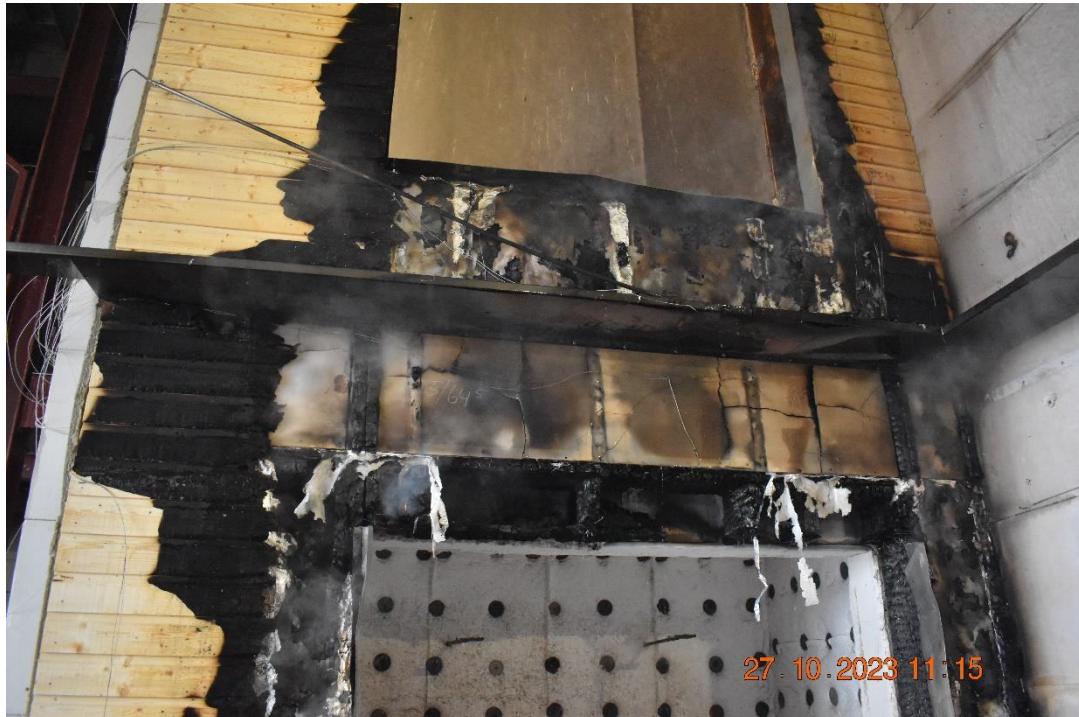
Photo No. 29 Test specimen after the test. Detailed photo of cladding between the fire chamber and the first window.

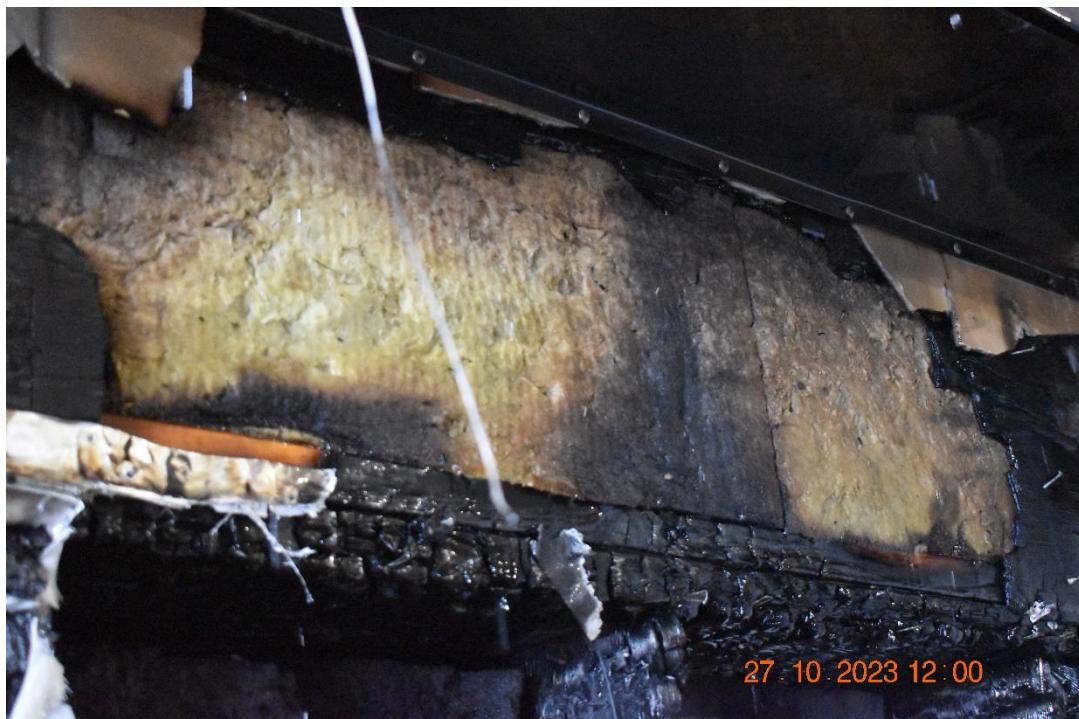
Photo No. 30 Test specimen after the test. Insulation between the fire chamber and the flame deflector.

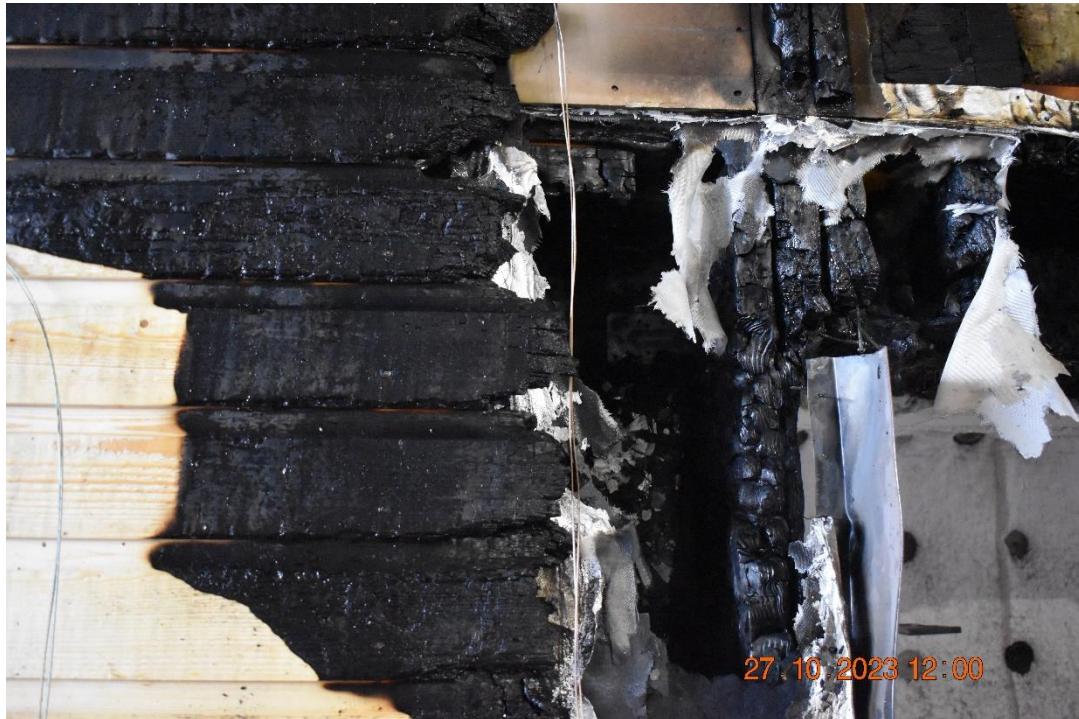
Photo No. 31 Test specimen after the test. Detailed photo of cladding and the cassette at the right side of fire chamber.

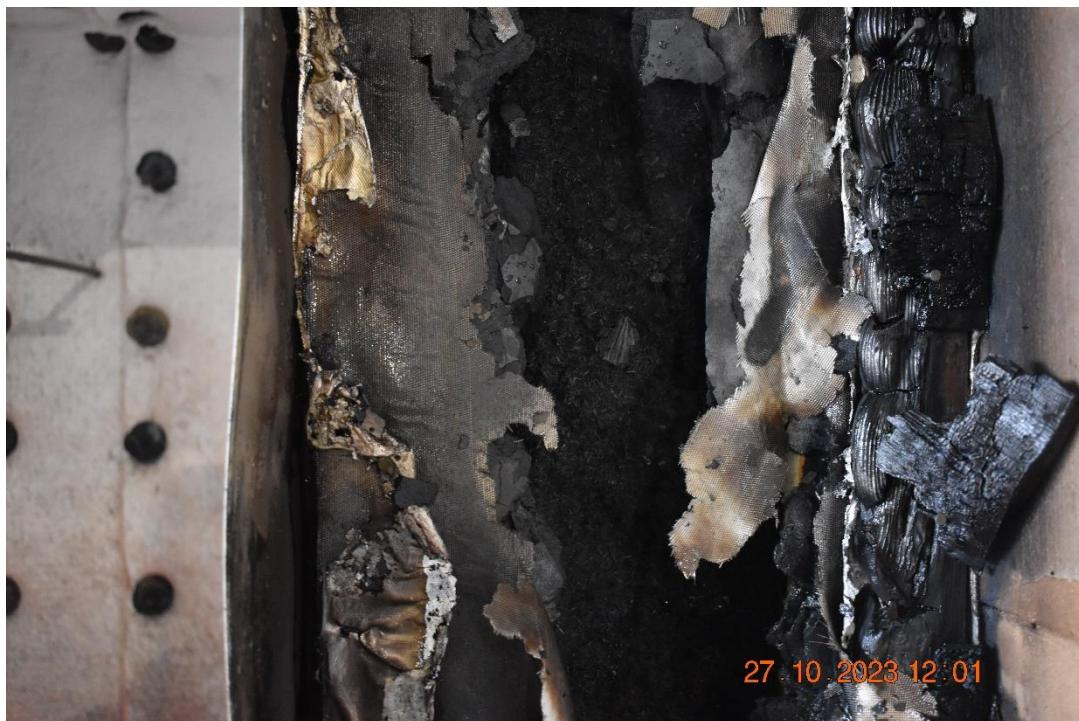
Photo No. 32 Test specimen after the test. Detailed photo of the left side of fire chamber.

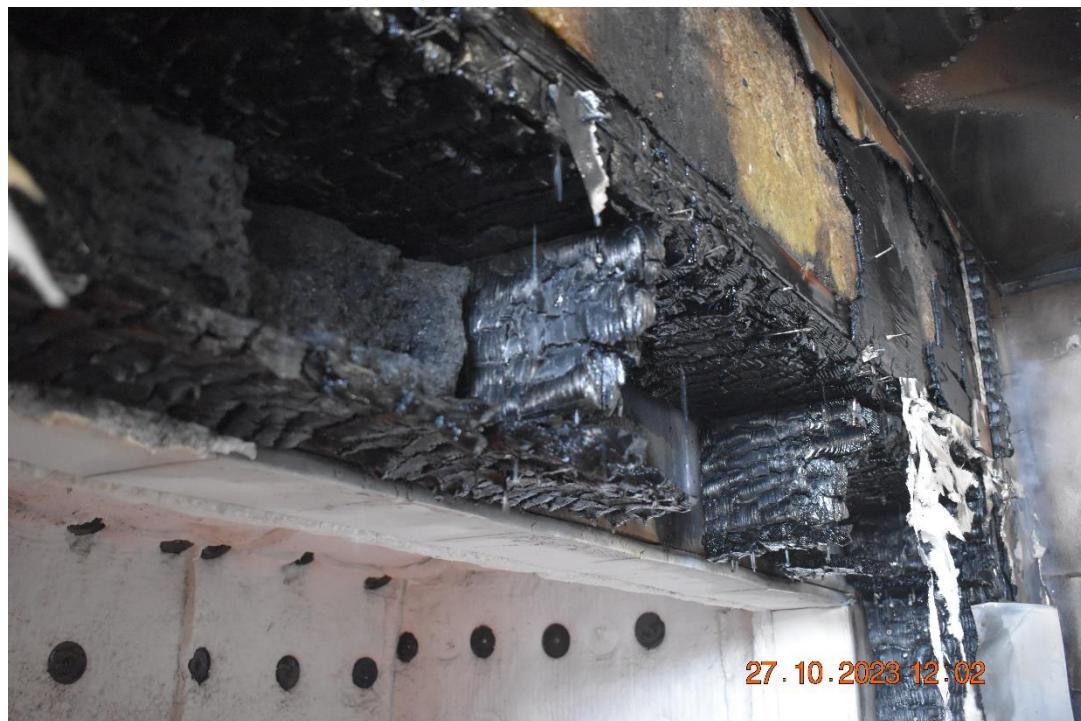
Photo No. 33 Test specimen after the test. The cassette above the fire chamber.

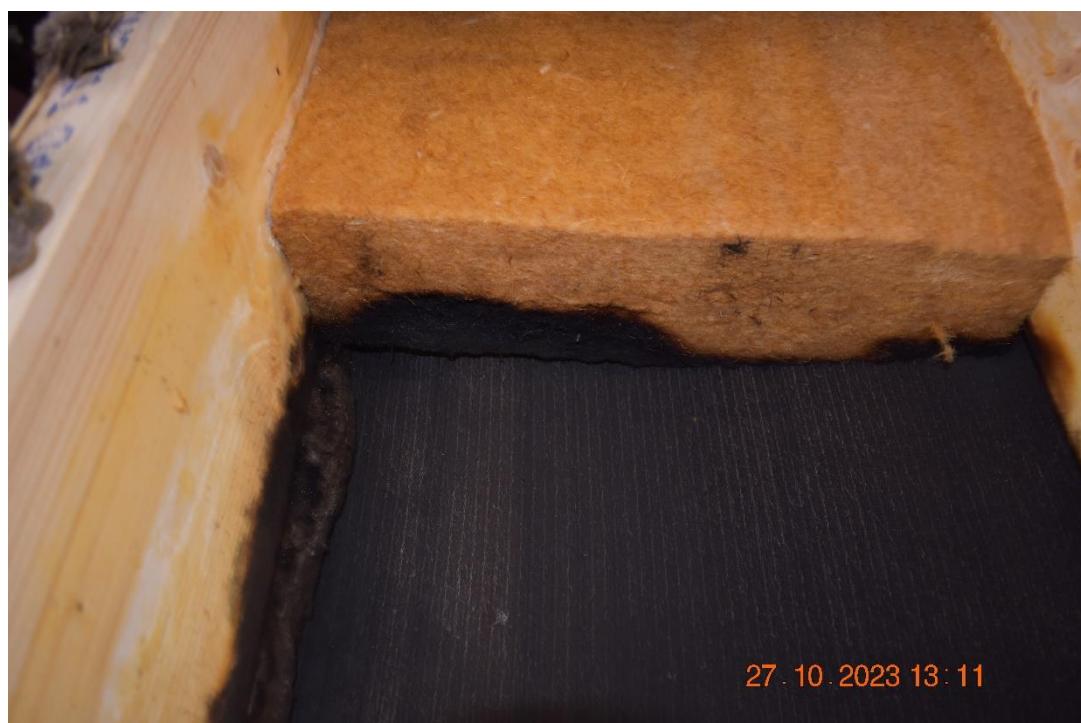
Photo No. 34 Test specimen after the test. Insulation at the right side of the first window.

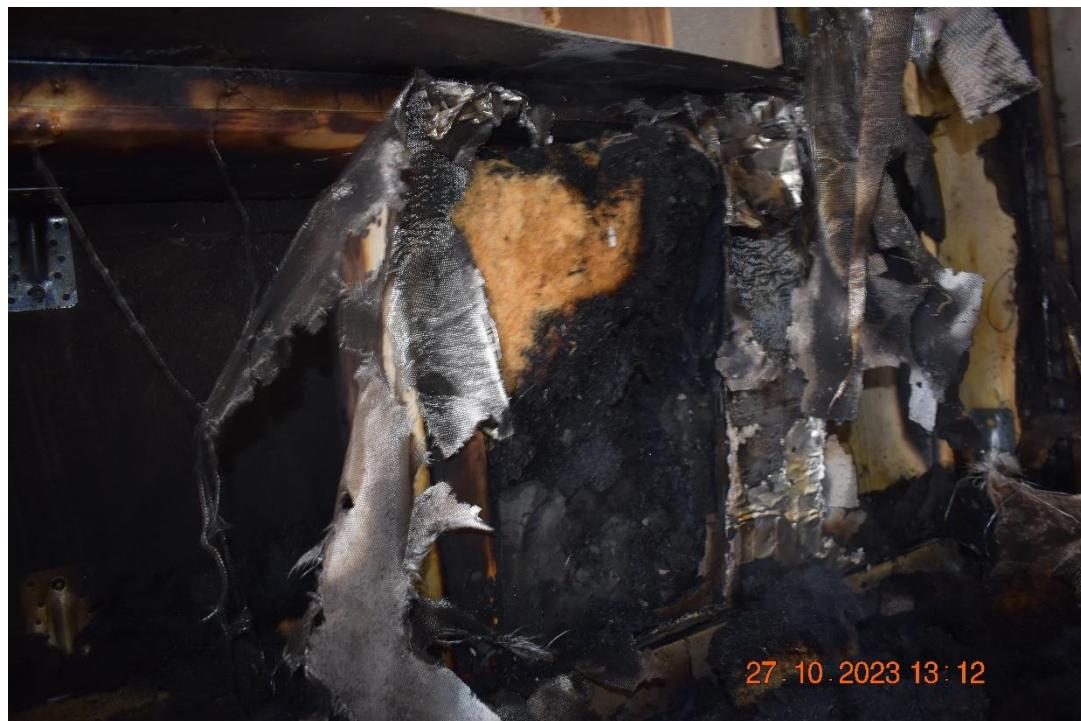
Photo No. 35 Test specimen after the test. Insulation at the bottom of the first window.

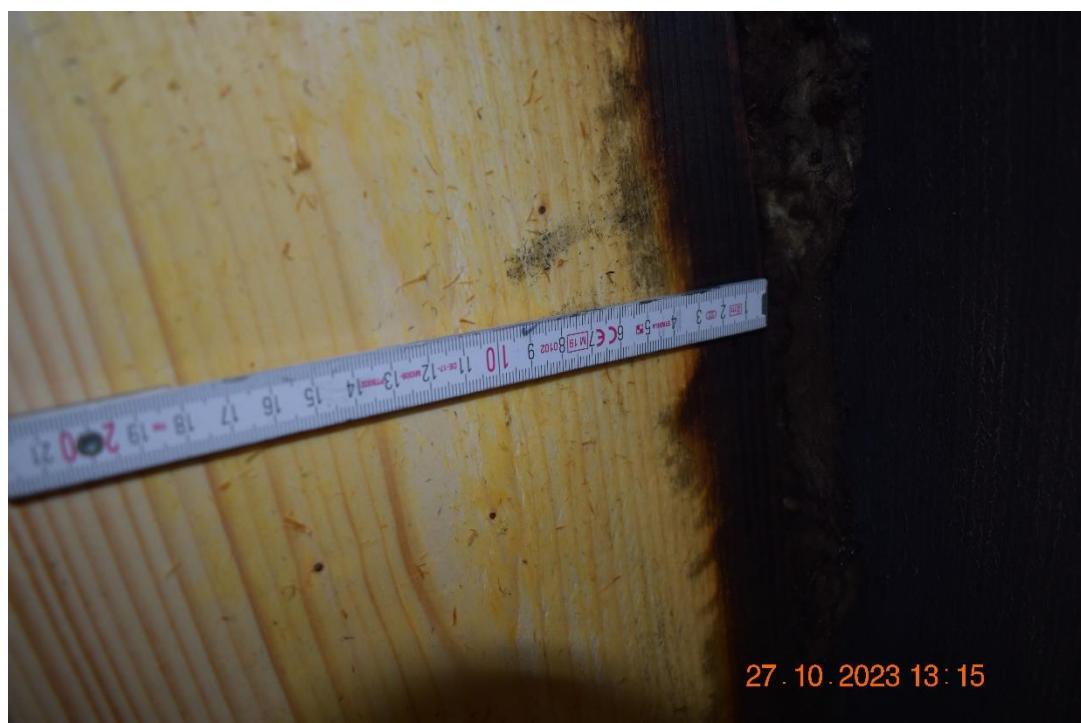
Photo No. 36 Test specimen after the test. Cassette at the right side of the first window.

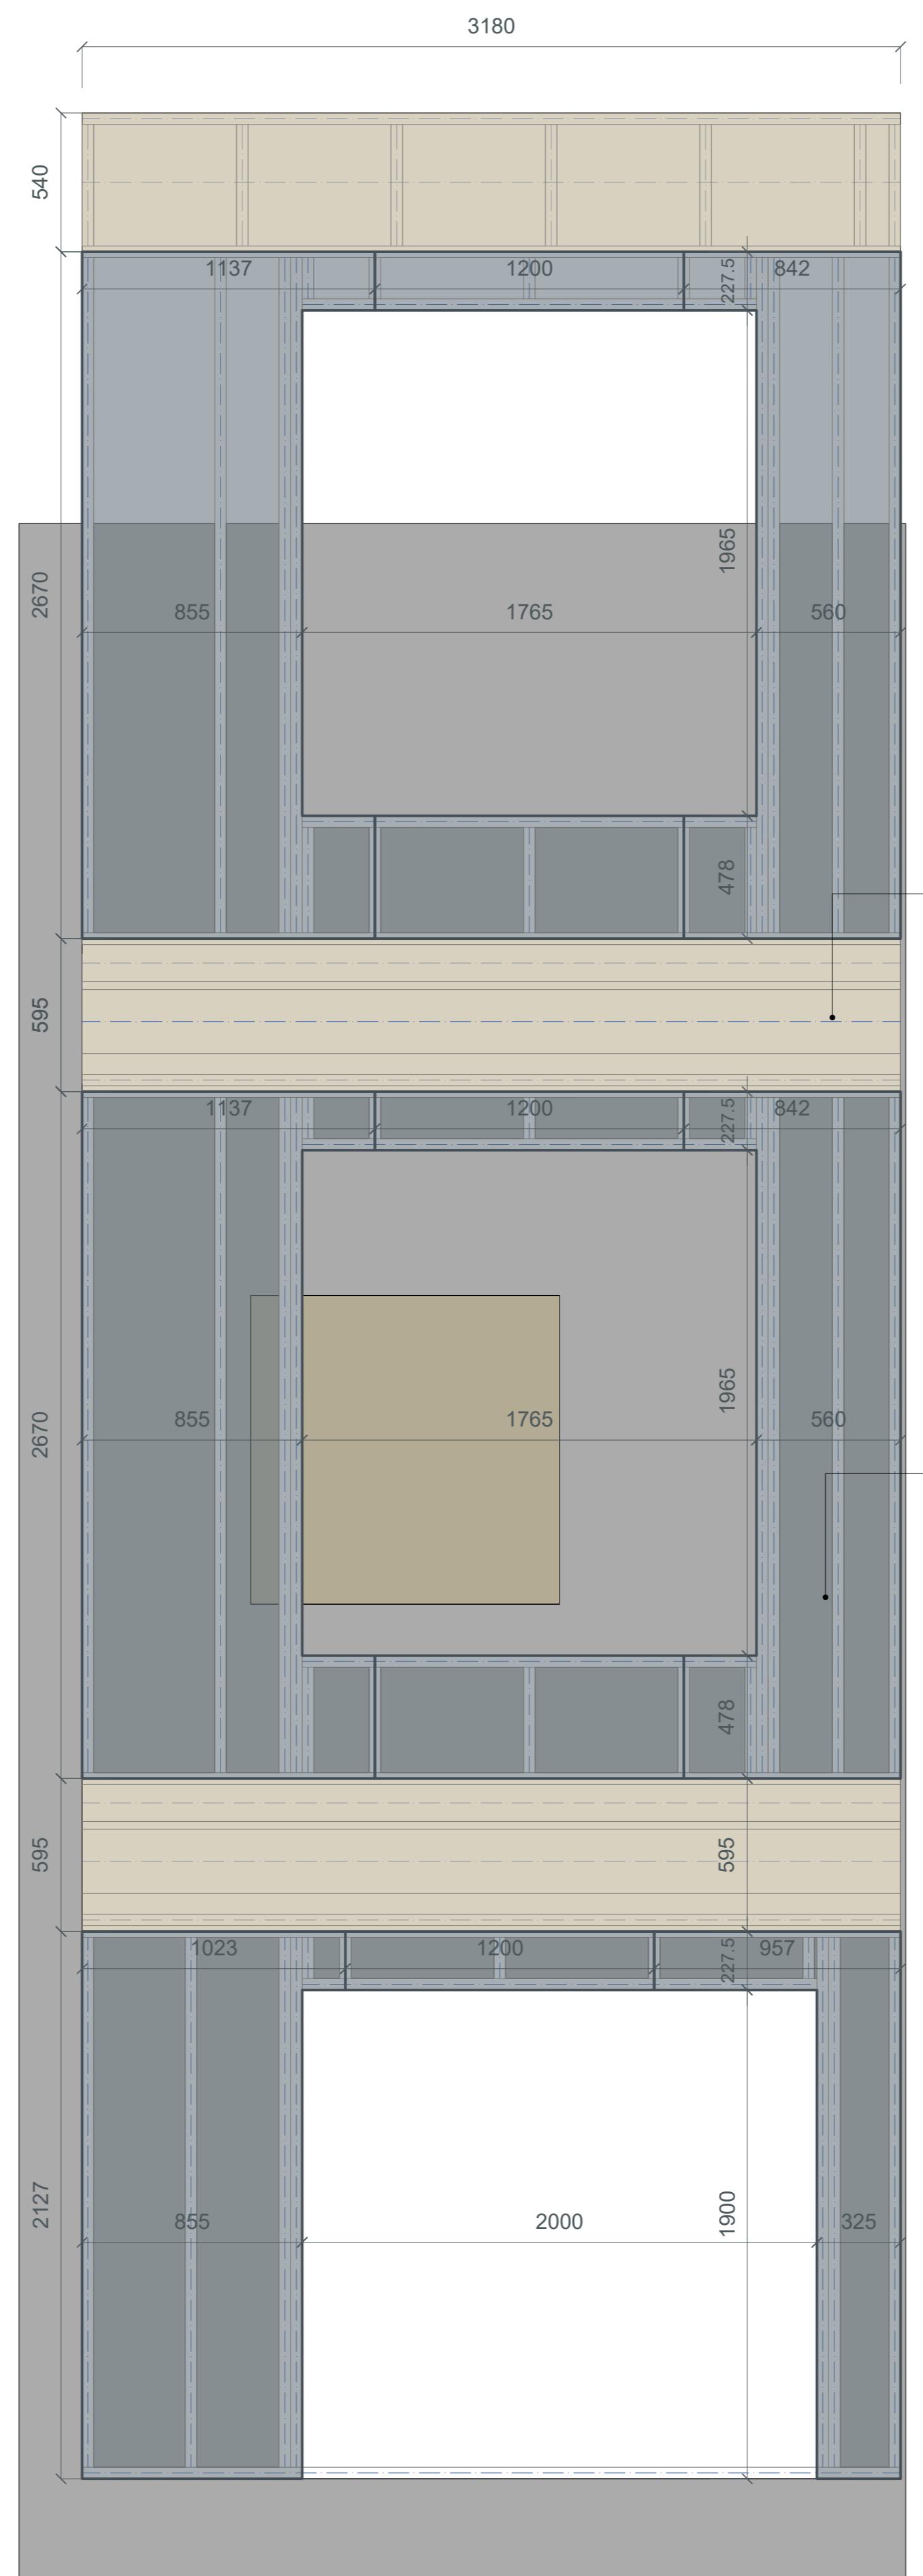
**Vindspærre**  
Hunton Vindtæt  
2x 12 mm  
Samlet i forbandt  
jf. tegninger  
Fæstnes med 840265 PZ-16  
klammer 64 mm,  
elgalvaniseret 12+  
Pladerne fæstnes med 100  
mm afstand langs  
pladekanterne og med 250  
mm afstand langs midten af  
pladerne for at sikre  
tilstrækkelig vindafstivning  
og tætning

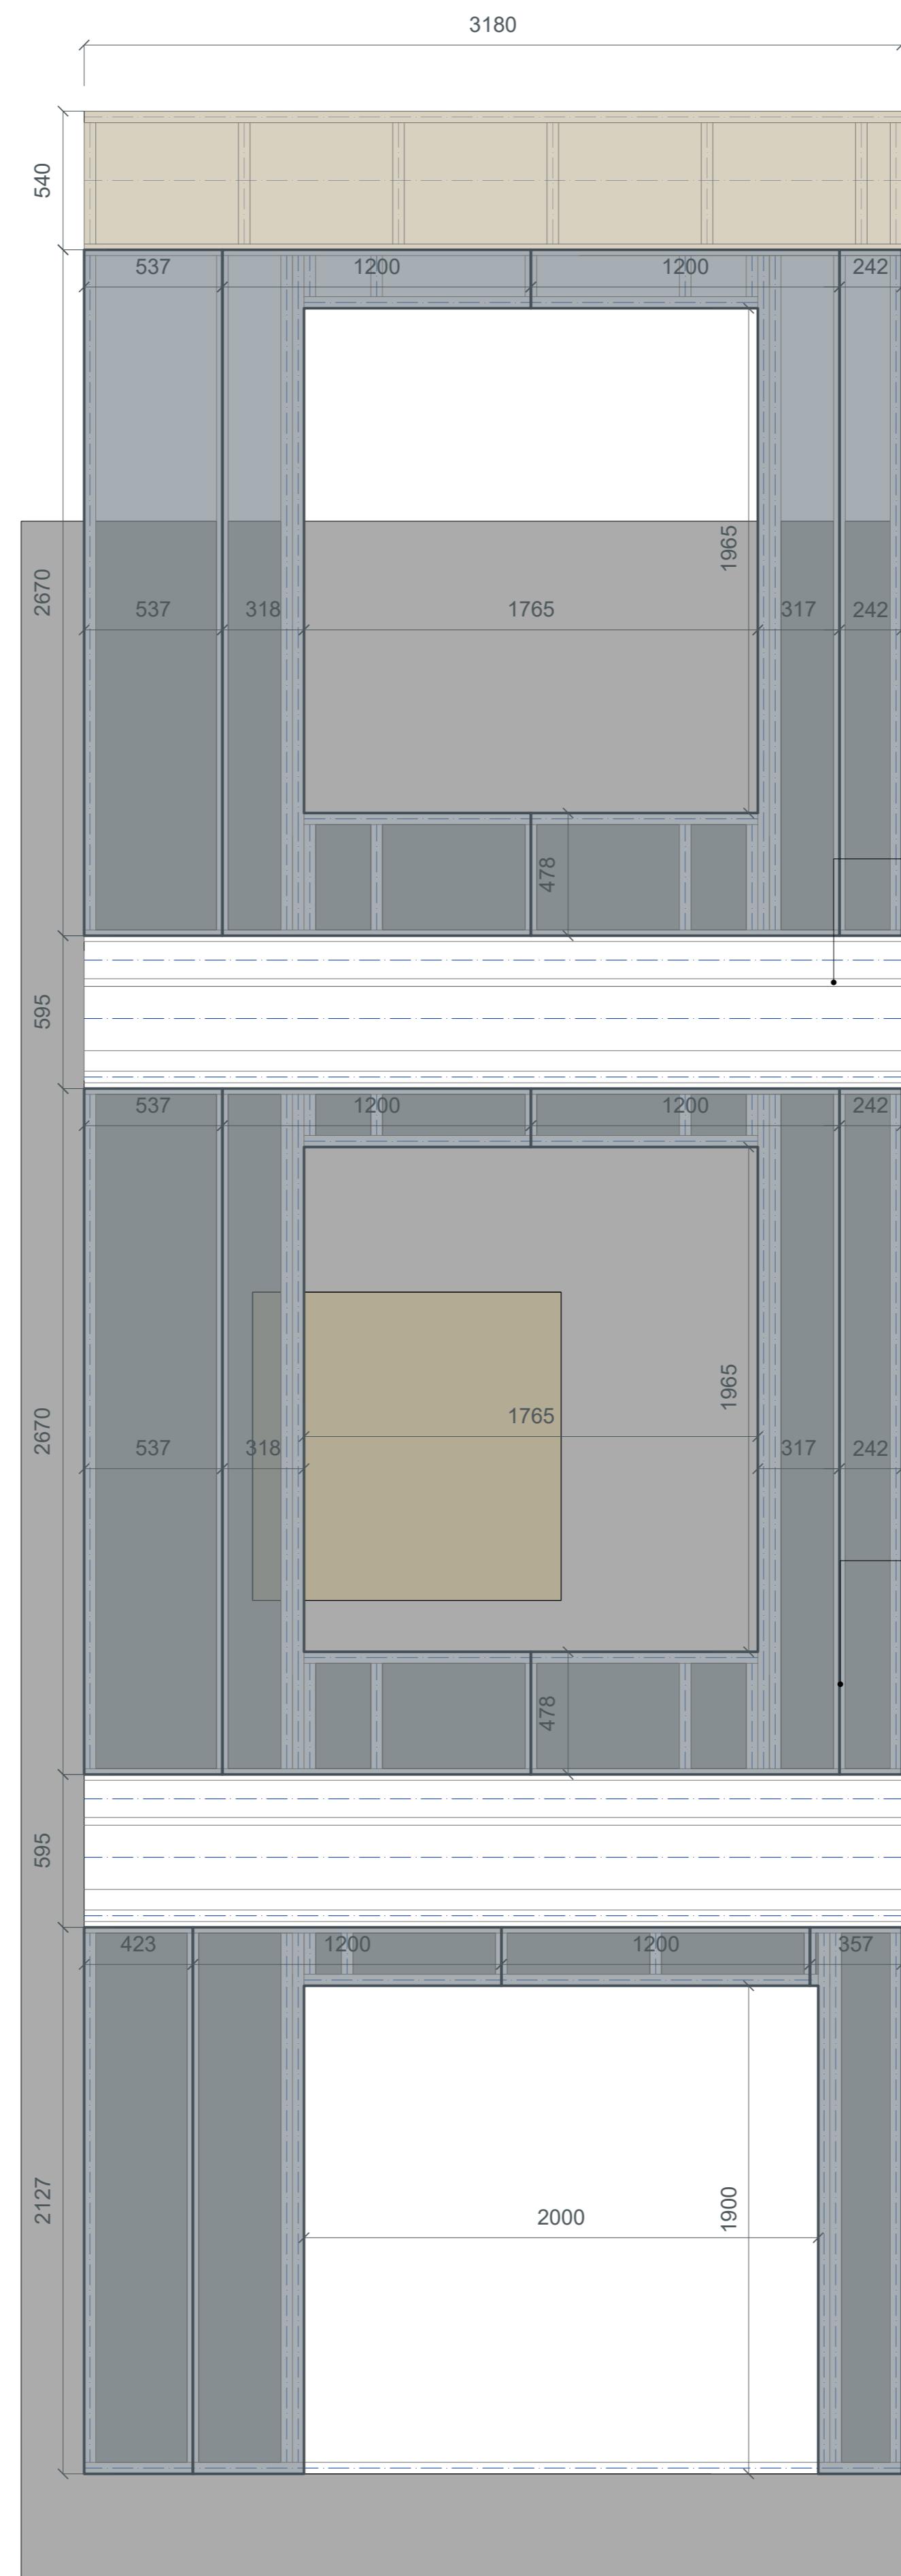
Cembrit Windstopper Basic  
i andet lag i etageadskillelsen  
Fastgøres med Tjep 2.5 x 65  
mm

**Vindspærre**  
Hunton Vindtæt  
2x 12 mm  
Samlet i forbandt  
jf. tegninger  
Fæstnes med 840265 PZ-16  
klammer 64 mm,  
elgalvaniseret 12+  
Pladerne fæstnes med 100  
mm afstand langs  
pladekanterne og med 250  
mm afstand langs midten af  
pladerne for at sikre  
tilstrækkelig vindafstivning  
og tætning

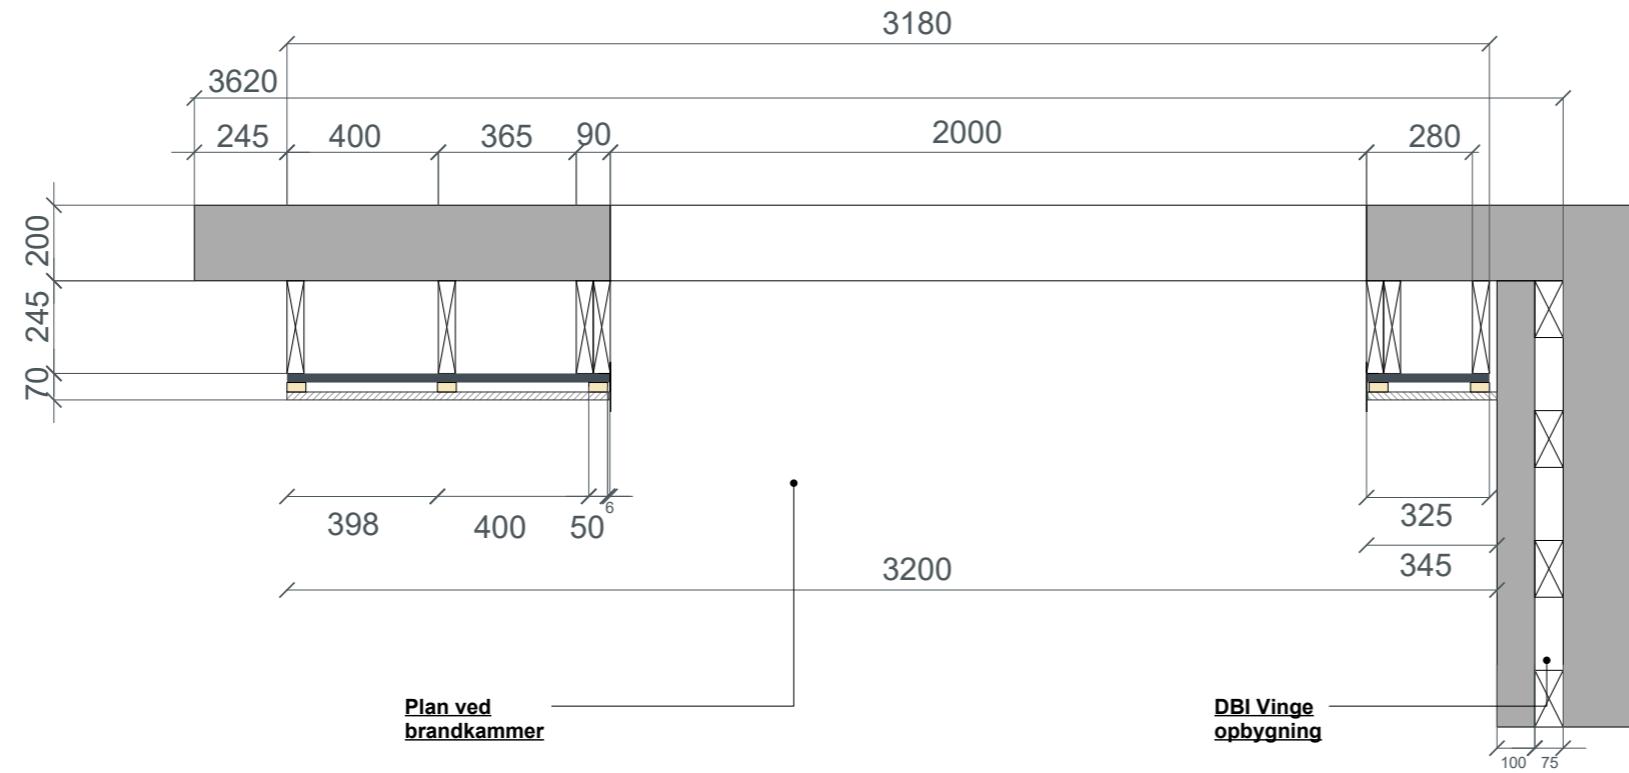
Detalje plan brandkammer	
Skala:	1 : 20
Format:	A3
Tegn.:	RSM
Kontrol:	SNI
Træksignatur:	
CPH VILLAGE	Referatsserie 1012 142 København K
	Dato: 25.10.2023
	TU_ST1_N01

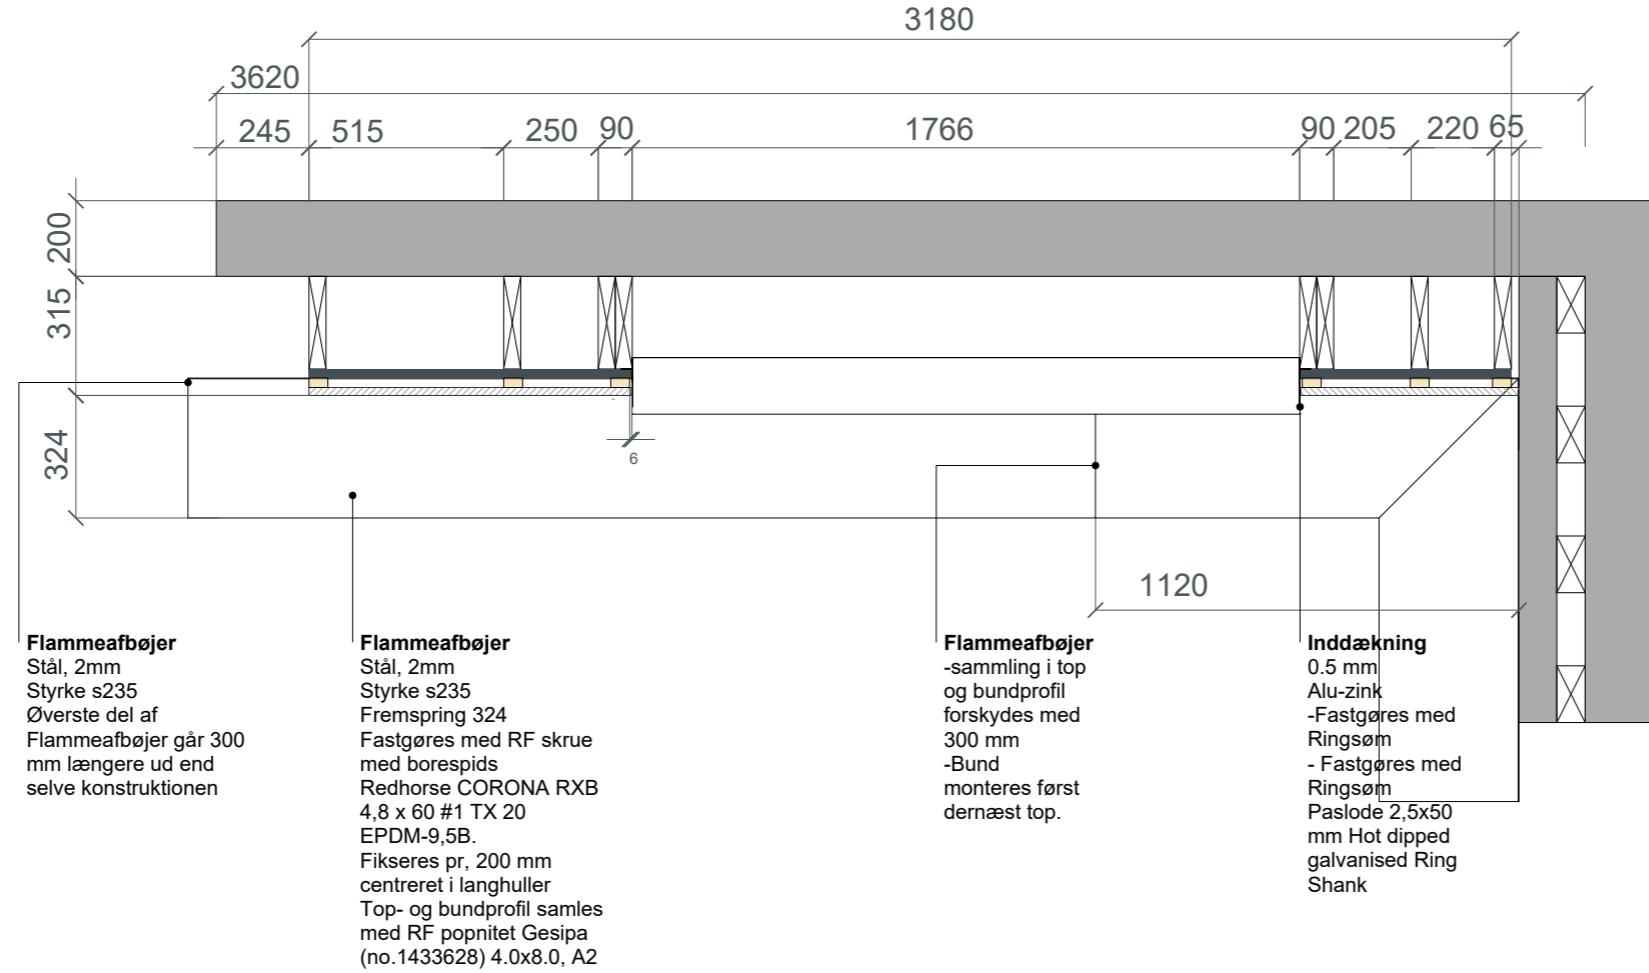
Konstruktionstræ C24, 45X145 mm.

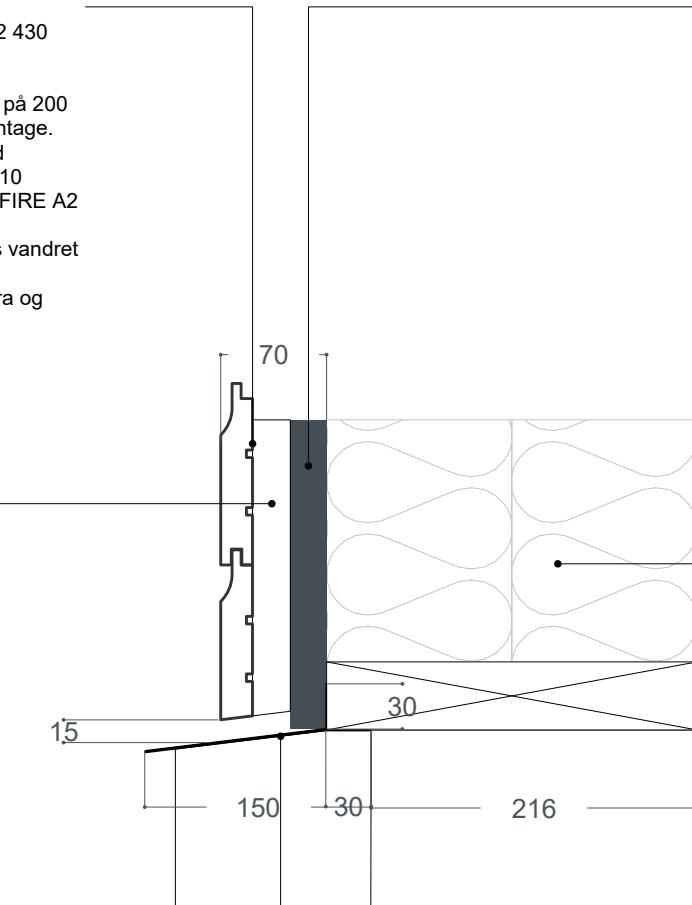
**TU\_ST1\_N05**

**Isolering**  
Hunton Nativo  
2 x 120  
Klasse E  
Monteres i forbandt

**Inddækning**  
**over vindue**  
0.5 mm Alu-Zink  
Hældning 7  
grader  
Fasgøres med  
ringsøm- paslode  
2.5 x 50

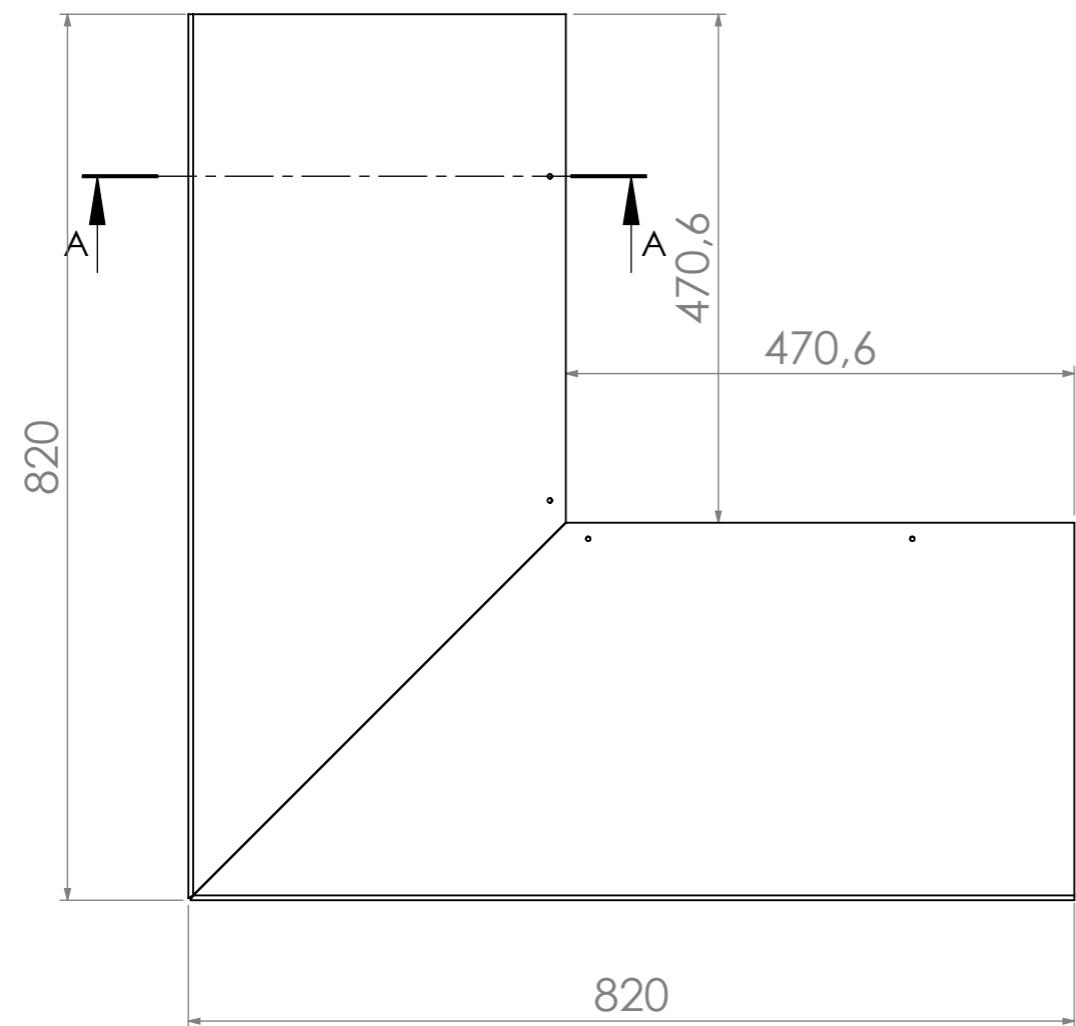
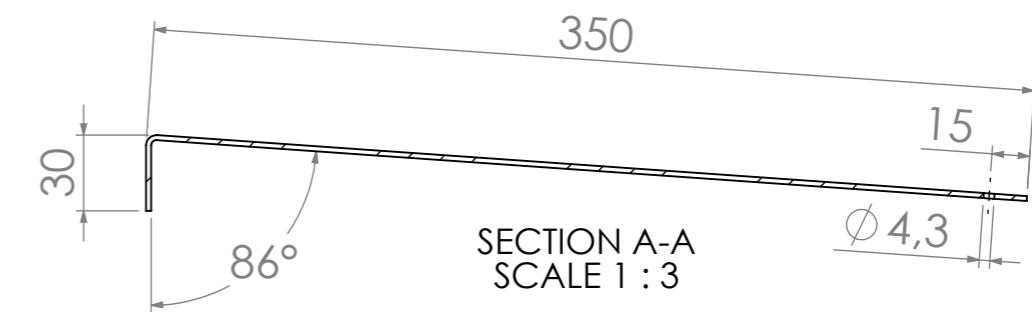
SECTION A-A  
SCALE 1:3

DRAWN	NAME	DATE	Folder name: X:\CPH Village Holding\
	casper	13-10-2023	Customer: CPH Village
			TITLE: Indv. Hj. Top, 2 mm plade
			MATERIAL: 1.0330 (DC01 (SPO))
			DWG NO. GKB-116646-indv
			REVISION
		Hvor intet andet er angivet, er tolerancer i henhold til DS/ISO 2768-1(m) Alle mål er i millimeter, medmindre andet er angivet. Tegningen må ikke skaleres.	SCALE:1:7
		WEIGHT: 13331.14	A3 SHEET 2 OF 2

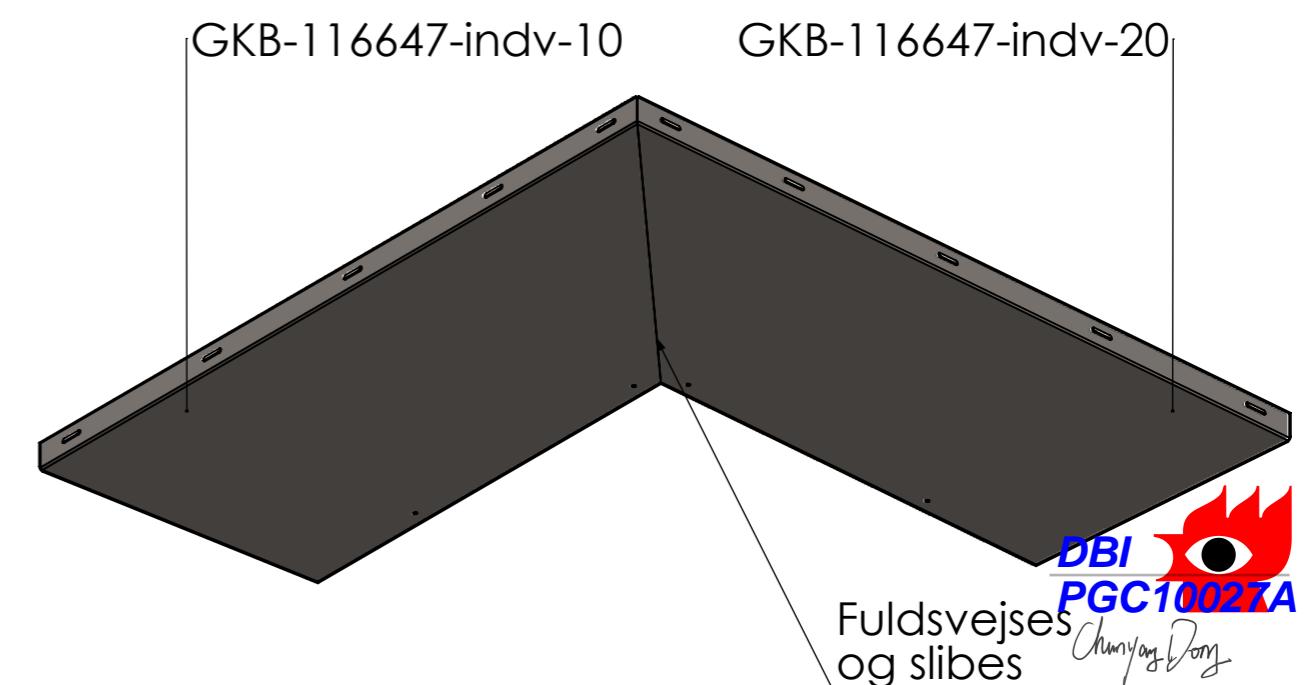
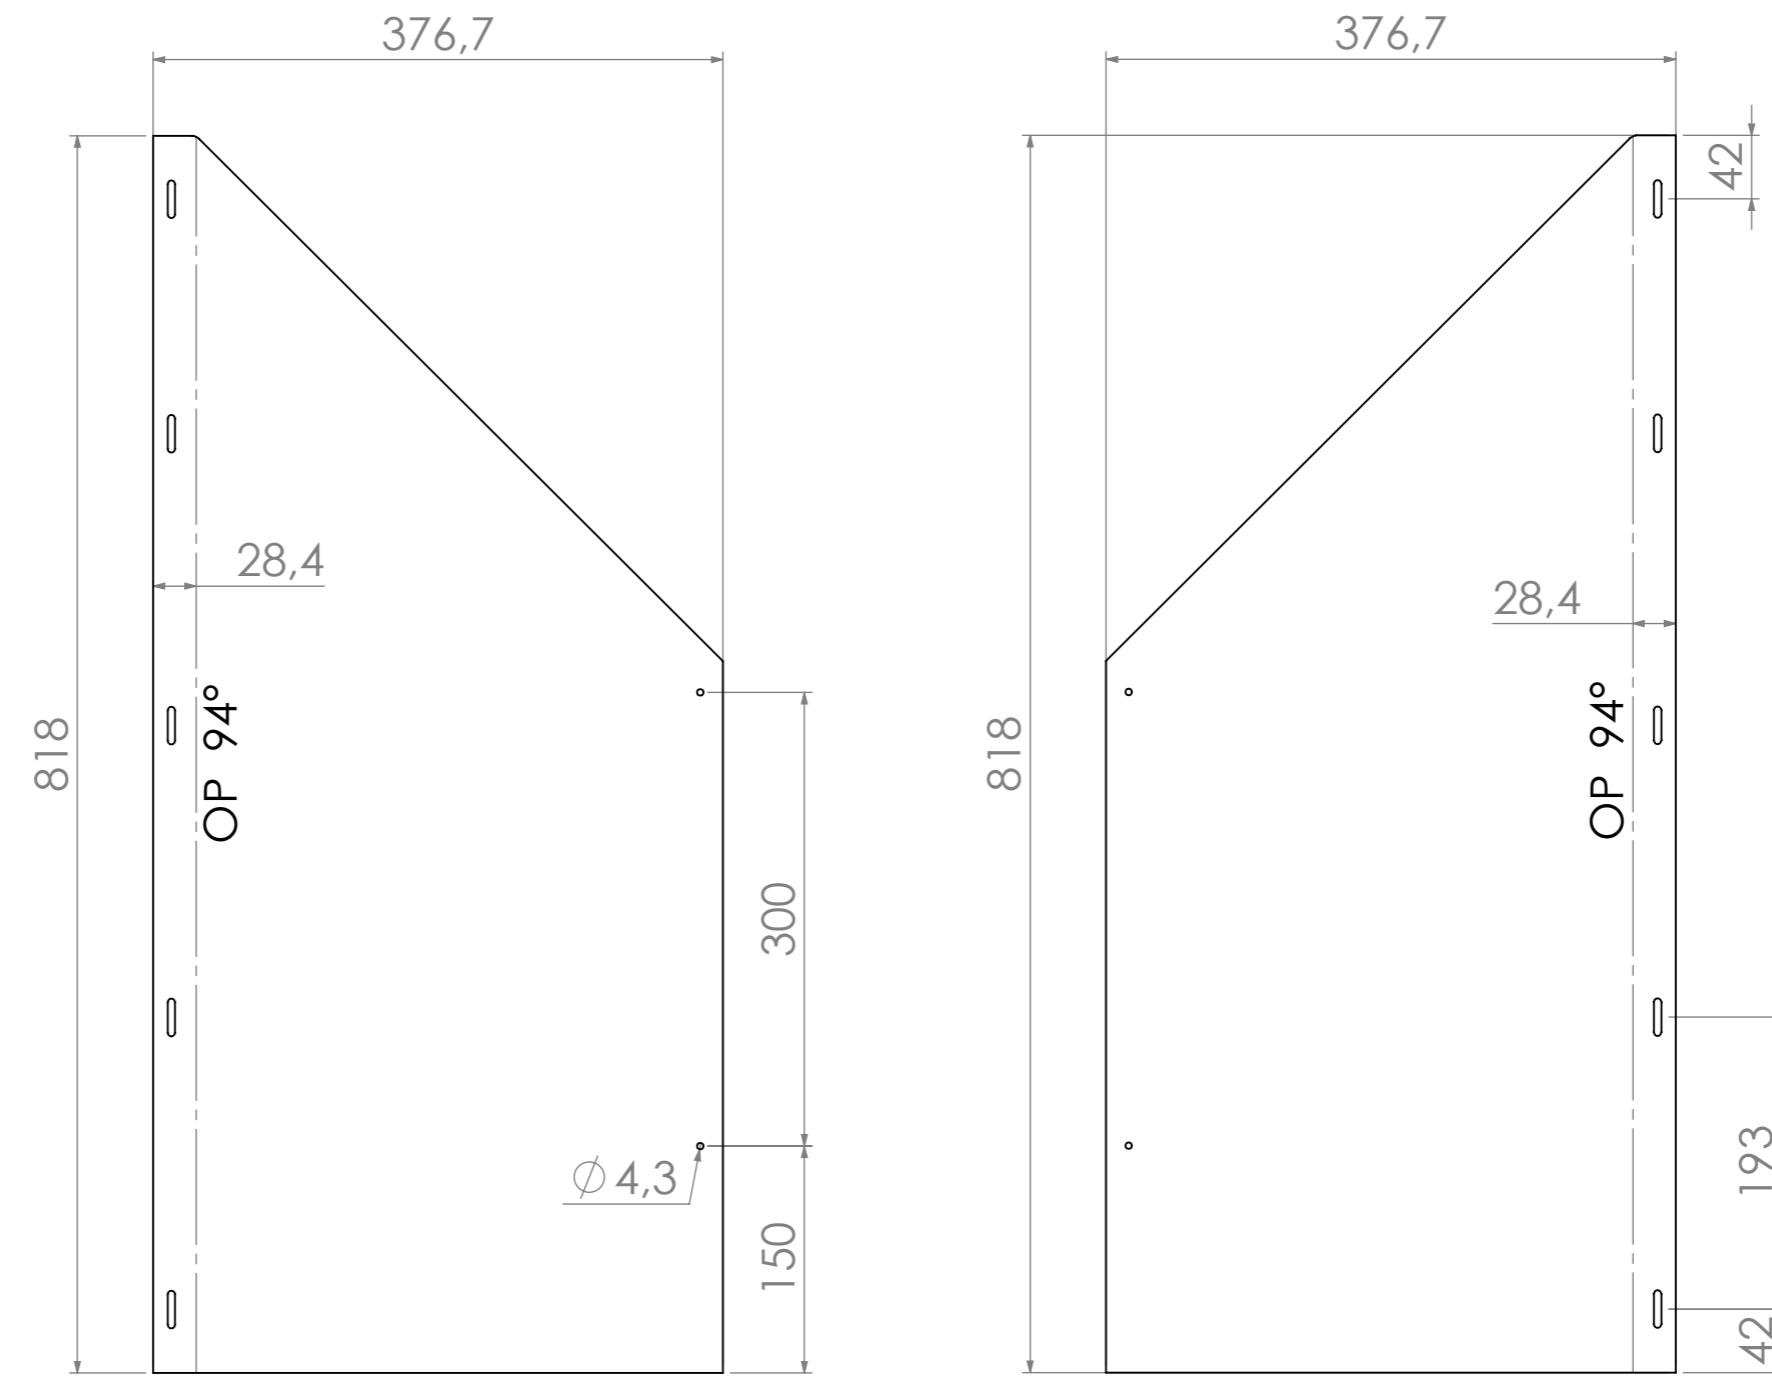
DRAWN	NAME	DATE	Folder name: X:\CPH Village Holding\
	casper	13-10-2023	Customer: CPH Village
			TITLE: Indv. Hj. Bund, 2 mm plade
			MATERIAL: 1.0330 (DC01 (SPO))
			DWG NO. GKB-116647-indv
			REVISION
		Hvor intet andet er angivet, er tolerancer i henhold til DS/ISO 2768-1(m) Alle mål er i millimeter, medmindre andet er angivet. Tegningen må ikke skaleres.	SCALE:1:7
			A3 SHEET 1 OF 2
		WEIGHT: 7712.77
