APPENDIX to

PILOT PROJECT “CONTAIN” – Exploring the Challenges of Containership Fires

APPENDIX A

1 Cone calorimeter tests

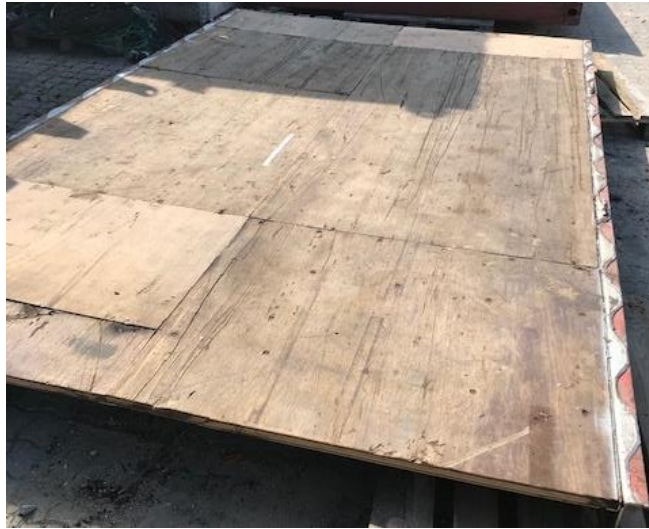
Figure 2 – floor of purchased container

It was discovered when purchasing a container for experimental purposes, that the floor was not a single material, but was made up of a patchwork of various plywood sections – varying in age, condition, materials, and surface treatments as shown in Figure 2 below.

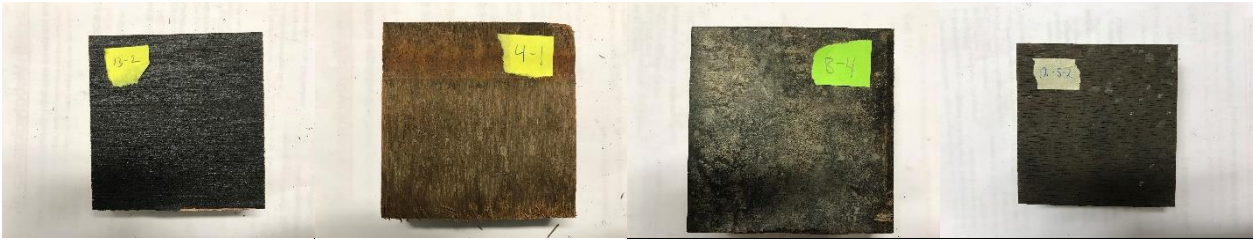
Figure 4 – examples for plywood samples

Sample 5 and 6 are taken from the same plate, Sample 7 and 13 are taken from the same plate. The plate where sample 12 is taken is a standalone plate. Figure 4 illustrates some examples of the differences in plywood materials extracted from the floor of the purchased container. Differences were not only visually observable, i.e. in appearance or having surface treatment (e.g. asphalt layer for water proofing) or not, densities were also recorded as varying significantly with values ranging between approximately 600 and 900 kg/m³.

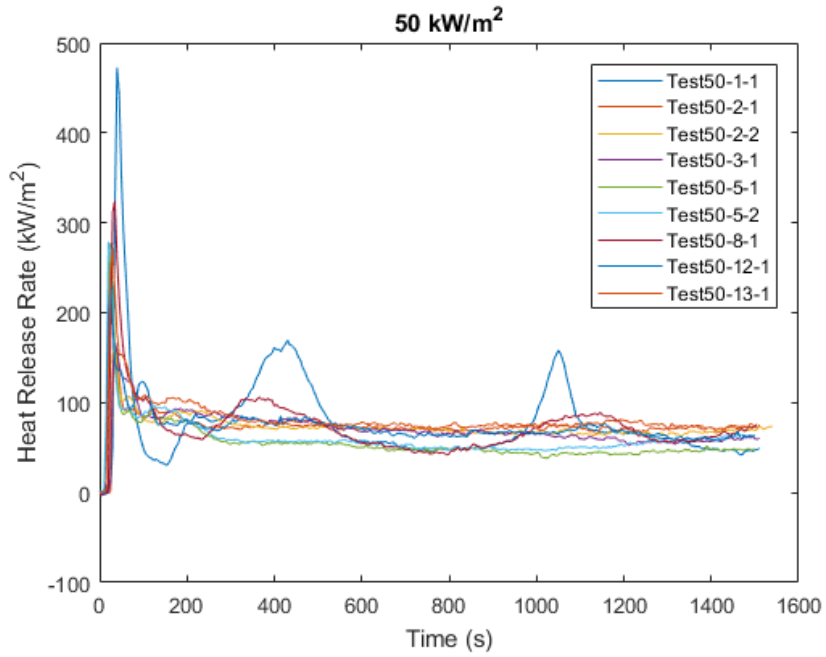
High Heat Flux – 50kW/m²

Figure 5 – heat release rate data from all samples tested

Figures presented below give a summary of results for the different heat exposures tested. Heat exposures presented represent a relatively “high” – 50kW/m², “medium-high” – 35kW/m², “medium” – 25kW/m² and “low” – 15kW/m².

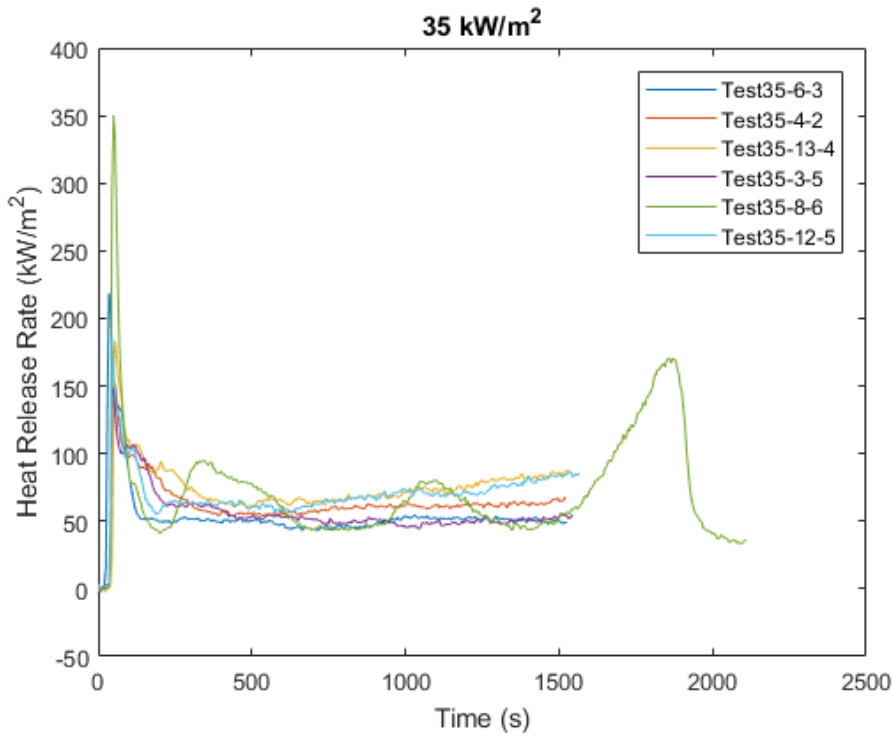
Medium-High Heat Flux – 35kW/m²

Figure 6 – heat release rate data from all samples tested

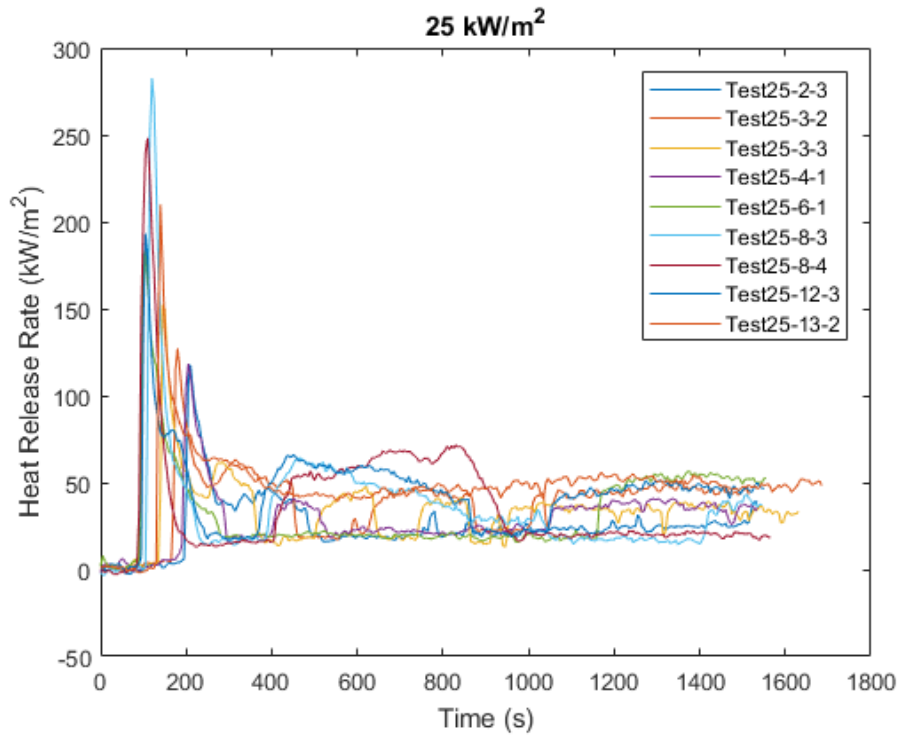
Medium Heat Flux – 25kW/m²

Figure 7 – heat release rate data from all samples tested

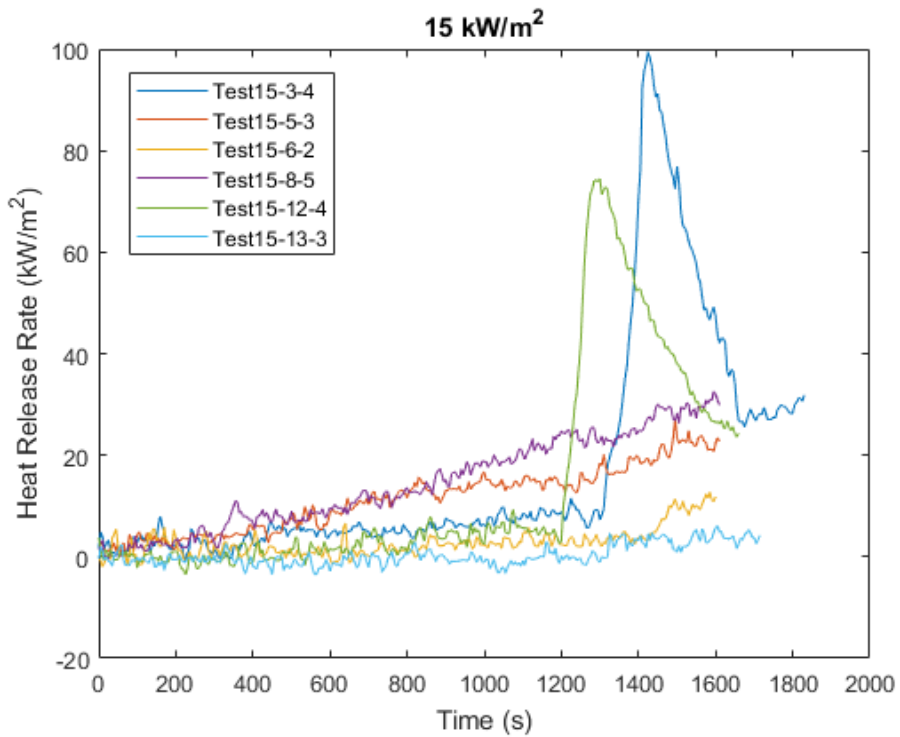
Low Heat Flux – 15kW/m²

Figure 8 – heat release rate data from all samples tested

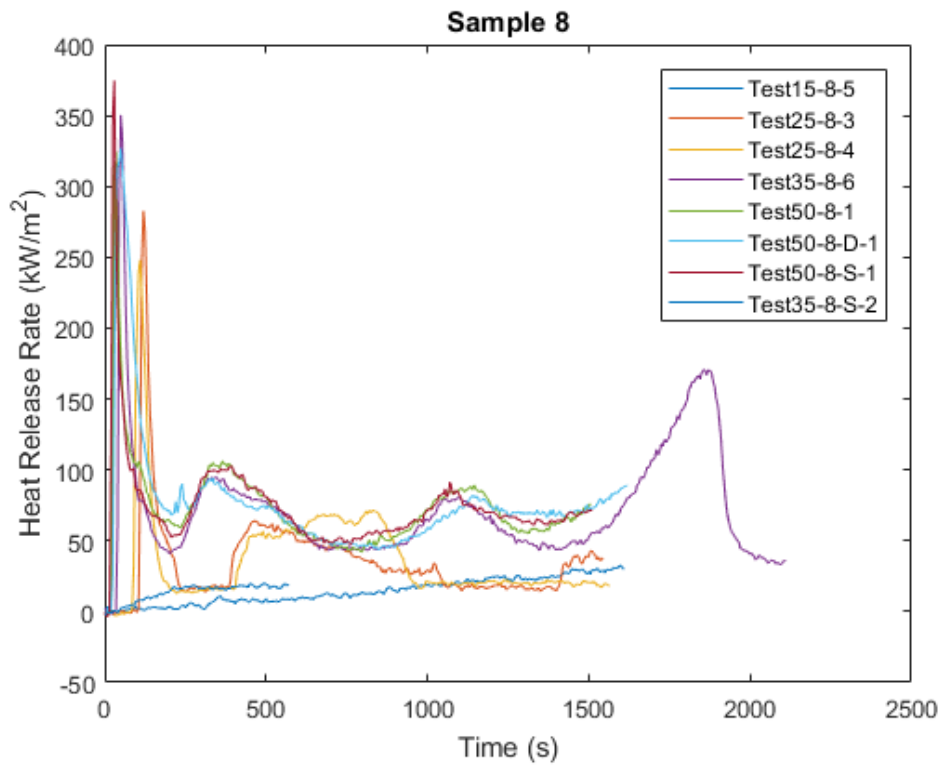
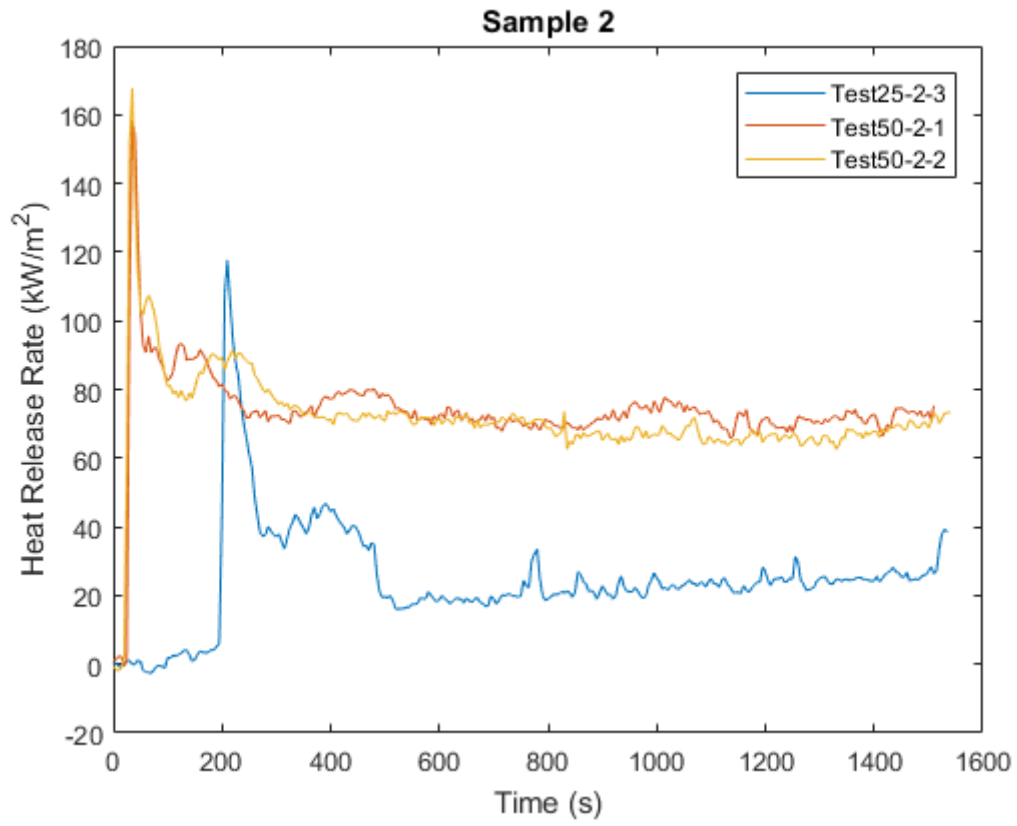
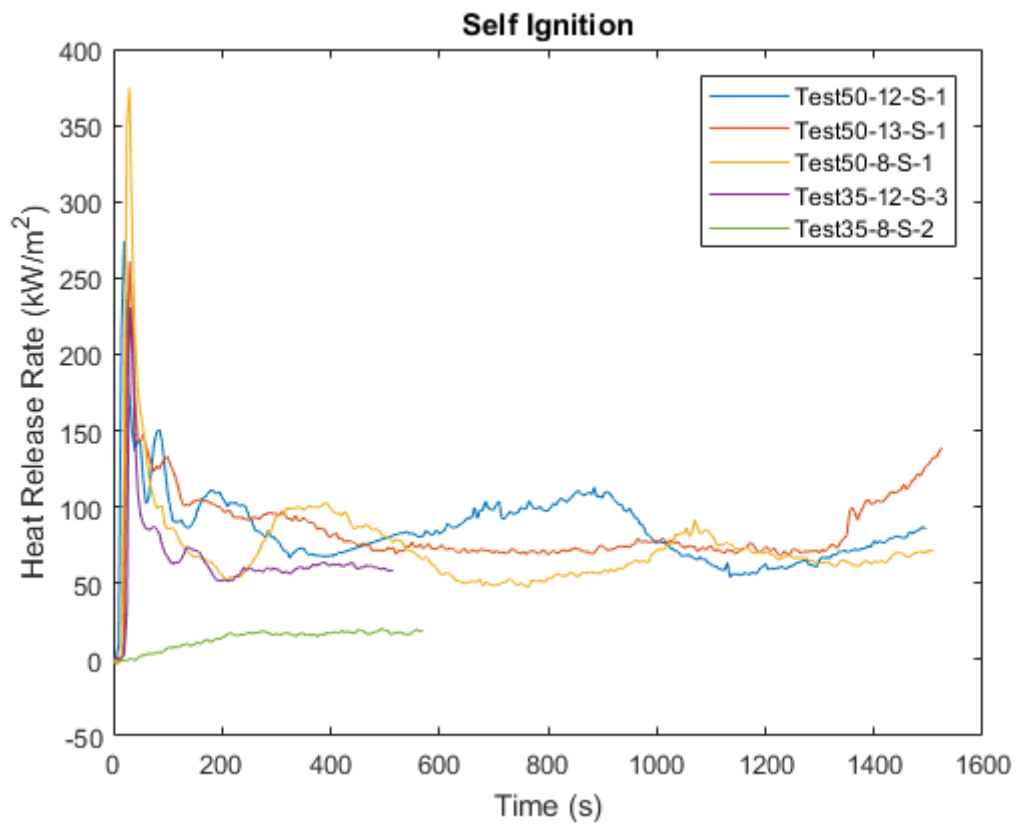
In this section, we compare results for tests using individual sample material across the various tested heat fluxes. This is done to better highlight the performance/variation of these individual materials. An “individual material” is defined as the set of samples that were taken from one particular section of the floor as per Figure 3. Legends in the following figure can be read as follows: TestX-Y-Z, where X is the incident heat flux tested at (e.g. 50kW/m²), Y is the sample location, according to Figure 3 and Z is the test number e.g. “3” indicate this is the 3rd sample tested from this location.

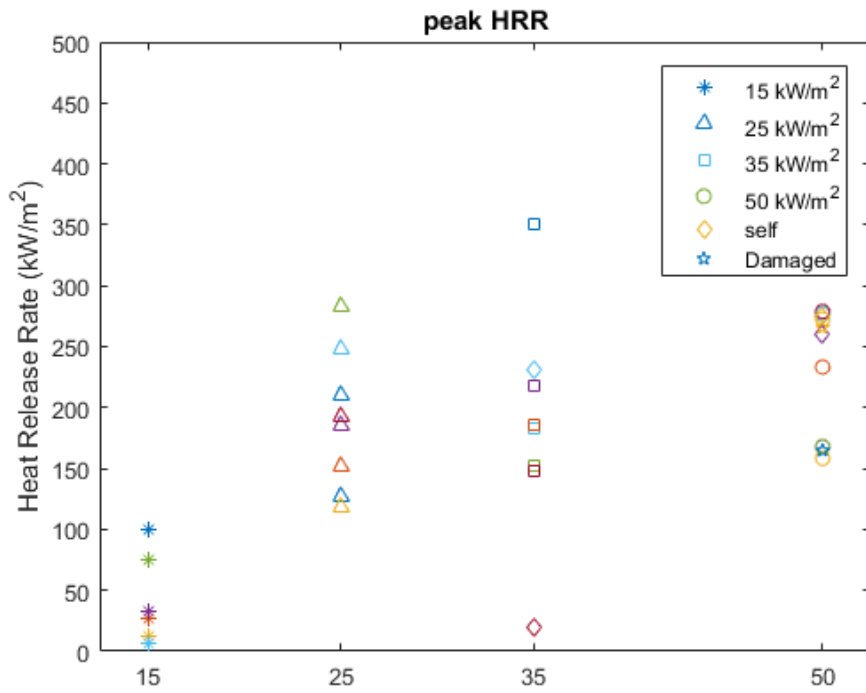
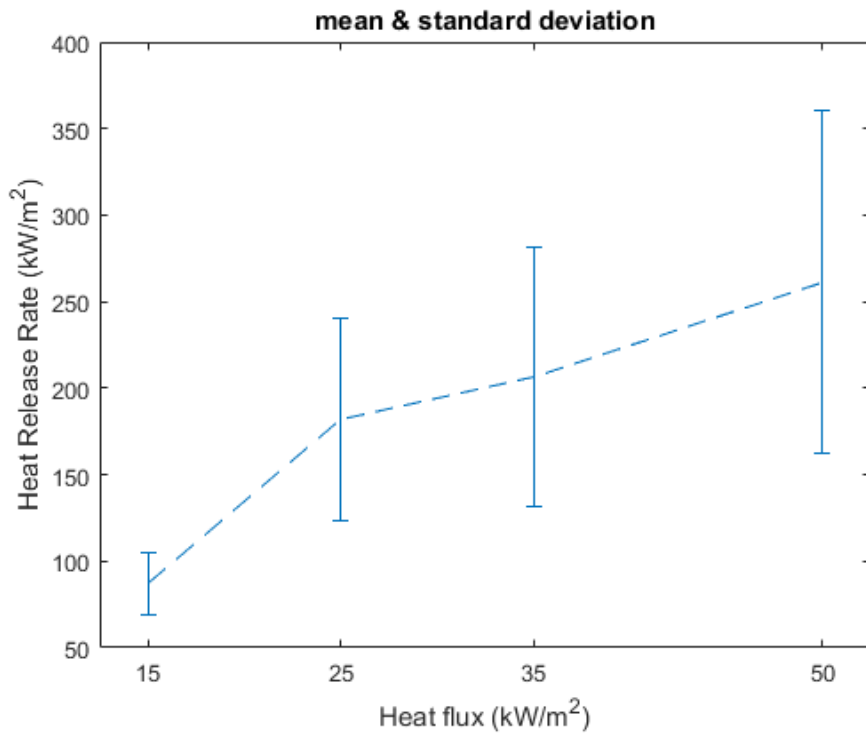
Peak HRR are outlined below from all samples, this is done to highlight the significant variation observed in the sample performance.

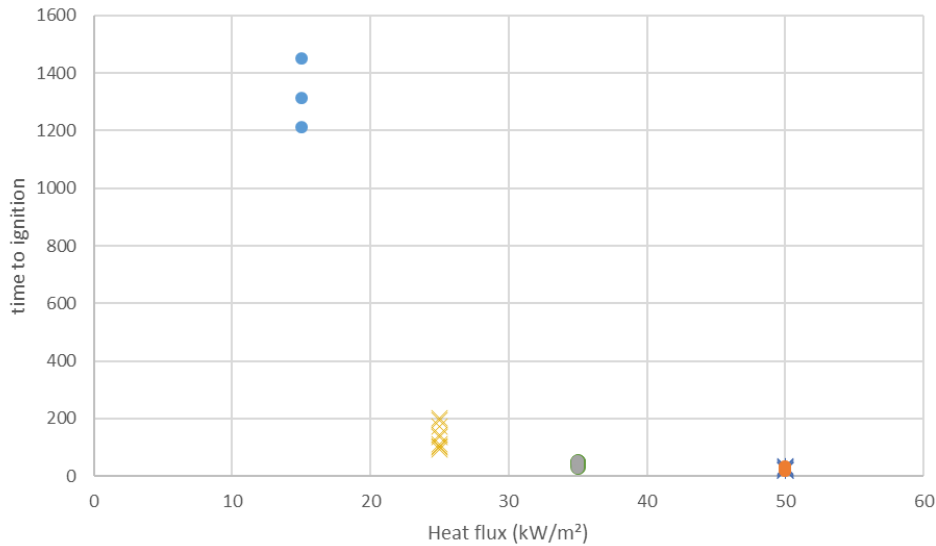
Figure 20

Figures below only provide an overall summary of the results for investigating ignition times and the calculation of critical heat flux. However due to the large spread in results due to the significant differences found in the materials. Thus this analysis is performed for individual samples, the results show that some sample will ignite much easier than others.

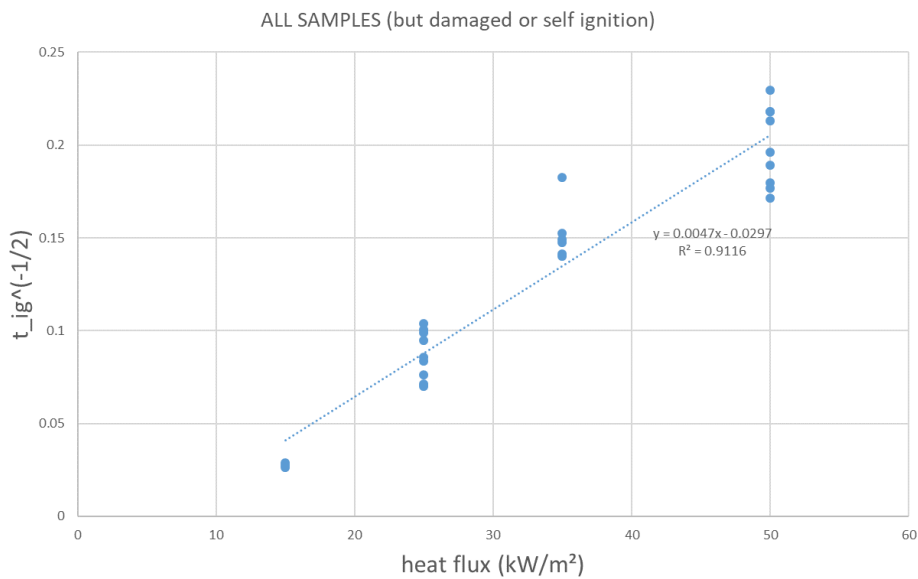
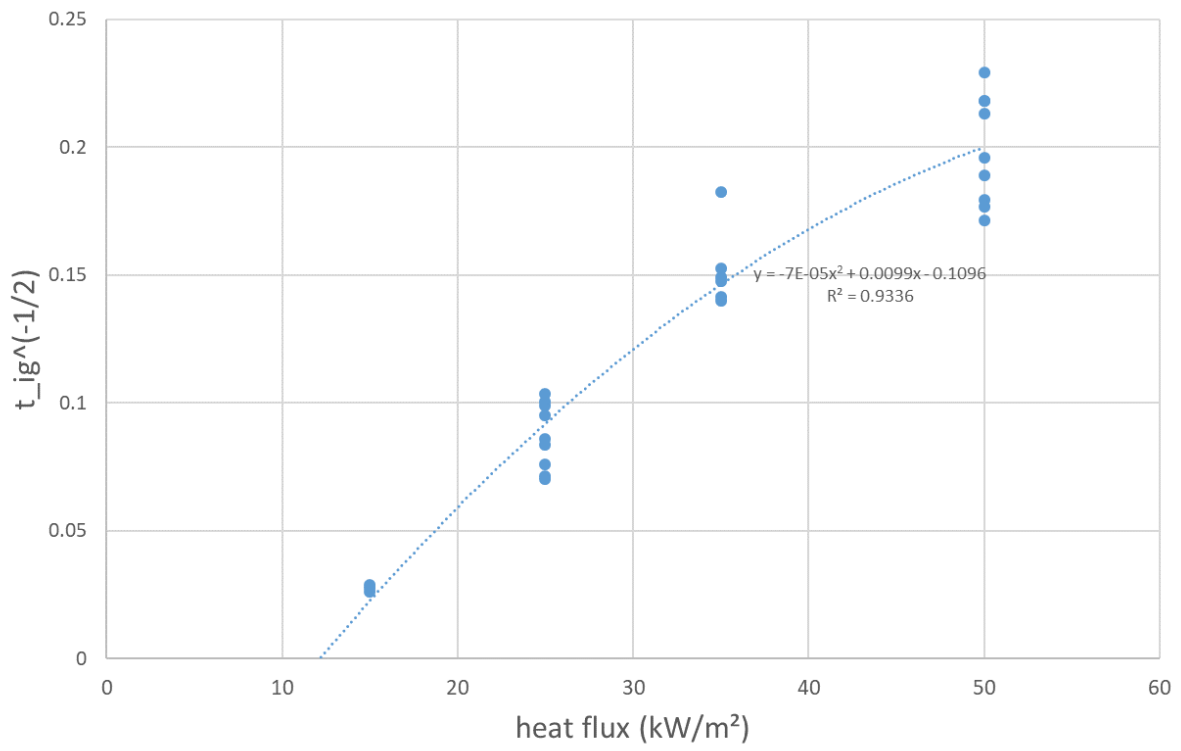
Figures 21 and 22 show difference between using linear trendline and polynomial, prediction using the polynomial is more in line with what may be expected based on previous literature.

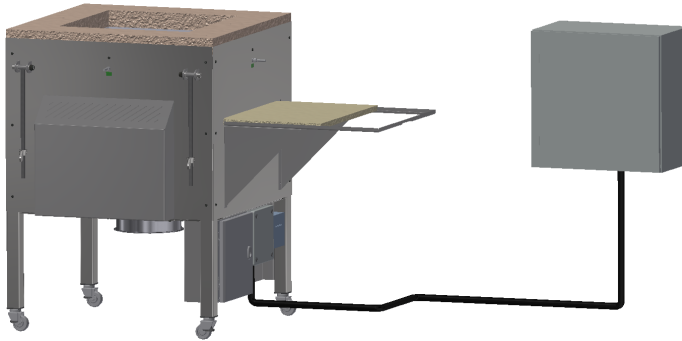
The Mobile Furnace is designed for conducting small scale resistance to fire type experiments. It is electrical heated and equipped for continuous sampling of surface temperatures, furnace temperature and running settings of the automatic furnace controls. Temperatures are sampled with approximately 0.8 Hz.

Figure A.1: The Mobile Furnace

The Mobile Furnace is a "development furnace" and the results in their form and presentation may be subjected subsequent changes. Possible modification of the furnace itself is expected and hence of the tests outcome, with streamlining on the measurement technique and on the control of the furnace. Figure A.1 illustrates the test furnace.

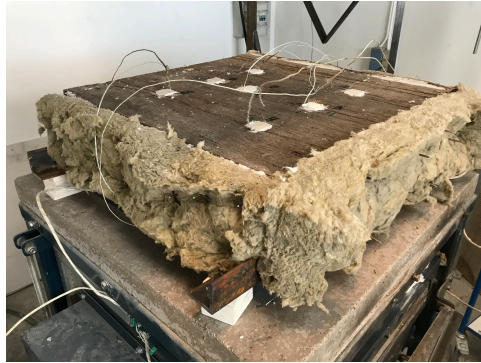
small scale set-ups. The top plate (fig. A.2c) was placed on top of the furnace, covering the furnace chamber and the bottom piece was mounted on top, allowing the 50 mm gap in-between them. Instead of using the main thermocouples inside the furnace for heat control, three thermocouples were welded on the top plate's unexposed side as a control instrument, such that the top plate could act as the heat exposure. The controlling temperature was set to $620\text{ }^{\circ}\text{C}$ with a warm-up time of 20 minutes. As shown in figure A.3, a steel lid was welded on the sample to close the opening, and the exterior sides were insulated with mineral wool in order to avoid heat losses.

(a) Bottom structure without lid

(b) Bottom structure with lid

(c) Isolated test sample

Figure A.3: Test sample with rock wool isolation

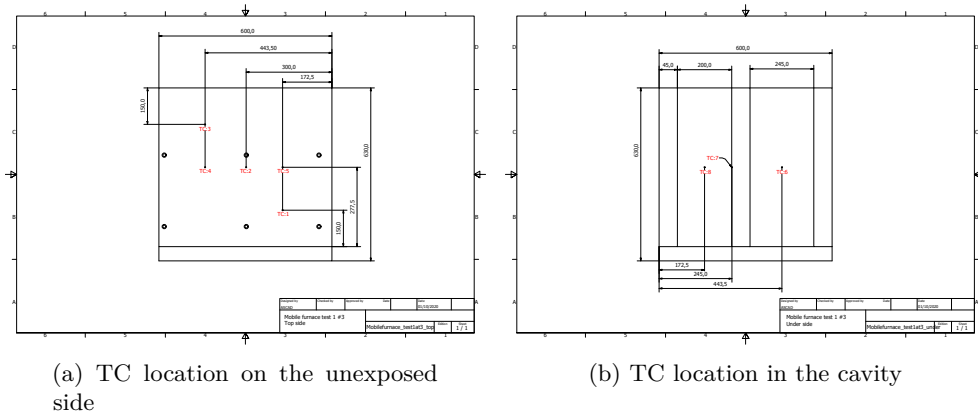
As shown in figures A.4a and A.4b, eight TC were mounted on the sample for temperature reading, five covered with pads and glued to the unexposed surface, and three in the components' cavity, one through a drilled hole, one hanging, and one placed between the mid beam and the plywood. A thermal camera was used for recording the heat distribution on the plywood unexposed side (the camera was mounted with a delay of 5 minutes, with respect to the test start).

Figure A.4: TC setup on the test sample, a full size version can be found at the end of this report

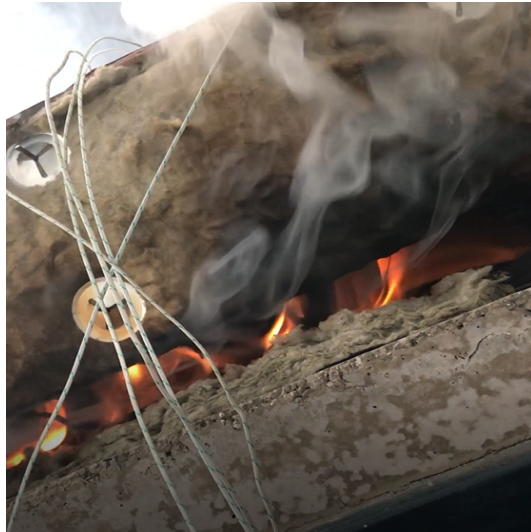
This test's primary focus is to replicate fire development between two containers, using a small sample from the container bottom and top plate. The test was run for 100 minutes. Ignition occurred after 23 minutes starting at the surface of the mid beam nearest the exposures. During the first minutes after ignition, the flames were in green, blue color. As figures A.5 A.6 and A.7 show, flames were detected elsewhere in the cavity and at the steel structure, and bitumen dropping on to the exposure plate was observed. The flames in the sample prolonged throughout the test time.

Figure A.5: Flames inside the cavity

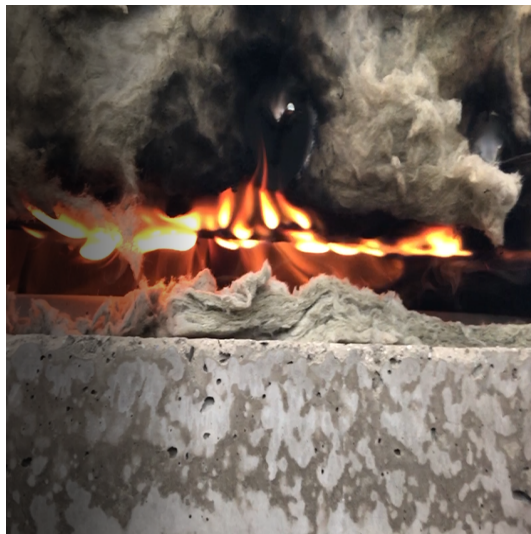
Figure A.6: Flames on a steel beam

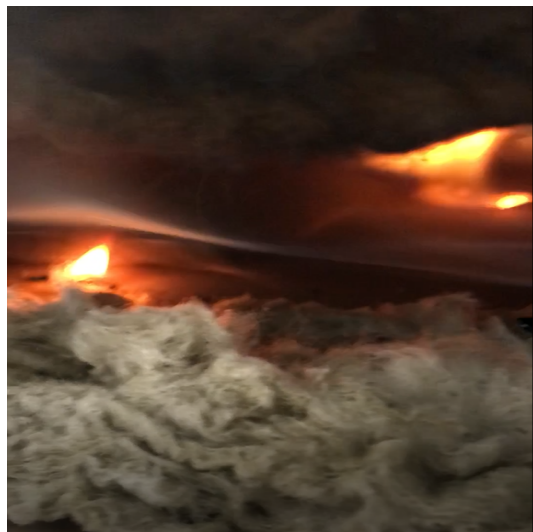
Figure A.7: Bitumen dropping on to the top plate

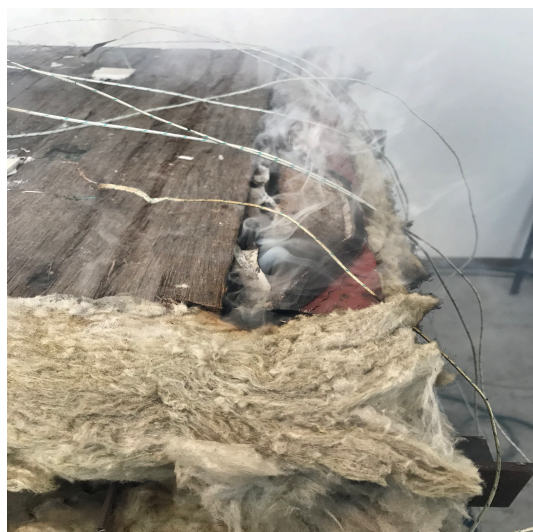
As shown in figure A.8, some smoke escaped from the cavity through the plywood and steel frame's junction and this occurred after the insulation material started to melt.

Figure A.8: Smoke at the junction of plywood and steel frame

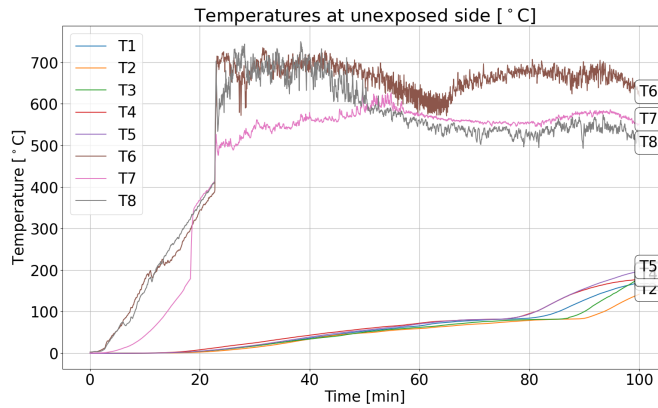
Figure A.9 shows all temperature measurements during the test and Figure A.9

illustrates the temperature at the exposure. At the unexposed side the temperatures increase uniformly between 20 and 80 minutes and then after increase steeper and not uniformly as shown in figure A.10. The TC located in the cavity increase sharply, and all have reached more than 350 degrees after 20 minutes. The peaking temperatures for TC 6,7 and 8 takes place just after the ignition reaching up to 700 °C.

Figure A.9: Temperature measurements

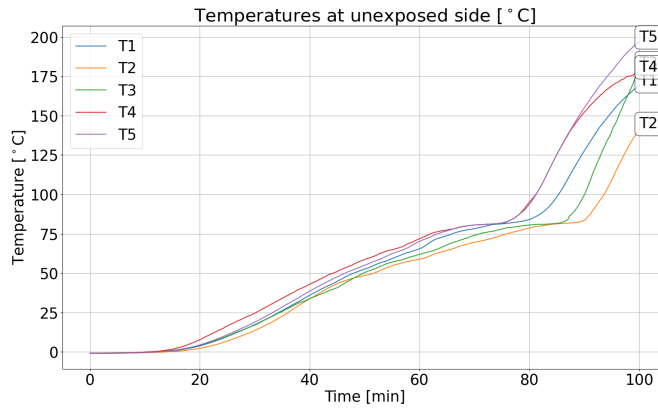
Figure A.10: Temperature measurements at the unexposed side

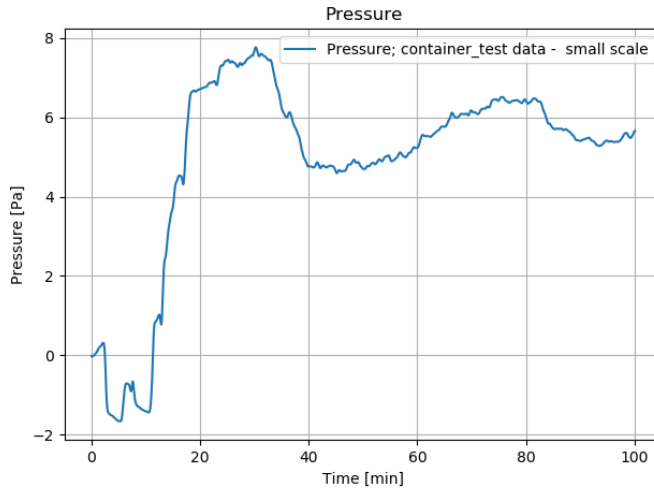
Figure A.11 is the graph for the air pressure inside the furnace, and as it can be seen, it initially decreased due to deformation of the top plate, affecting the airtightness of the furnace chamber. Mineral wool was stuffed after 10 minutes to fill in

the gaps between the top plate and the furnace surface so as to maintain a positive air pressure.

Figure A.11: Chamber pressure

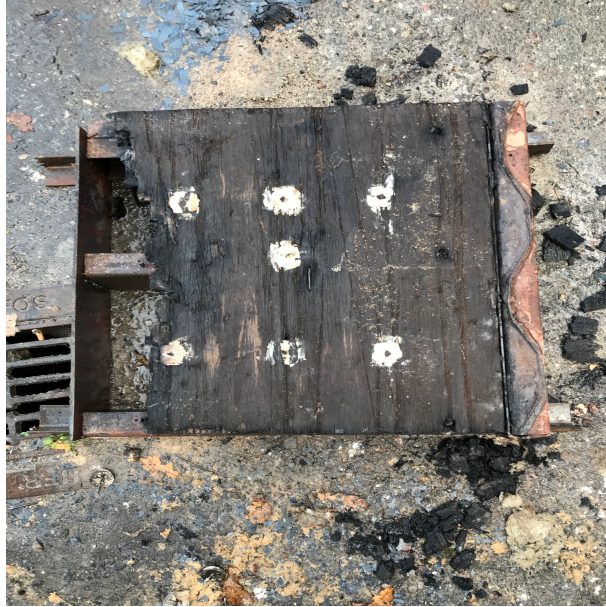
Figure A.12: The test sample after the test

After the test was stopped, the sample was removed outside for cooling and suppressing fire. It was noticed that little or nothing of the charred plywood had fallen to the top plate. The remains of the plywood came off from the steel frame rather easily. As figure A.12 shows, approximately 1/4 of the plywood has burned through at the left side. And can partly be explained by a not sufficiently isolated gap between the lid and the plywood. No deformations were notched on the steel frame.

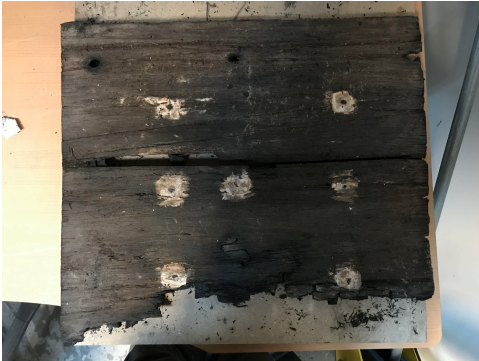
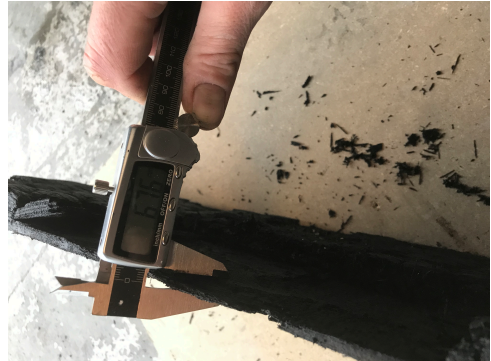
Figure A.13: Examination of the plywood after test

After scraping the loose charred lay off the unburnt plywood the remaining layers of the plywood was measured to be approximately 6.5 mm as shown in figure A.13b.

(a) Plywood after test cut in half

(b) Thickness measurements

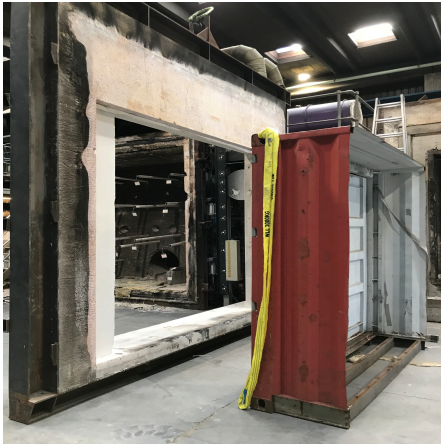
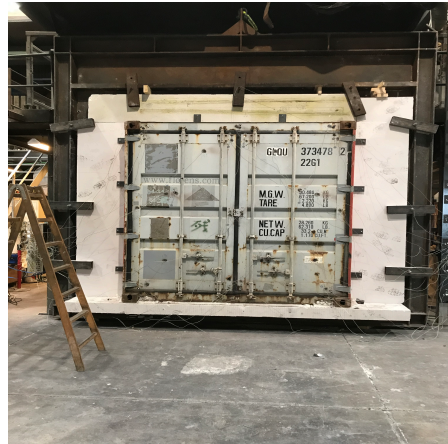
Figure B.1: Installation of the door section to the test frame

(a) Door section before mounting in to the test frame

(b) Door section after being mounted in test frame

In this full scale test a part of the container, including the door leaves and frame, was cut off from a 20-foot seaworthy container¹ and placed in a designed test frame as shown in figure B.2. The test frame was constructed with aerated concrete with a hole slightly bigger than the dimensions of the door section. The door section was mounted in the test frame and screwed fast through the concrete, the surrounding gap between the container and the concrete was isolated with rock wool and ceramic wool as illustrated in figure B.2b. The remaining of the plywood flooring in the container part was removed and gaps between the steel cross members isolated to avoid heat loss as shown in figures B.1b. The test frame was then mounted vertically on front of a 3x3 m full-scale fire test furnace. The test was run for approximately 90 minutes and the furnace temperature set to follow the iso 834 standard fire curve. Thermocouples and infra red camera were used for temperature measures on the unexposed surfaces and as well deflection and heat flux was measured.

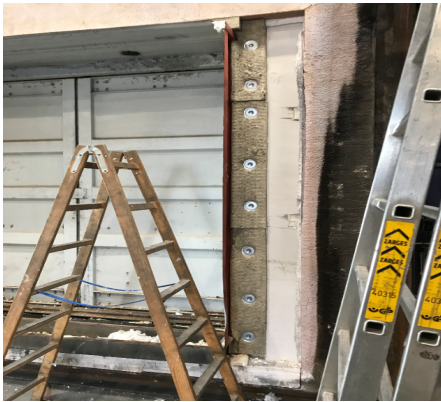
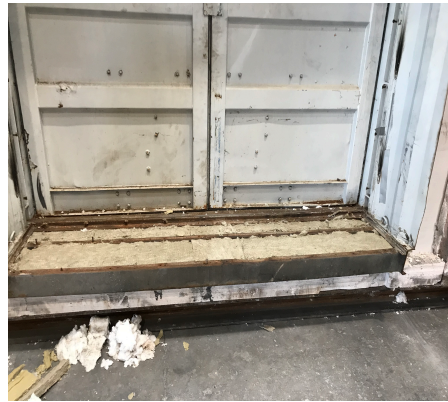
Figure B.2: Door section after being mounted in test frame

(a) Isolation of the gap between container and aerated concrete

(b) Isolation between the cross members after removing plywood flooring

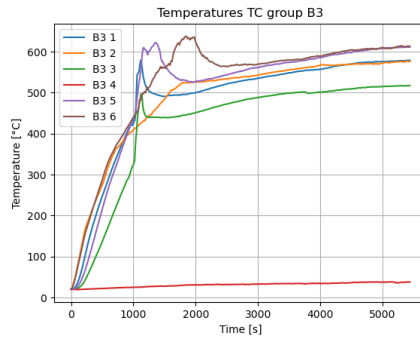
Figure B.4: Temperature measurements of the test sample

The temperatures increased fast during the first minutes of the test, and after approximately 17 minutes, the door gasket caught fire. From figures B.4a, B.4b, B.4c and B.4d it can be seen that the flames were touching the TC and causing the disturbance of the temperature curves during the time interval between 1000 and 2000 seconds. After that, most of the rubber seal was burned off, and the temperature increased more uniformly throughout the remaining of the test period. Signal to TC "B3-4" was lost during the test as can be seen from the flat curve in figure B.4d.

(a) Temperatures for TC group 1 at the panel of the door leafs

(b) Temperatures for TC group 2 at the container header and sill

(c) Temperatures for TC group A3 at the left door rails

(d) Temperatures for TC group B3 at the right door rails

(e) Temperatures for TC group 4 at the side of the container

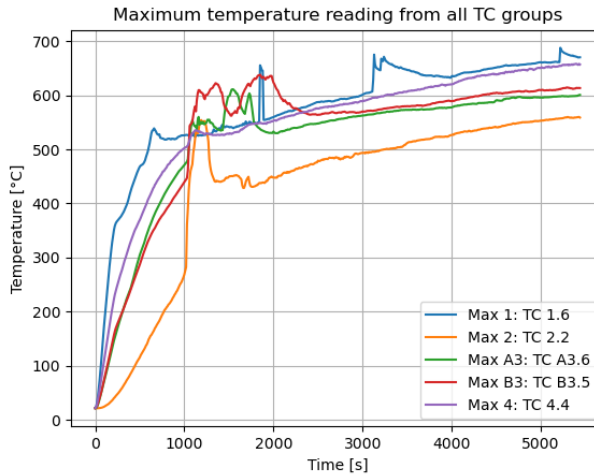
Figure B.5 shows the maximum temperature reading taken from each TC group. The highest temperature reading is found to be at "TC 1.6" placed far down at the panel of the right door leaf. The lowest maximum temperature is at "TC 2.2" placed in the middle of the door header.

Figure B.5: Maximum temperatures from each TC group plotted to gather

Thermocouple	Max Temperature
TC 1.6	687 °C
TC 2.2	560 °C
TC A3.6	611 °C
TC B3.5	638 °C
TC 4.4	658 °C

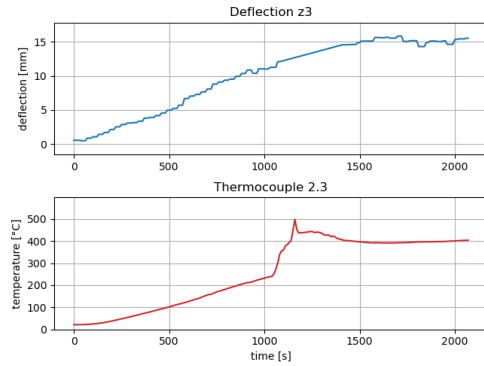
Figure B.7: Deflection measured at the top of the door header

From figure B.7 it can be seen that the top of the door header deforms in positive direction for all three points measured. From figures B.7a and B.7c it can be seen that the deformation occurs more slowly after the temperature reaches 400 °C, because of lack of data this can not be concluded for B.7b but can be assumed.

(a) Deflection point z1 and TC 2.1

(b) Deflection point z2 and TC 2.2

(c) Deflection point z3 and TC 2.3

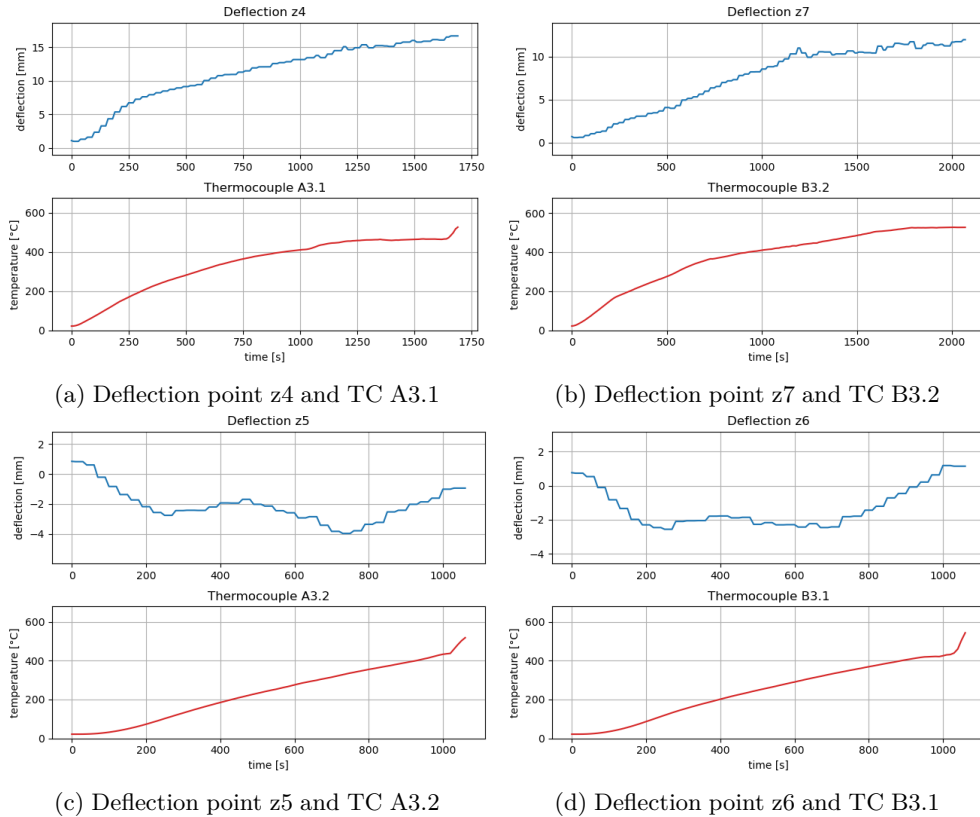
Figure B.8 shows the deformation of the top door rails for both door leaves. It can be seen in figures B.8a and B.8b that the outer corners of each door leaf are deforming similarly as the door header described in figure B.7. Figures B.8c and B.8d show the deformation of the inner corners of each door leaf which are bending inside the furnace as the temperatures approach 400 °C and there after starts to move externally in the positive direction.

Figure B.8: Deflection measure at the upper door rails

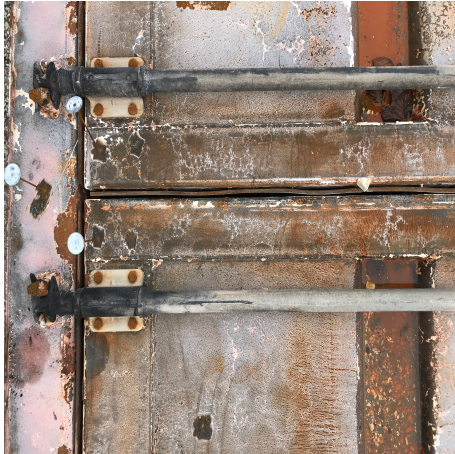
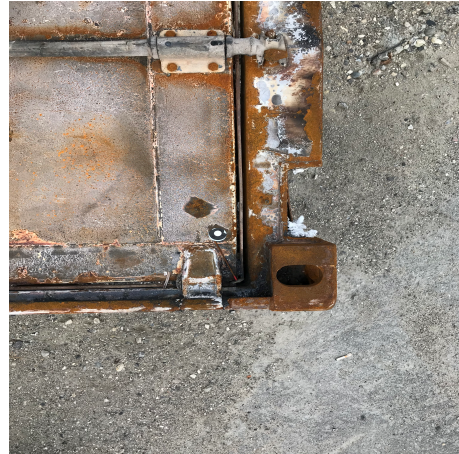
Figure B.13: Examination of the door section after test

An examination of the test material revealed that the deformation had been reversed and the door frame had gained its initial shape. The door gasket was completely burned away leaving 2 cm gap around the door leafs as figure B.13 shows. No cracks, damages or permanent deflection were noticed on the remains, all functioning part such as door hinge and locking bars were in functional shape.

(a) Junction of the door leaves and the header, showing deflection measuring points z_2 , z_5 and z_6

(b) Left lower corner where deflection measuring points z_{12} and z_{16} were located

(c) Joint of the door leaves showing z_{13} and z_{14}

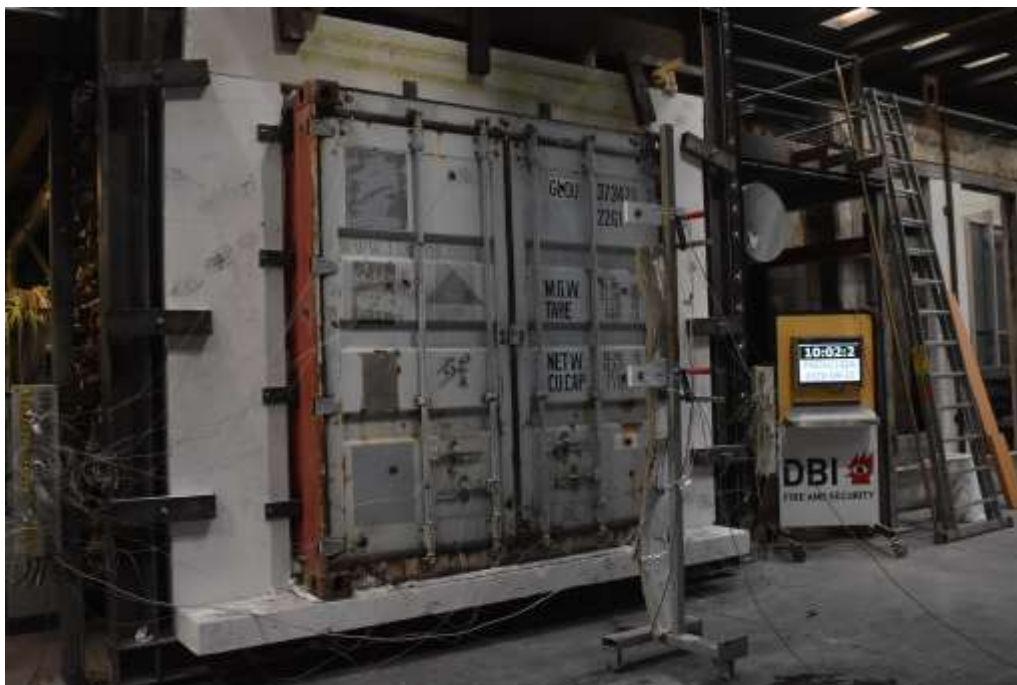
Status of the door before the tests

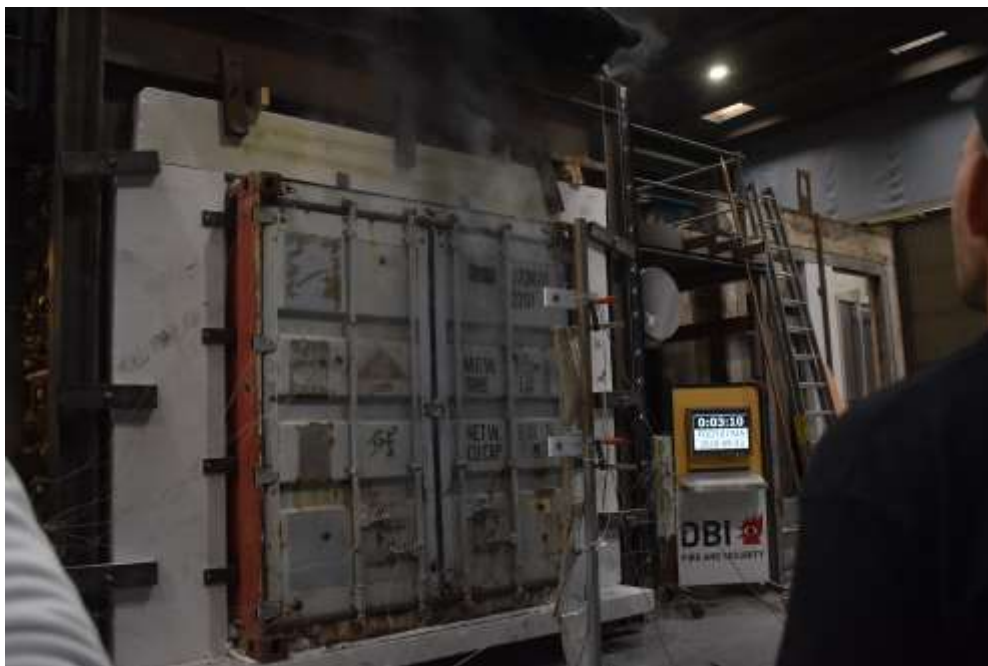
Slight smoke coming out after couple of minutes into the test

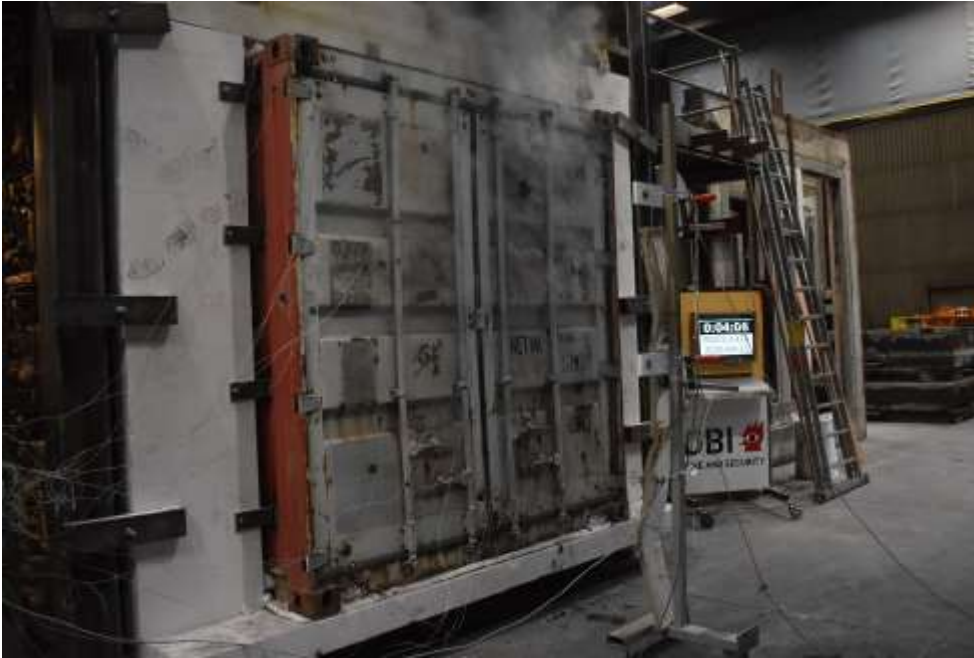
Amount of smoke increases 4 minutes, letters peel off

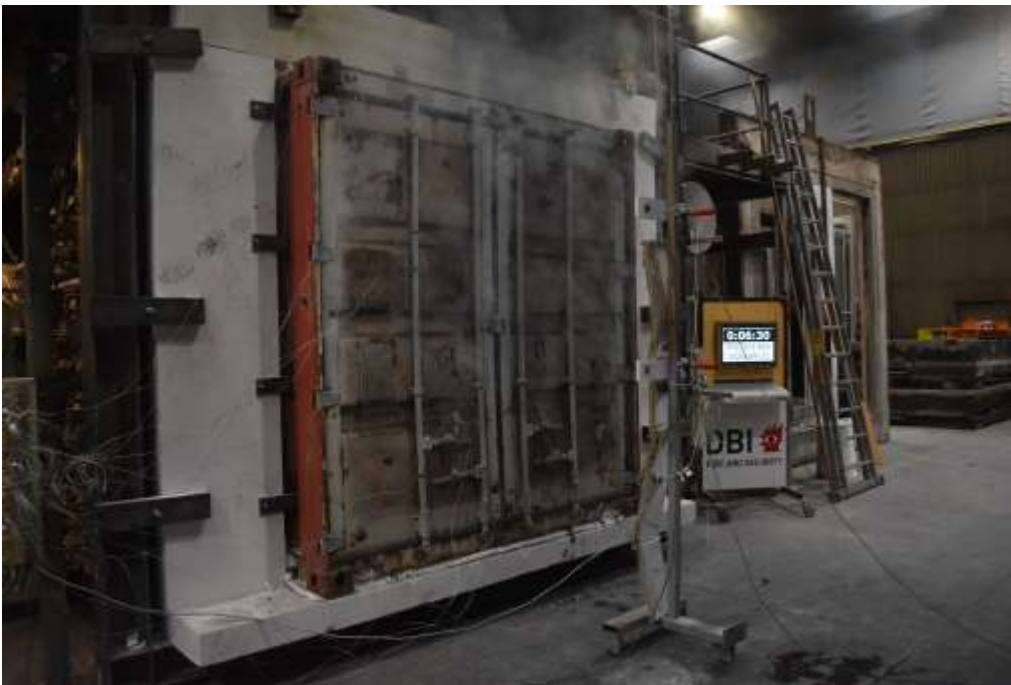
At 6 minutes discoloration of the door leaves

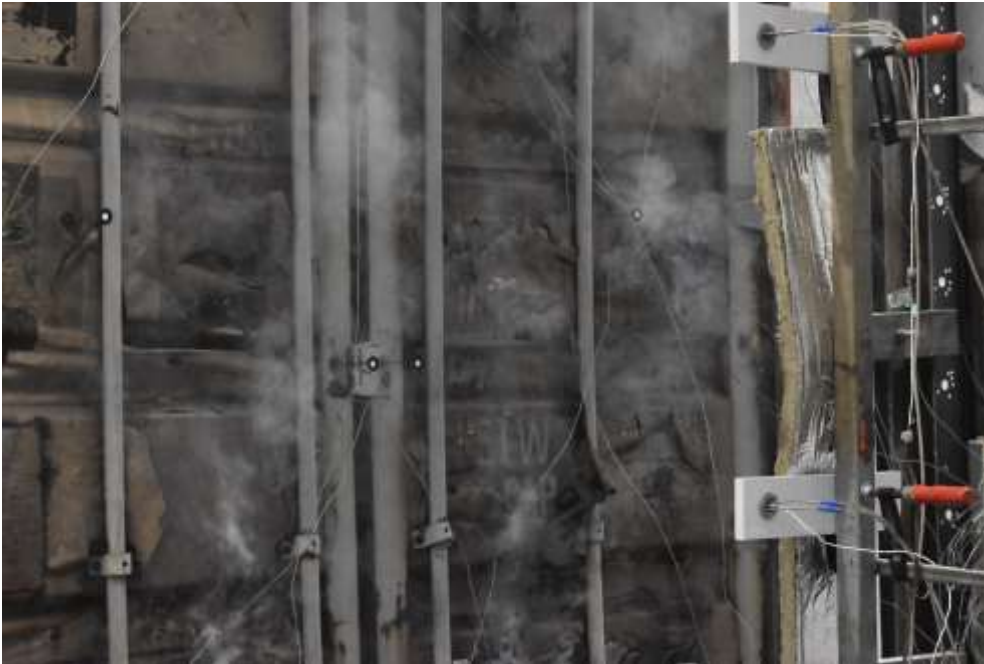
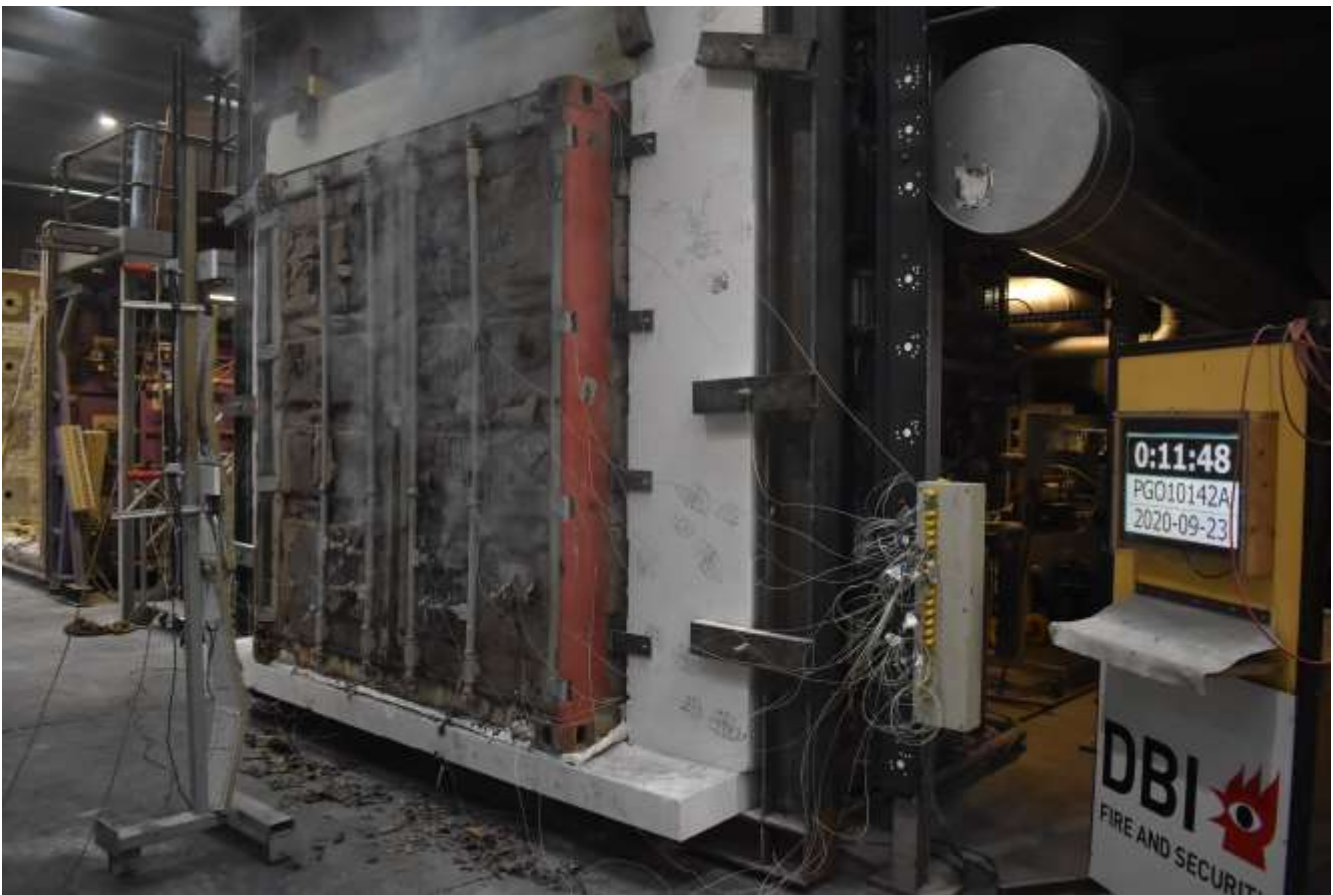
10 minutes, painture falling off. Much less smoke at this point
