APPENDIX to

PILOT PROJECT “CONTAIN” – Exploring the Challenges of Containership Fires

APPENDIX A

1 Cone calorimeter tests

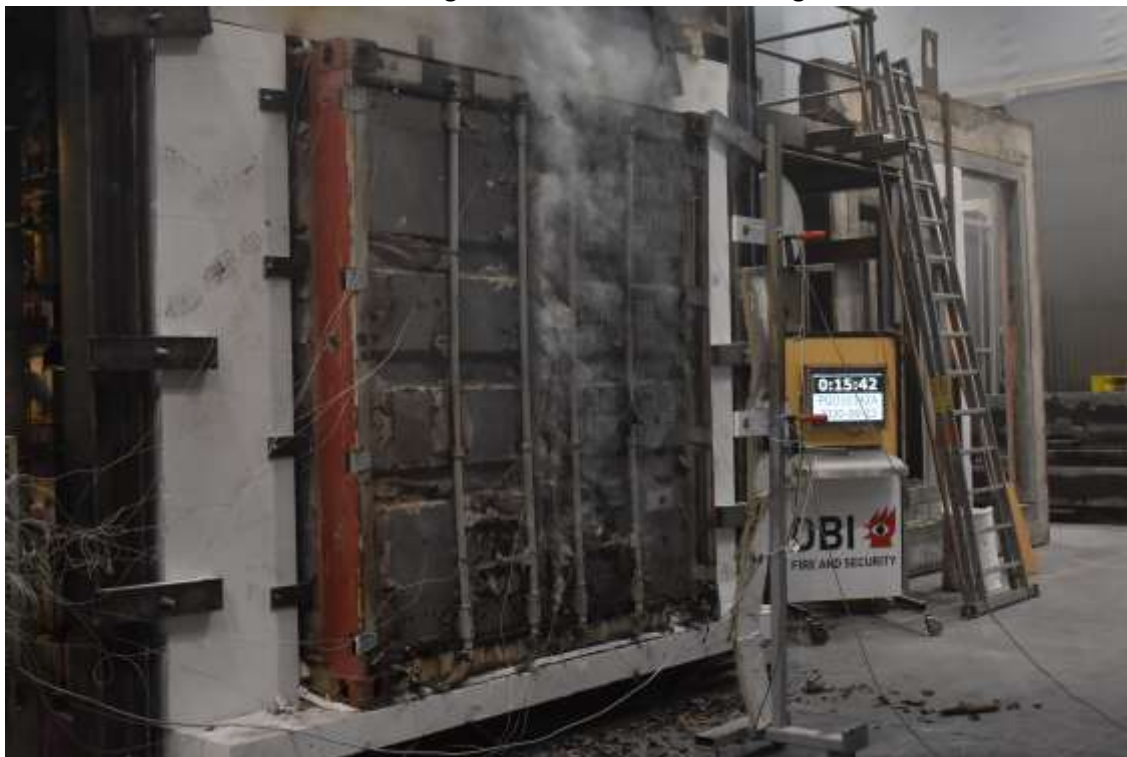
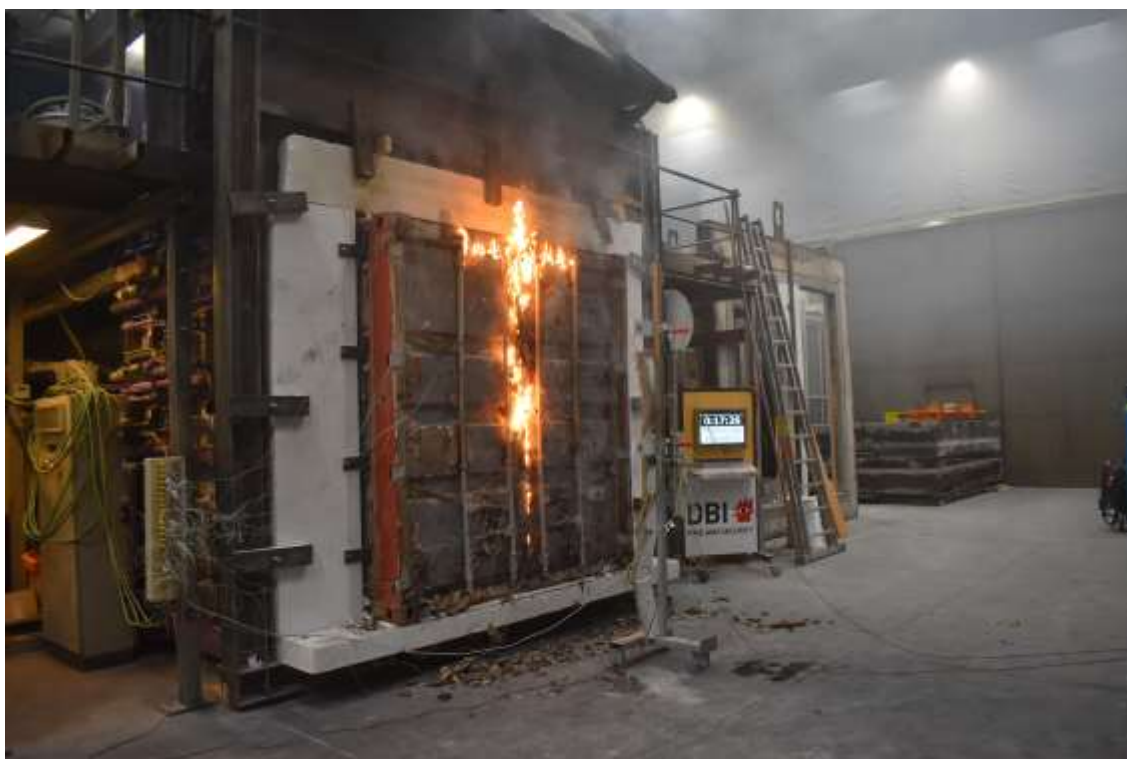
A bit after 14 minutes smoke starts again and at 17 minutes sealing catches fire

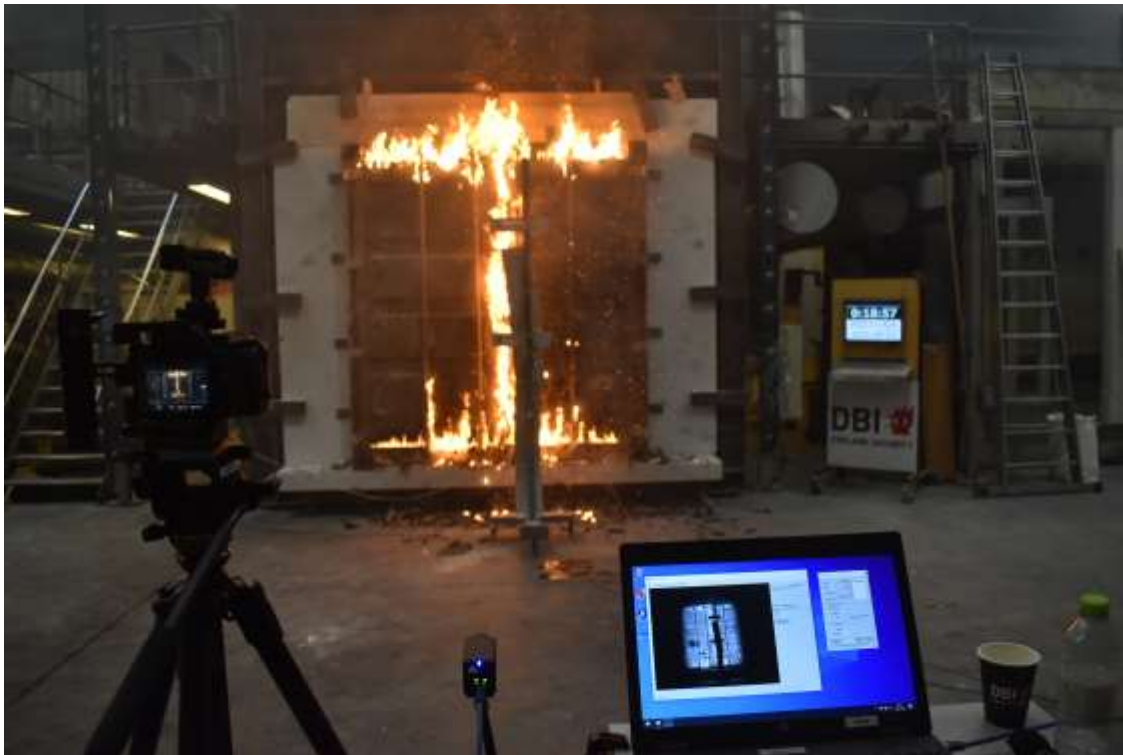
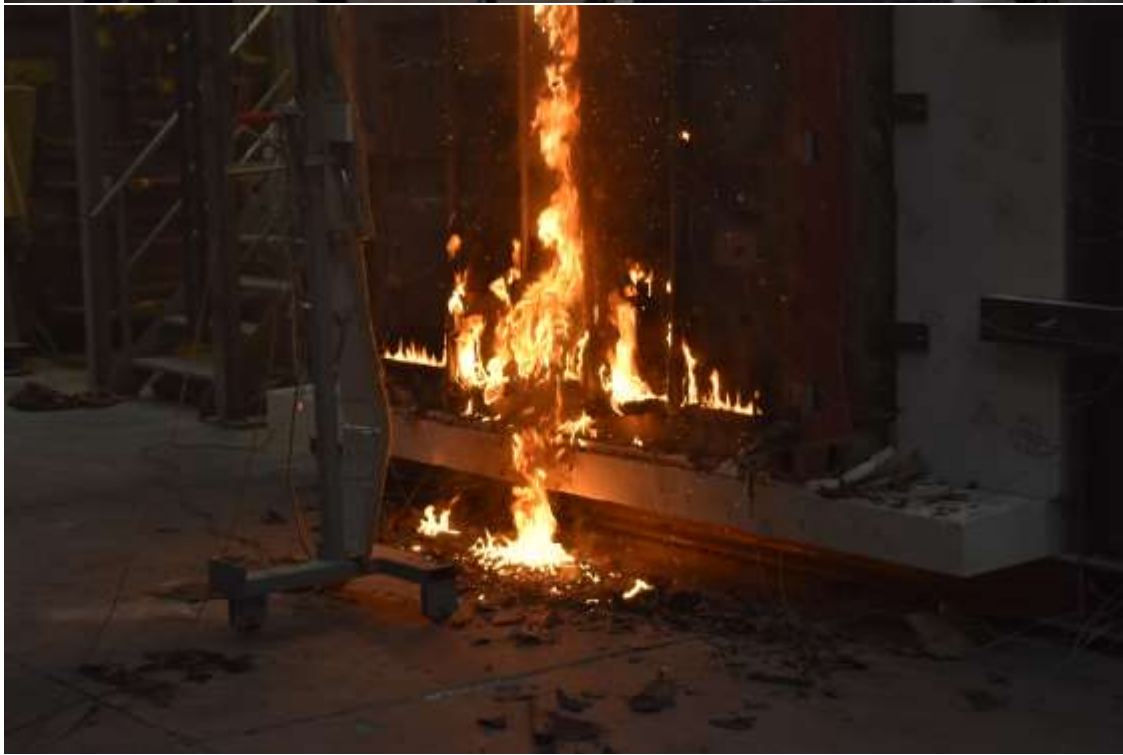
Severe burning of the sealing, and falling and burning on the floor. There is also burning droplets.

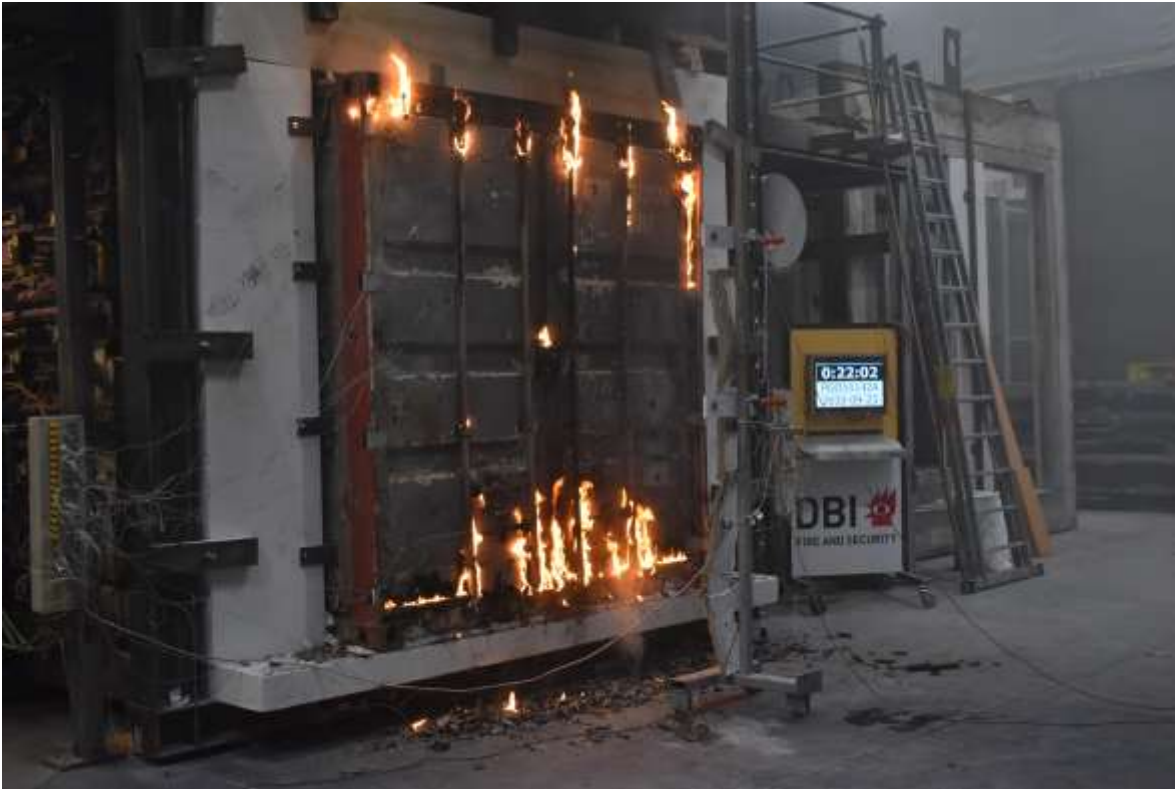
Burning decays

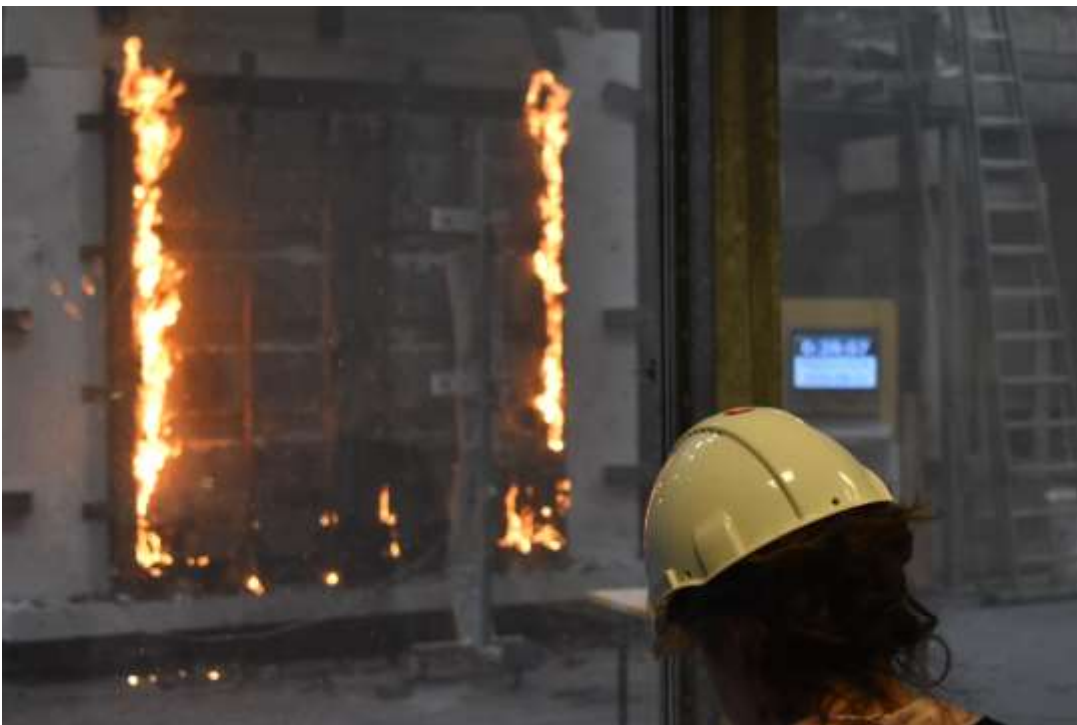
And it increases again on burning on the rubber on both sides

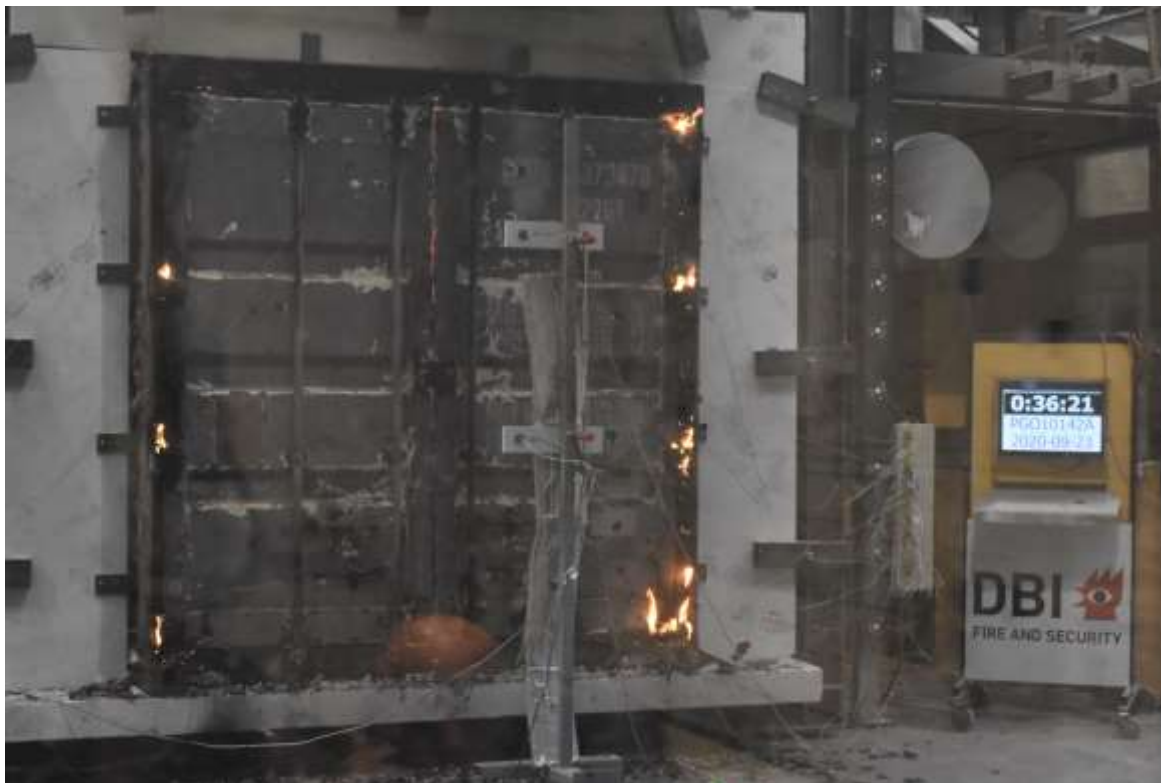
At 36 minutes there is very little burning left

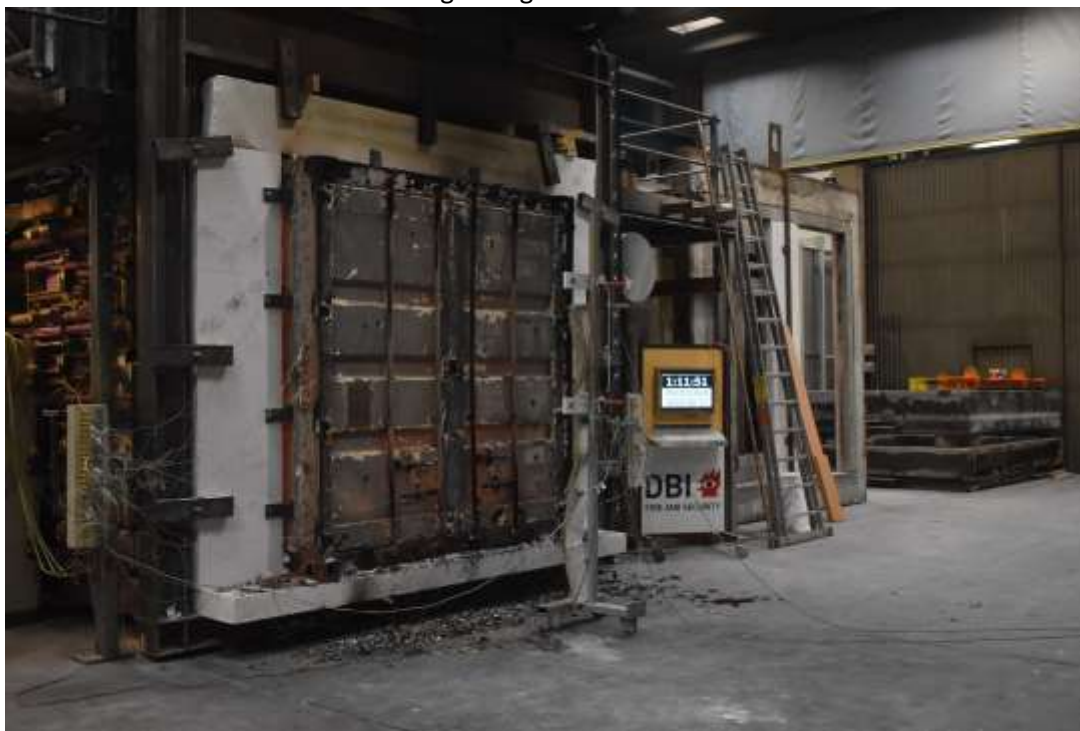
After one hour the door leaves start glowing

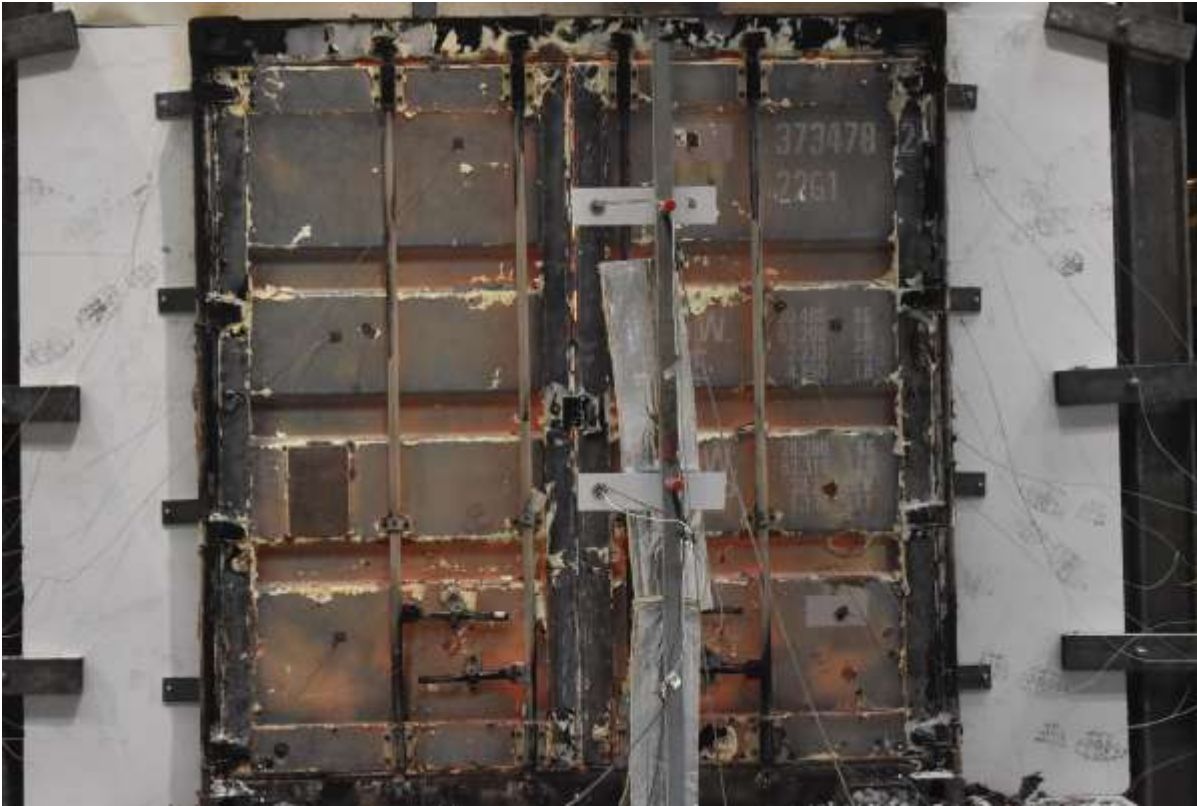
The test is stopped at 1,5 hours
