# TEST REPORT LOADBEARING WALL

<b>Name of sponsor:</b>	Wood:UpHigh		
<b>Product name:</b>	Loadbearing wall		
<b>File no.:</b>	PGA12233A	<b>Revision no.:</b>	1
<b>Test date:</b>	2023-01-11	<b>Date:</b>	12-07-2023
<b>Pages:</b>	11	<b>Encl.:</b>	55
<b>Ref:</b>	JBK / CHB

Subject: Load bearing wall

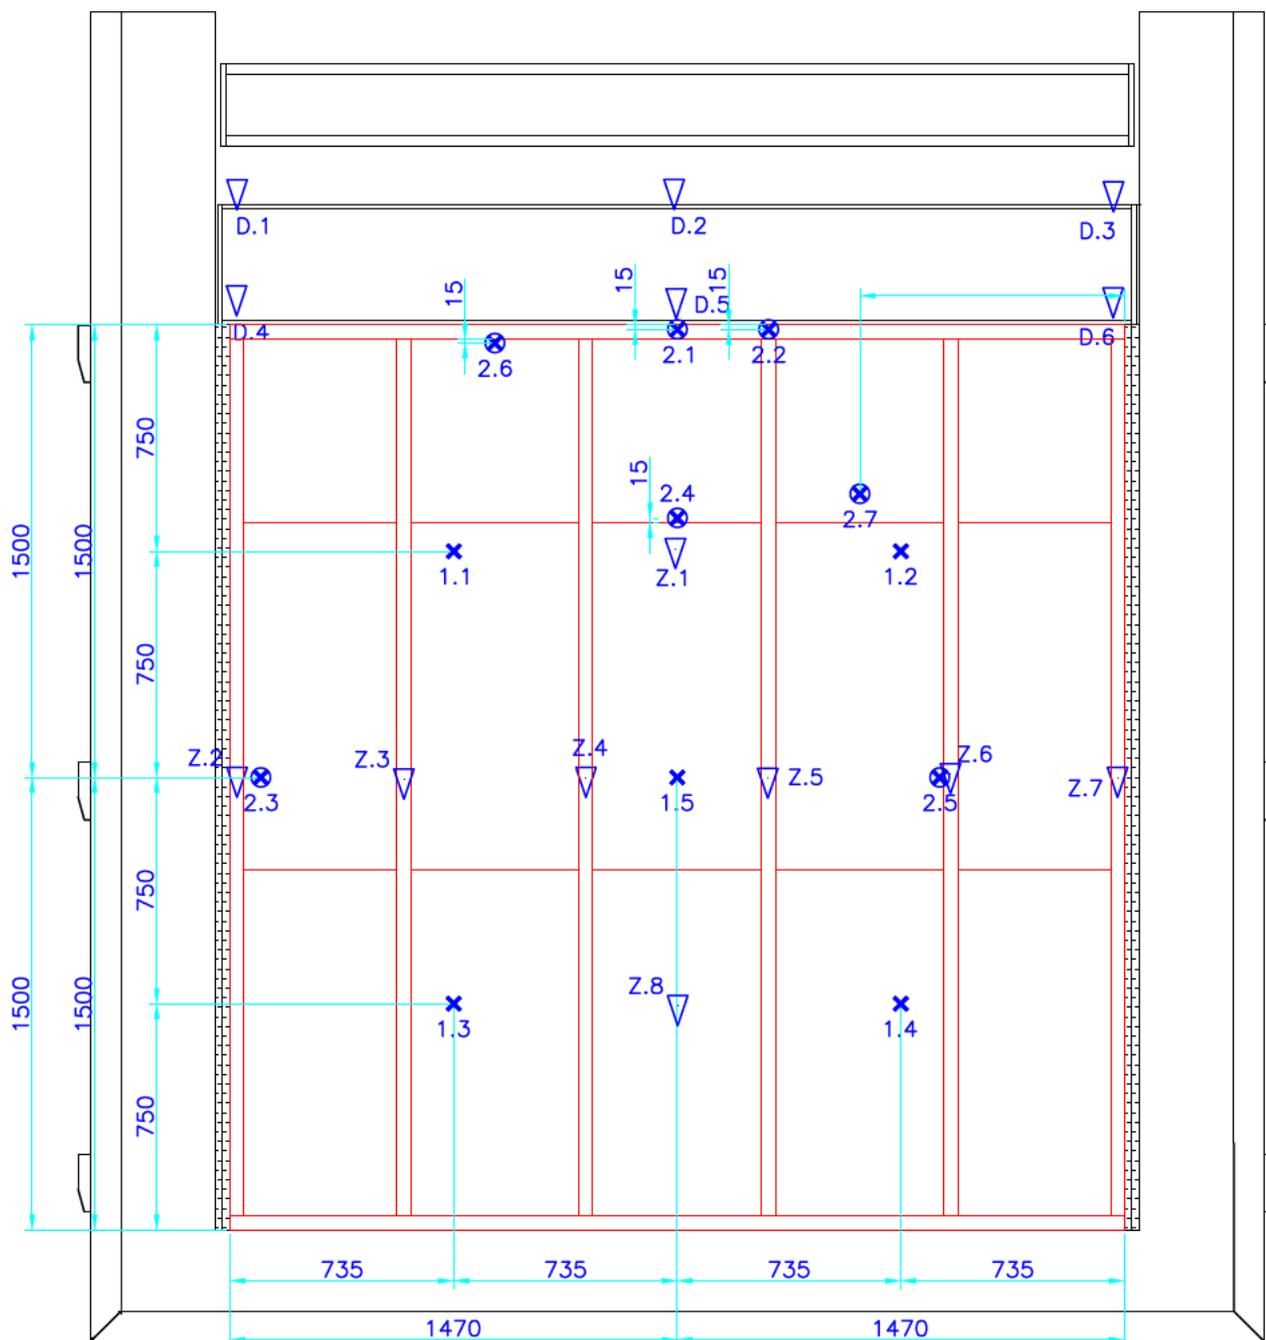
Enclosure: 1.0

- ✕ Thermocouple placed on the unexposed surface (average)
- ⊗ Thermocouple placed on the unexposed surface (maximum)
- ▽ Deflection measuring point

All measurements are in mm

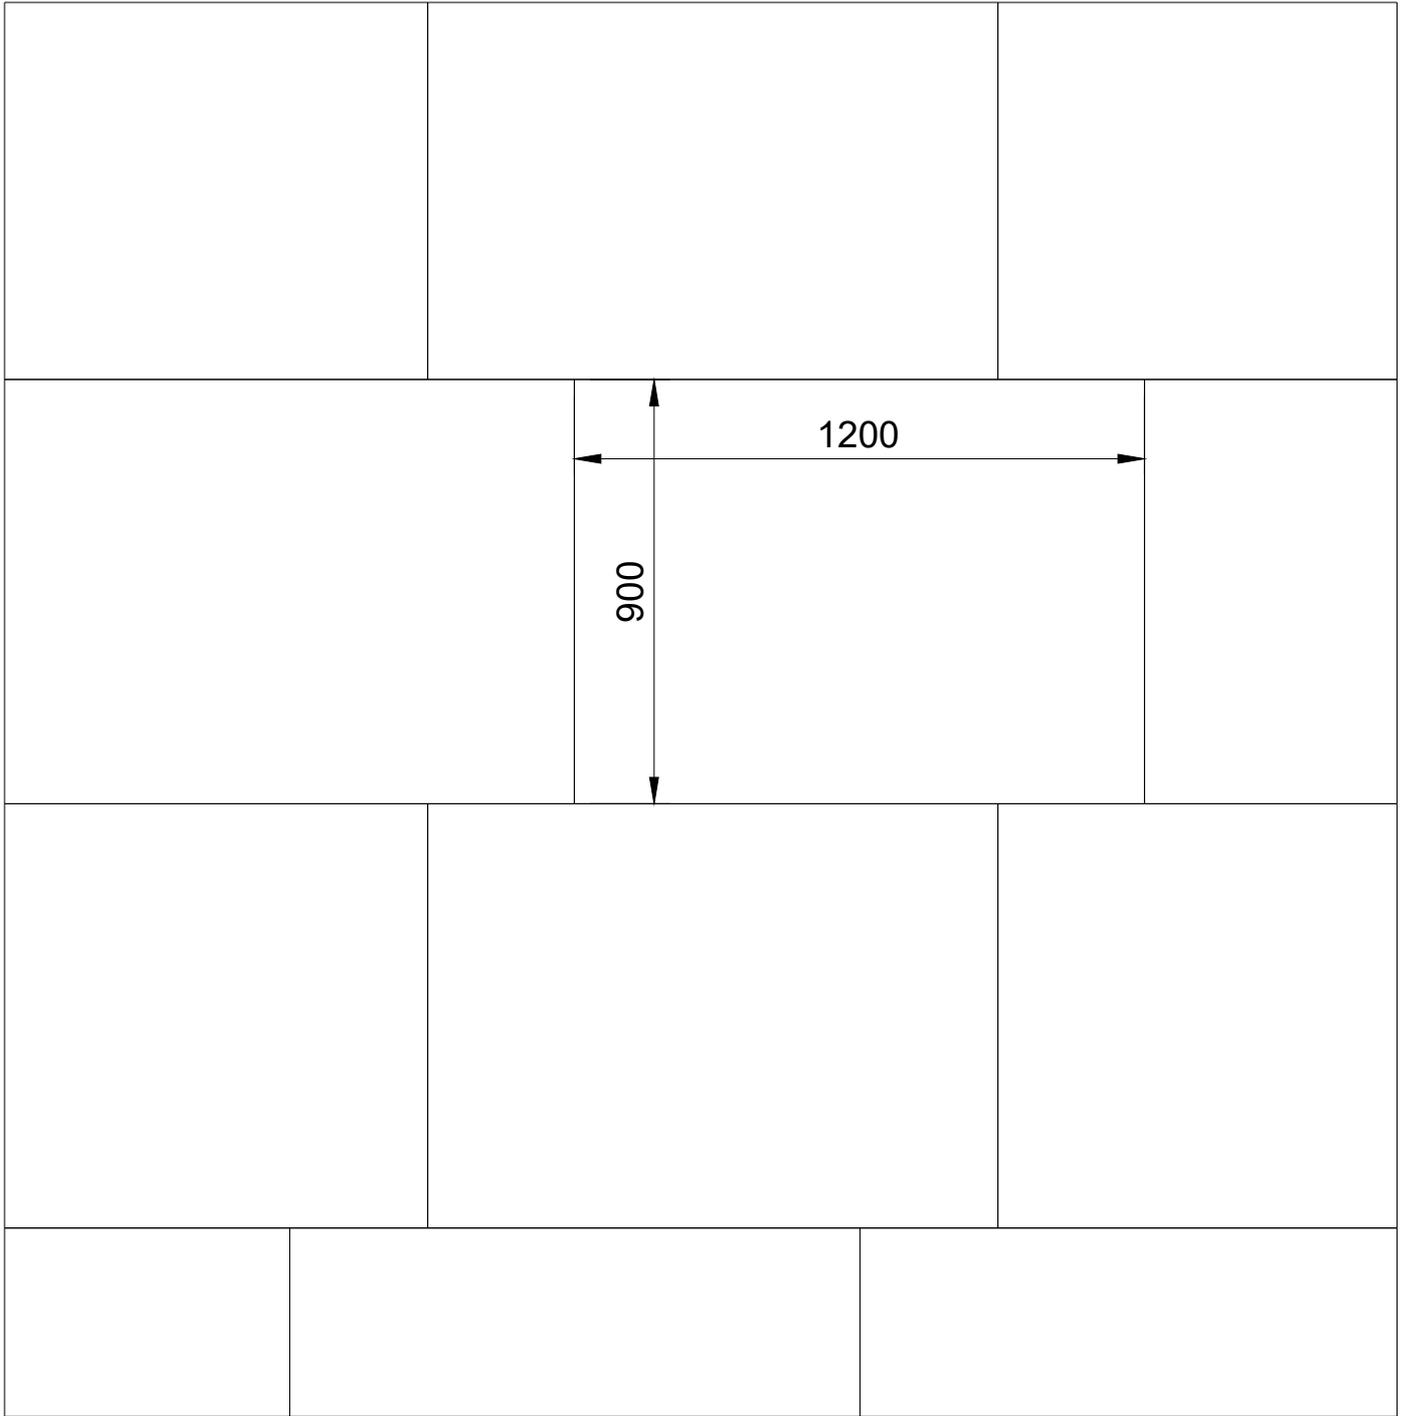
**Enclosure:** 1.2

All measurements are in mm

Subject: Loadbearing wall - Outer layer of fiber gypsum on exposed side

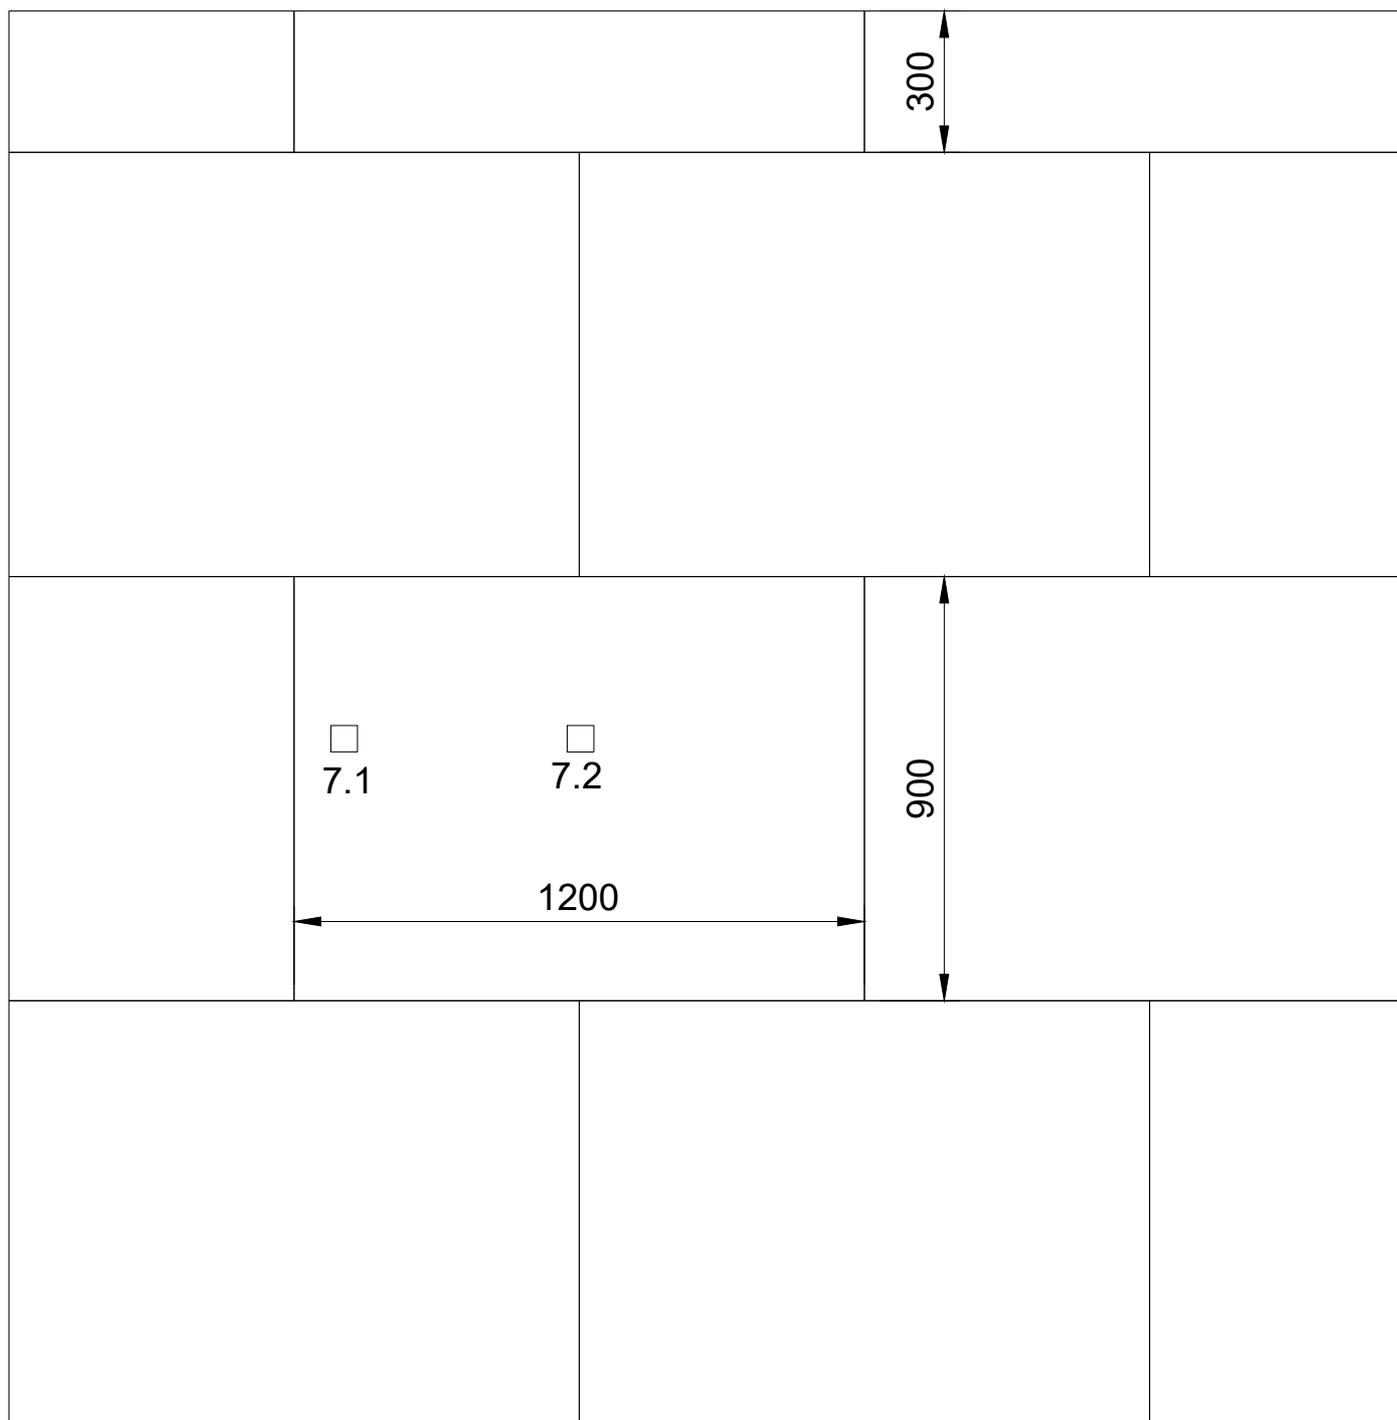
**Enclosure:** 1.3

All measurements are in mm

Subject: Loadbearing wall - Inner layer of fiber gypsum on exposed side

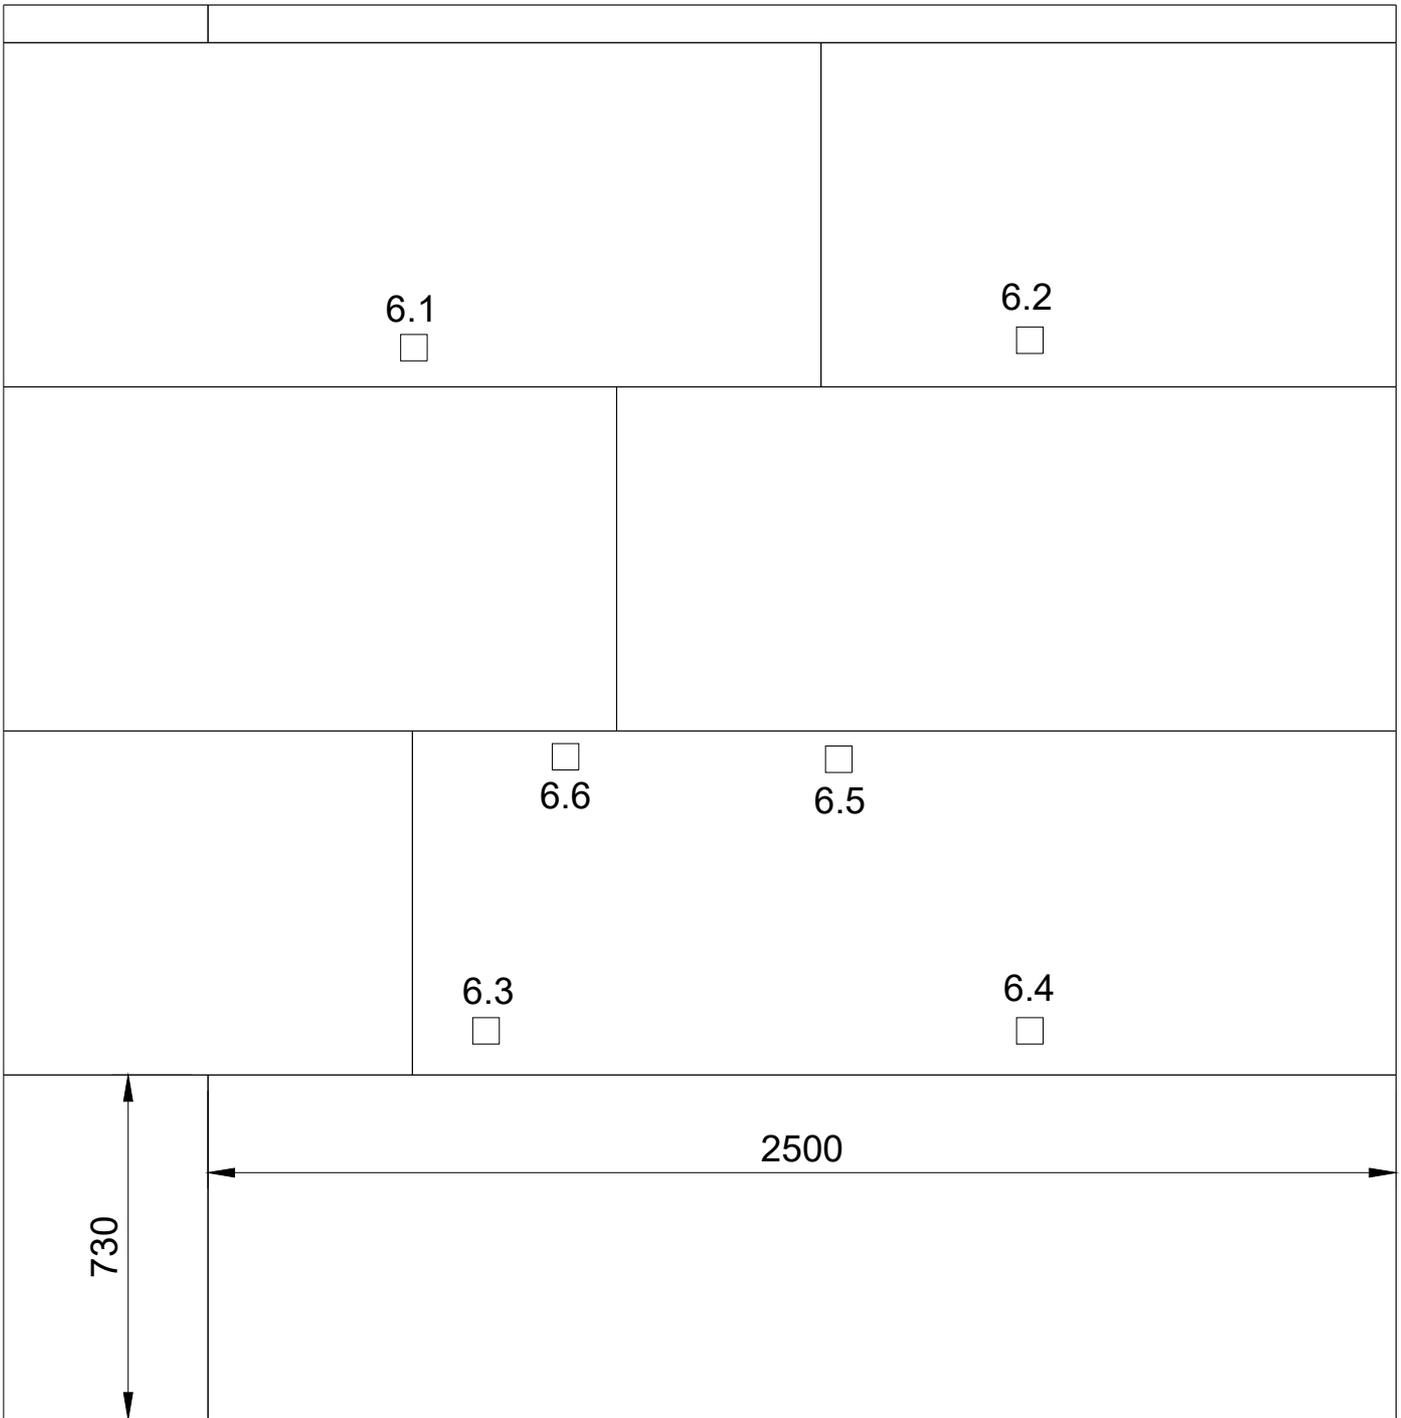
**Enclosure:** 1.4

The wood fiber boards with tongue and groove have maximum dimensions of 750 x 2500 mm.

Subject: Loadbearing wall - wood fiber board behind fiber gypsum boards on exposed side

Wood fiber board	See sponsor drawing no. 2 and photo no. 6.
Fibre gypsum boards	<p>Two layers of 12.5 mm thick gypsum fibre boards designated [REDACTED] (type EN 15283-2, ETA-03/0050) with a nominal density of 1150 kg/m<sup>3</sup> were fixed with designated [REDACTED] 30 mm at a c/c of 200 mm. The staples were fixed 10 mm from the board edges and 50 mm from the board corners. A full-size board measured 900 x 1200 mm.</p> <p>Approximately 2 mm thick layer of spackle was applied to the joints on the gypsum boards. The designated spackle was [REDACTED].</p> <p>See sponsor drawing no. 4 and photos no. 9 - 10.</p>
<b>Outer layers (unexposed side)</b>	Sarking and roofing felt with monolithic TEEE-Membrane were fixed to the unexposed side of the straw elements with staples. The felt was designated [REDACTED]. The felt consisted of 3 layers and was highly diffusion open $s_d = 0.05$ m and $g$ -value = 0.25 MNs/g.

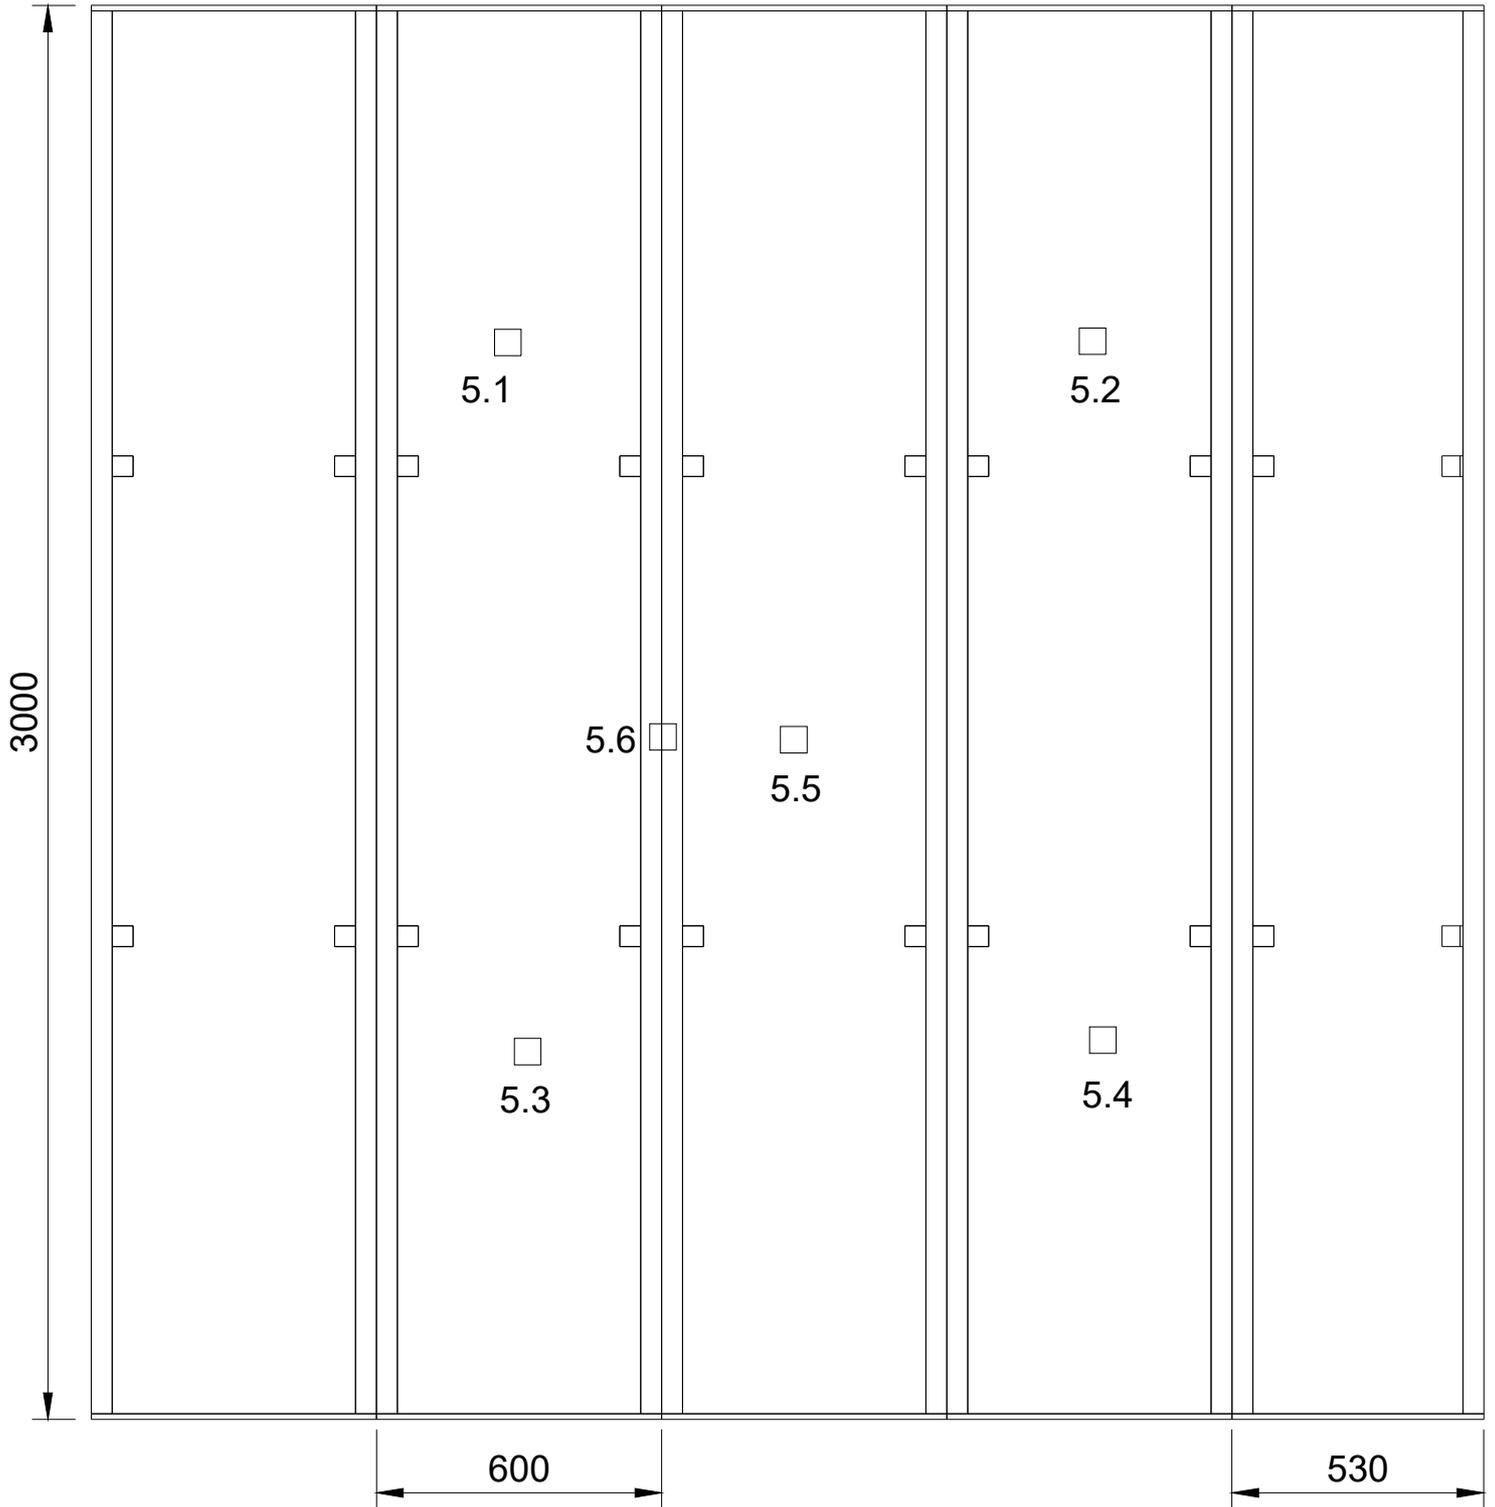
**Enclosure:** 1.5

Subject: Loadbearing wall - Straw elements seen from exposed side

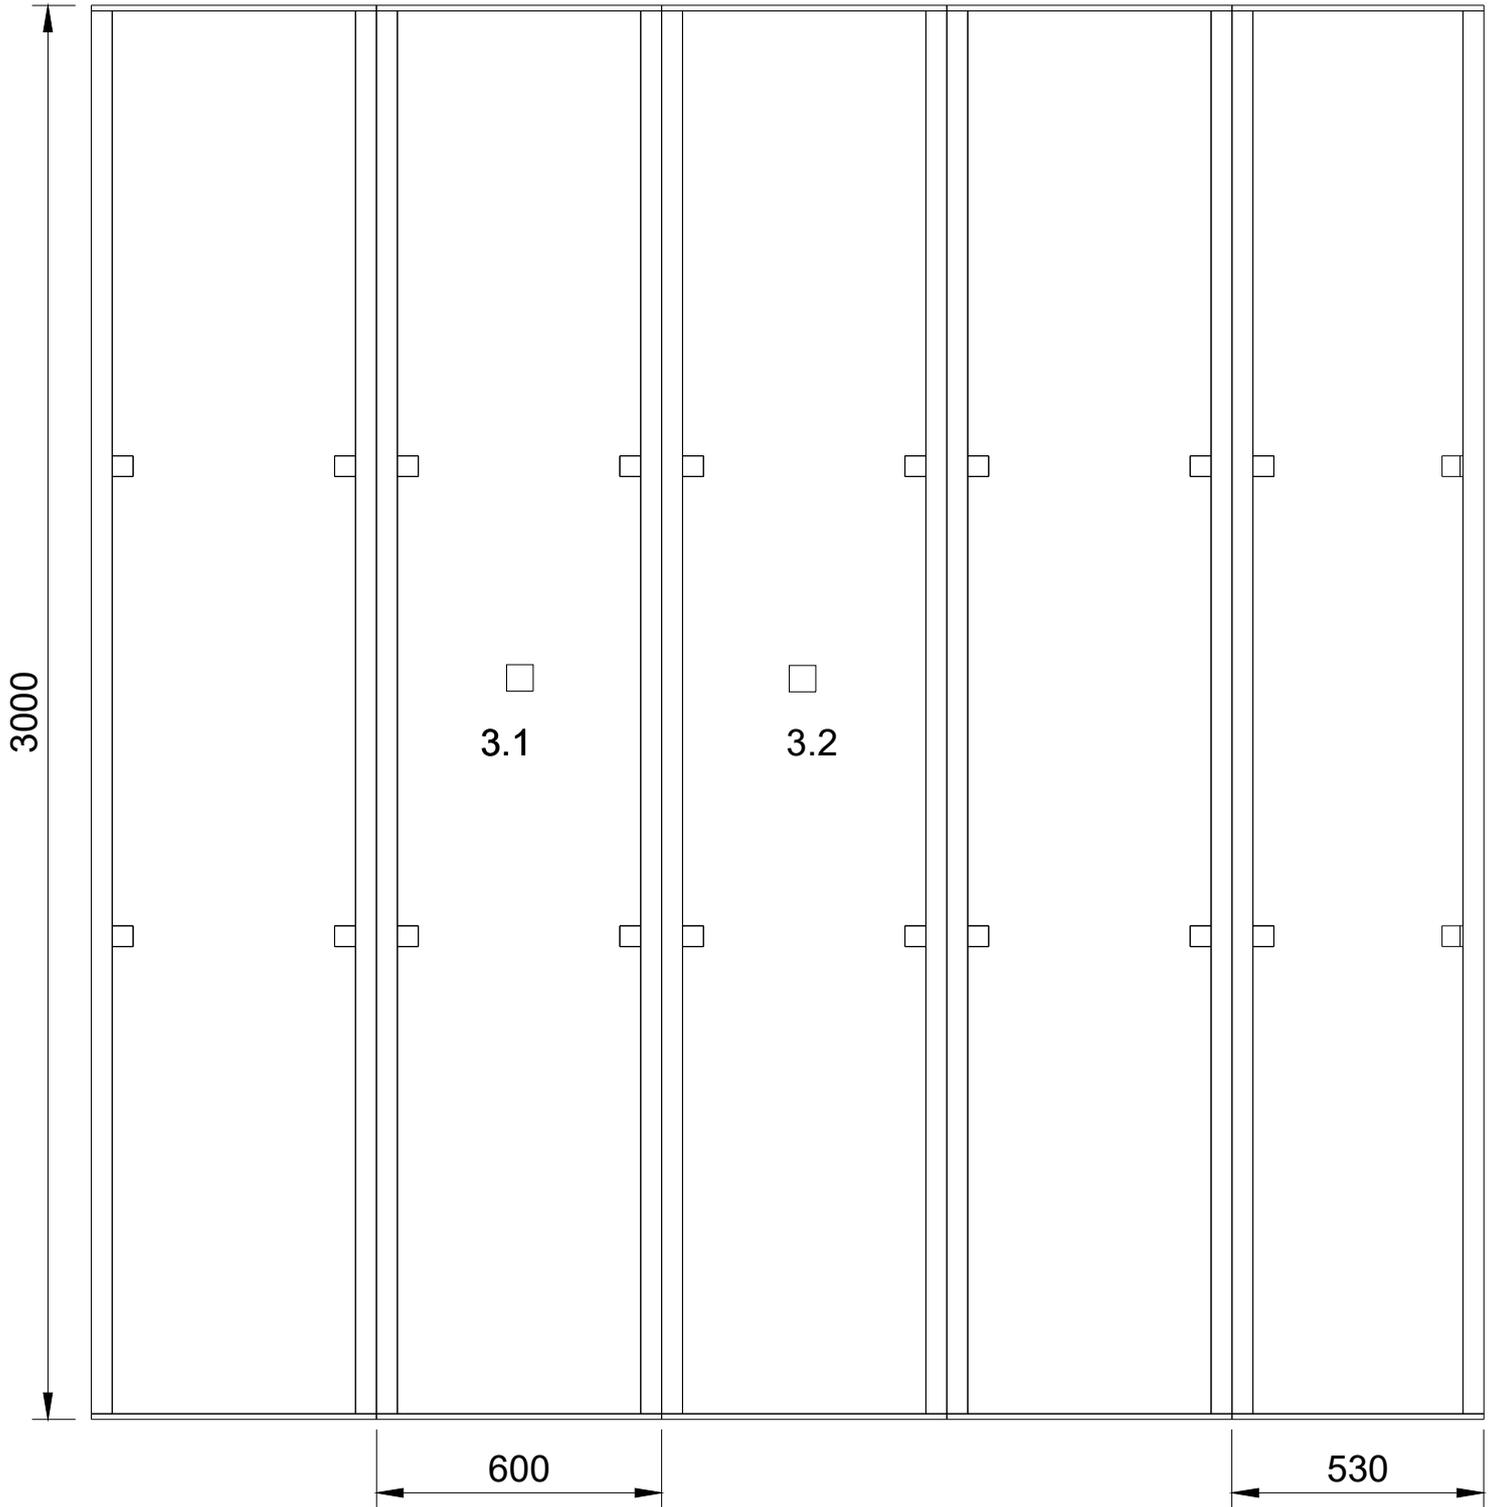
**Enclosure:** 1.6

Subject: Loadbearing wall - Straw elements seen from unexposed side

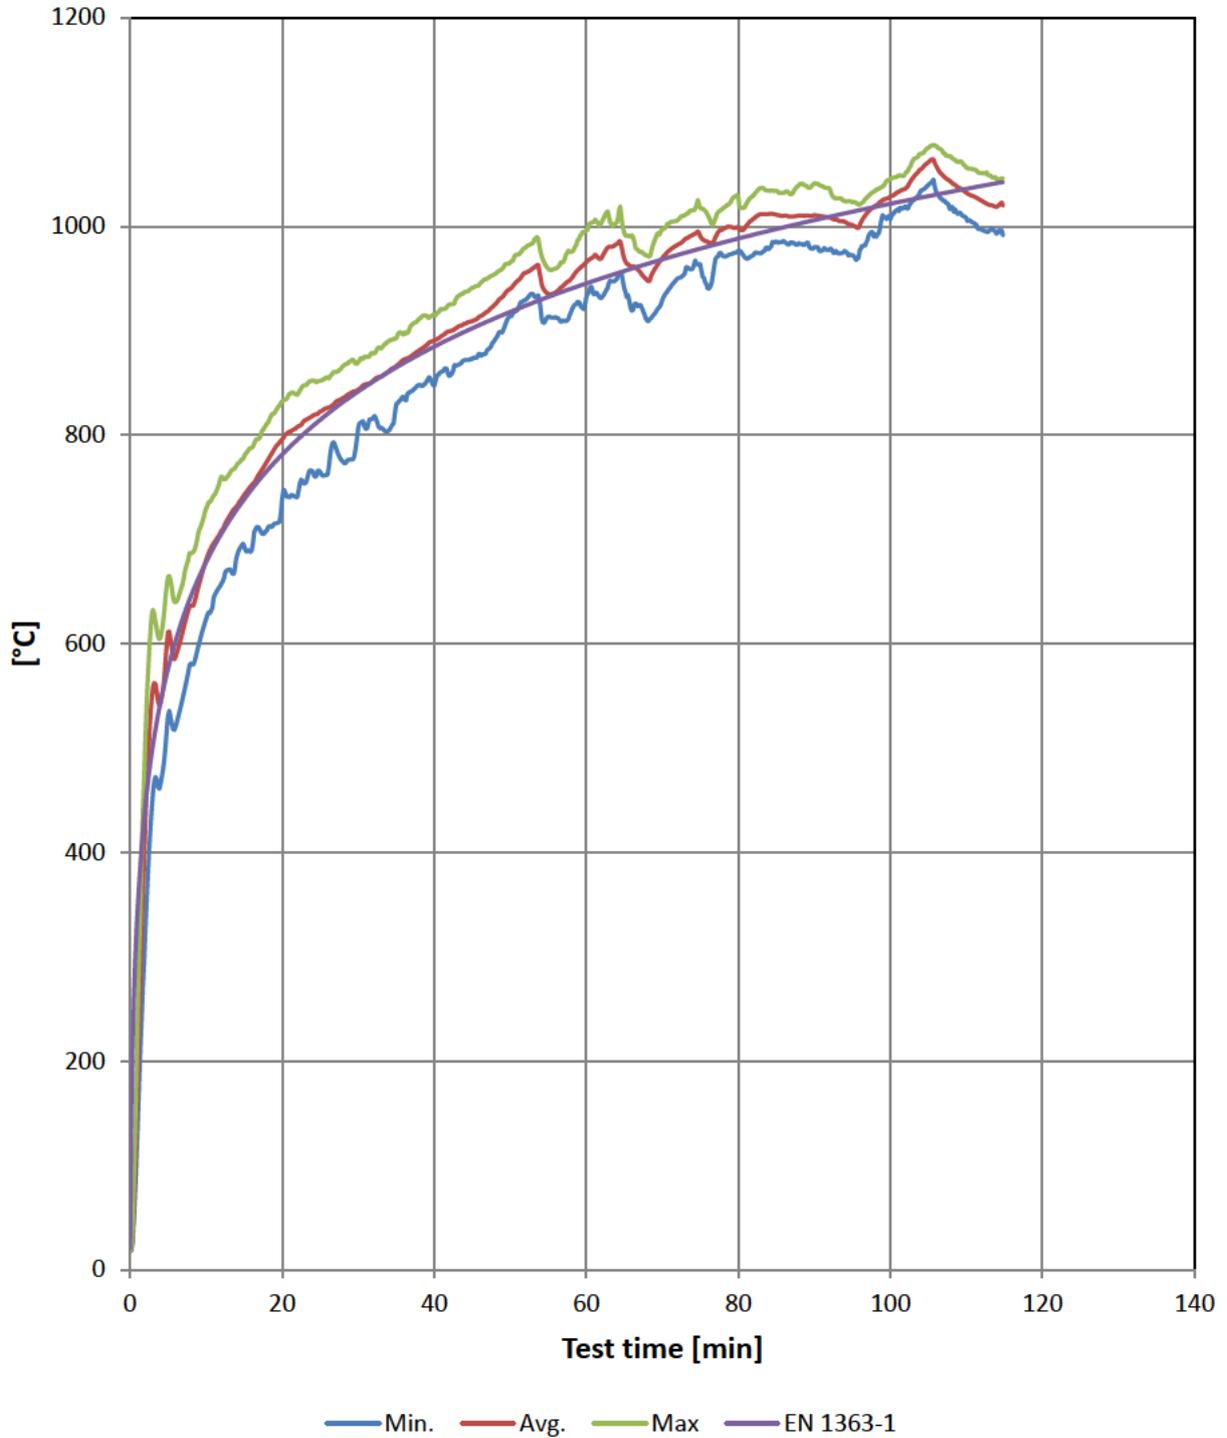
## Furnace temperature

Time Minutes	Measured			Norm EN 1363-1	Area under curve		Dev. [%]	Limit [%]
	Minimum	Average	Maximum		Measured	EN 1363-1		
0	18	18	18	20	0	0	0.0	
5	531	611	664	576	2022	2200	-8.1	
10	623	680	729	678	5157	5366	-3.9	15
15	694	743	780	739	8727	8918	-2.1	13
20	740	796	833	781	12572	12723	-1.2	10
25	764	823	852	815	16625	16716	-0.5	8
30	807	844	870	842	20791	20859	-0.3	5
35	830	866	893	865	25064	25127	-0.3	5
40	847	891	916	885	29458	29502	-0.2	4
45	873	909	941	902	33962	33971	0.0	4
50	914	940	965	918	38576	38522	0.1	3
55	914	936	960	932	43330	43149	0.4	3
60	931	965	996	945	48069	47844	0.5	3
65	941	969	994	957	52946	52601	0.7	3
70	929	970	997	968	57739	57415	0.6	3
75	964	991	1018	979	62660	62283	0.6	3
80	977	999	1028	988	67625	67201	0.6	3
85	986	1011	1034	997	72661	72166	0.7	3
90	981	1011	1042	1006	77712	77175	0.7	3
95	973	1001	1023	1014	82746	82225	0.6	3
100	1007	1028	1045	1022	87820	87315	0.6	3
105	1039	1062	1075	1029	93035	92442	0.6	3

110	1008	1032	1056	1036	98271	97605	0.7	3
114	993	1019	1045	1041	102370	101760	0.6	3

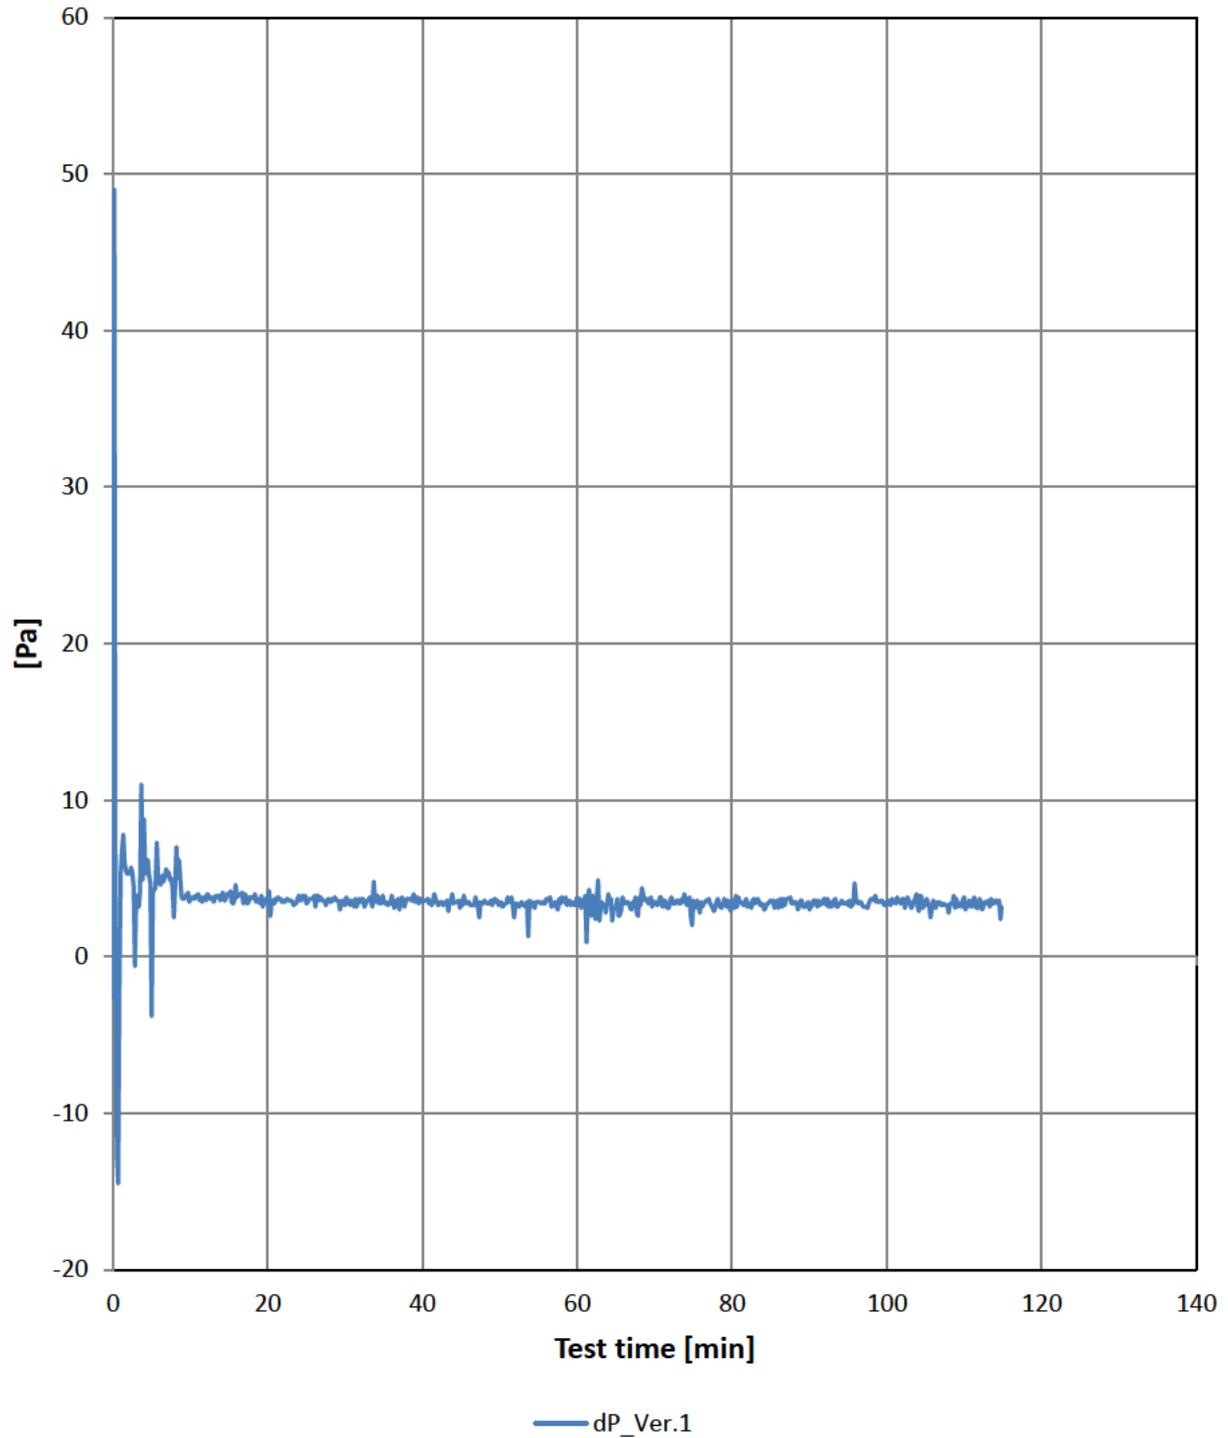
*The differential pressure in the furnace during the test, measured 1,16 m above notional floor level*

Min. / Pa	dP_Ver.1
0	-2.6
5	-3.8
10	3.8
15	3.9
20	3.6
25	3.4
30	3.3
35	3.5
40	3.5
45	3.6
50	3.4
55	3.5
60	3.8
65	3.2
70	3.5
75	3.6
80	3.6
85	3.6
90	3.0
95	3.3
100	3.5
105	3.3
110	3.8
114	3.6

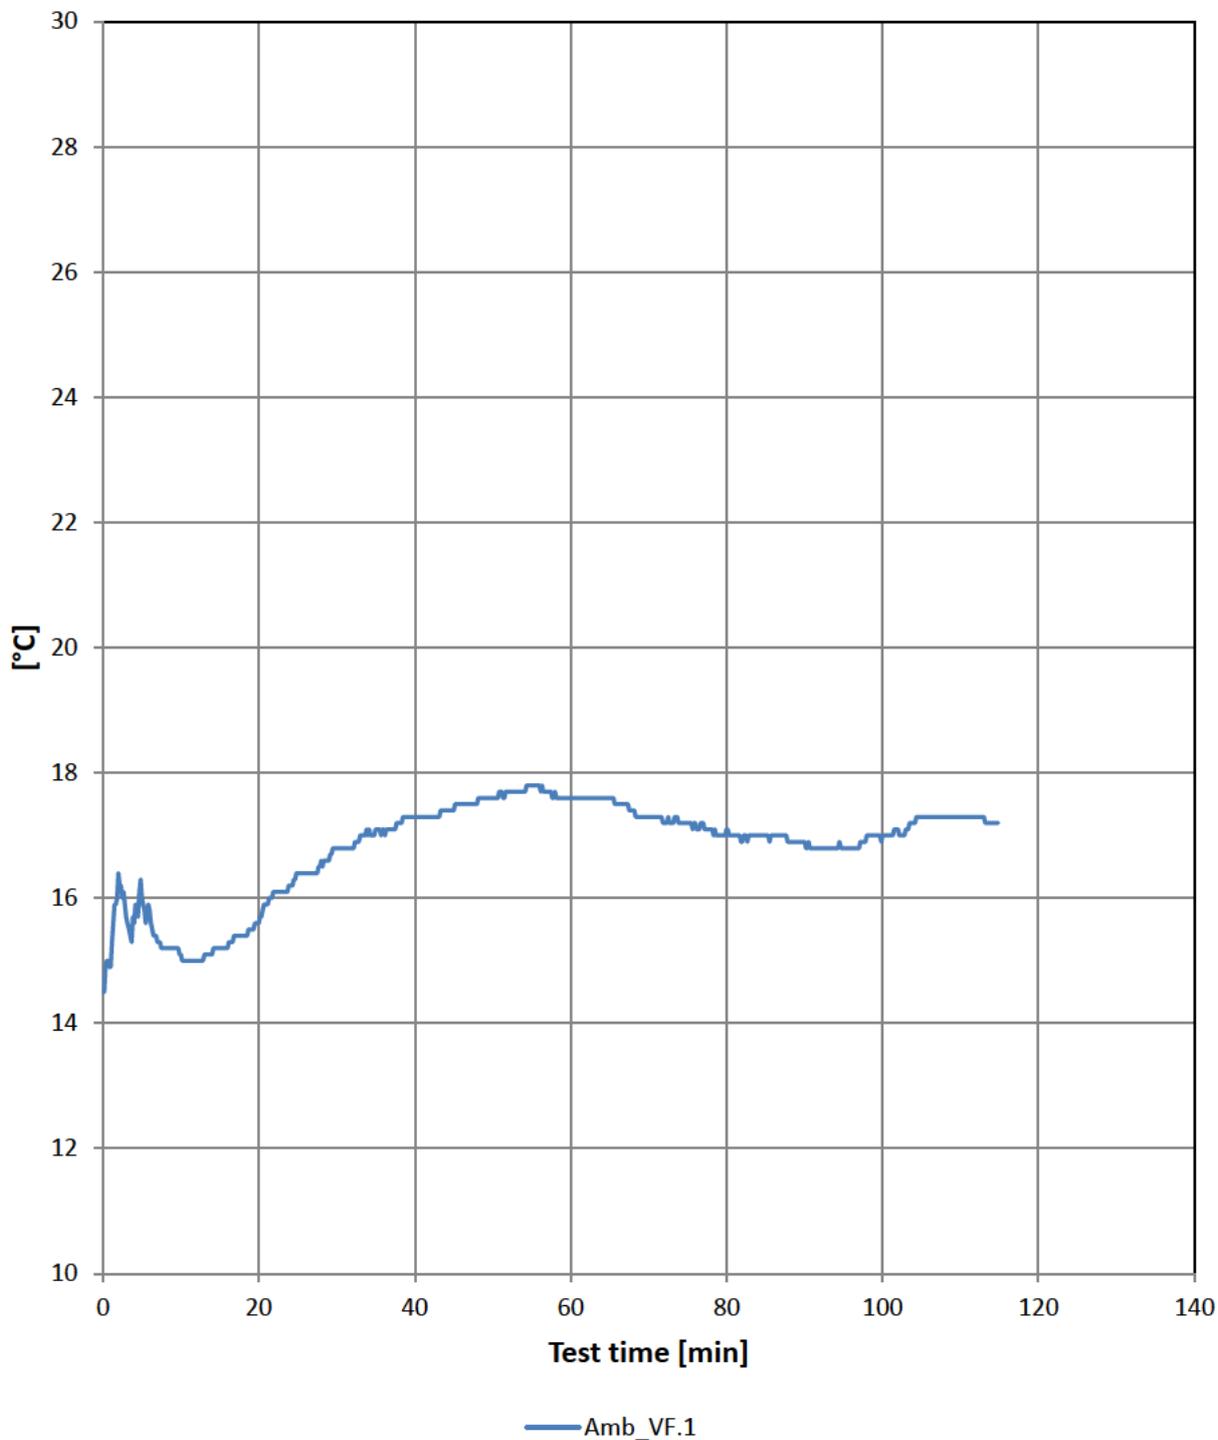
*The ambient temperature in the laboratory during the test*

Min. / °C	Amb VF.1
0	14.5
5	16.0
10	15.1
15	15.2
20	15.6
25	16.4
30	16.8
35	17.1
40	17.3
45	17.4
50	17.6
55	17.8
60	17.6
65	17.6
70	17.3
75	17.2
80	17.1
85	17.0
90	16.9
95	16.8
100	17.0
105	17.3
110	17.3
114	17.2

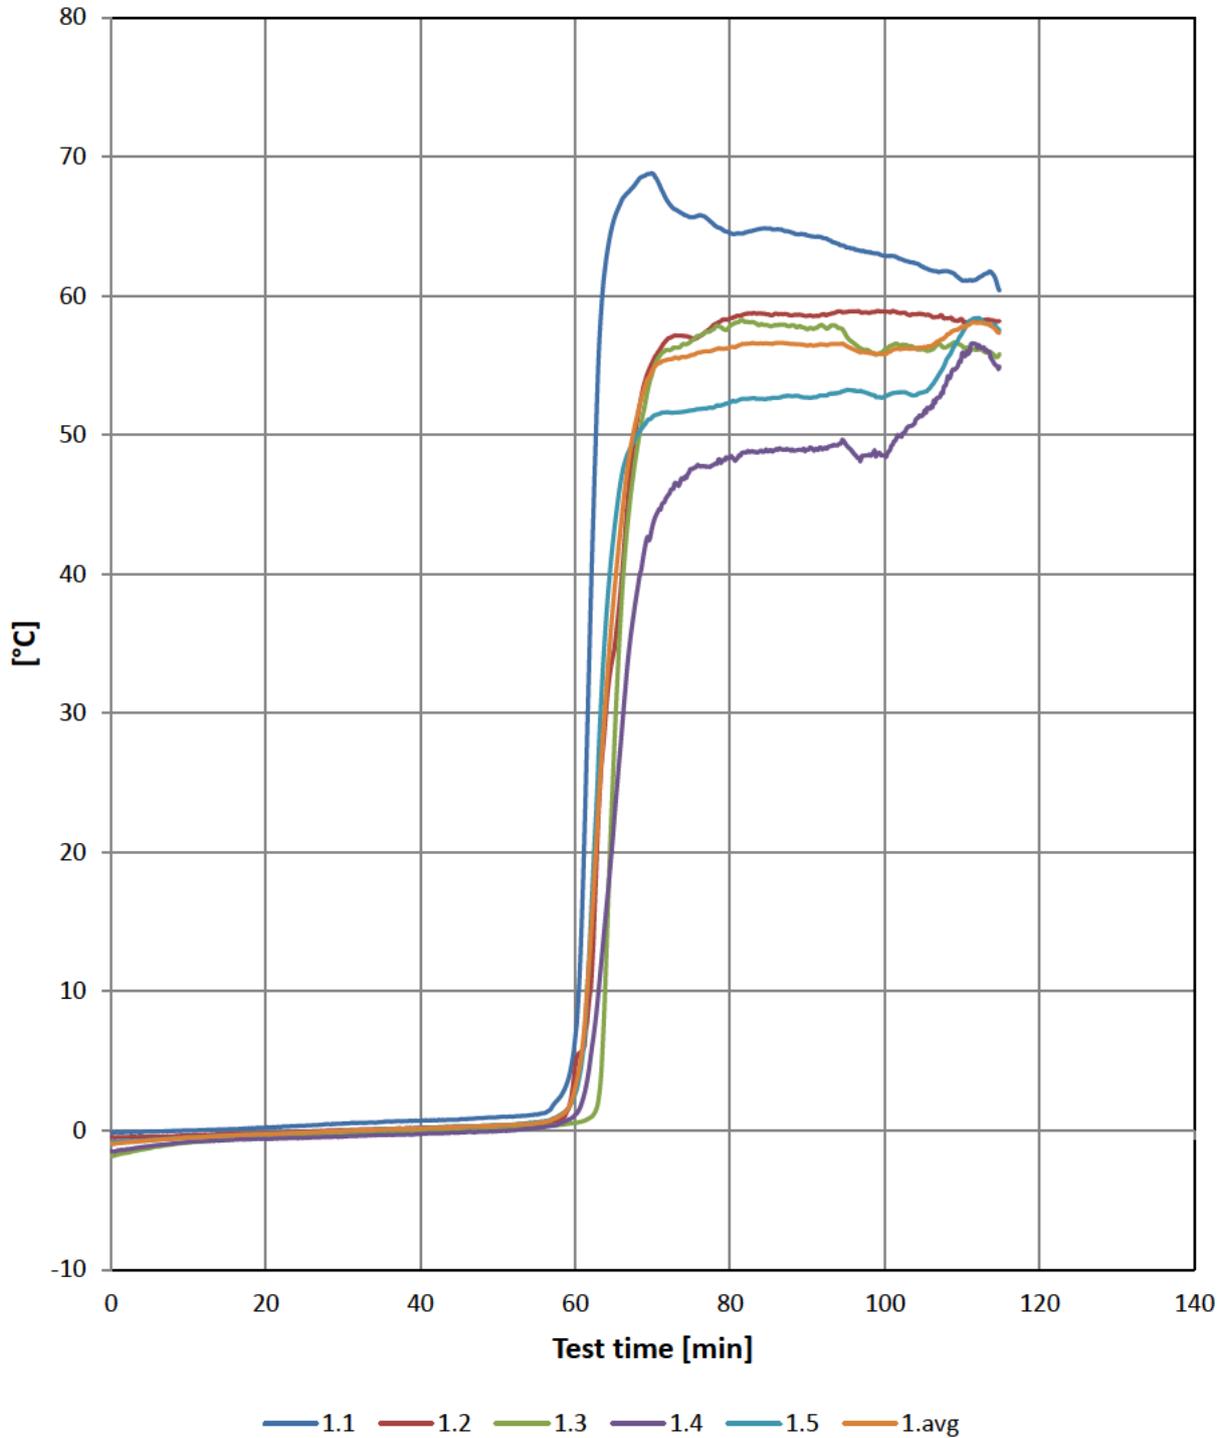
### Average temperature rise

Measured with 5 thermocouples on the unexposed side

Min. / °C	1.1	1.2	1.3	1.4	1.5	1.Avg	1.Max
0	0	0	-2	-1	-1	-1	0
5	0	0	-1	-1	-1	-1	0
10	0	0	-1	-1	0	0	0
15	0	0	-1	-1	0	0	0
20	0	0	-1	-1	0	0	0
25	0	0	0	-1	0	0	0
30	1	0	0	0	0	0	1
35	1	0	0	0	0	0	1
40	1	0	0	0	0	0	1
45	1	0	0	0	0	0	1
50	1	0	0	0	0	0	1
55	1	0	0	0	1	1	1
60	7	5	1	1	3	3	7
65	66	35	27	22	43	39	66
70	69	55	55	44	51	55	69
75	66	57	57	48	52	56	66
80	65	58	58	48	52	56	65
85	65	59	58	49	53	57	65
90	64	59	58	49	53	56	64
95	63	59	57	49	53	56	63
100	63	59	56	49	53	56	63
105	62	59	56	52	53	56	62
110	61	58	56	56	57	58	61
114	62	58	56	55	58	58	62

Failure [min]	-	-	-	-	-	-	-
Failure °C	180	180	180	180	180	140	180

- Failure of insulation occurred after 114 minutes of testing due to failure of integrity.
- The average temperature rise on the unexposed surface of the test specimen did not exceed 140°C during the test.
- The maximum temperature rise on the unexposed surface of the test specimen did not exceed 180°C during the test.

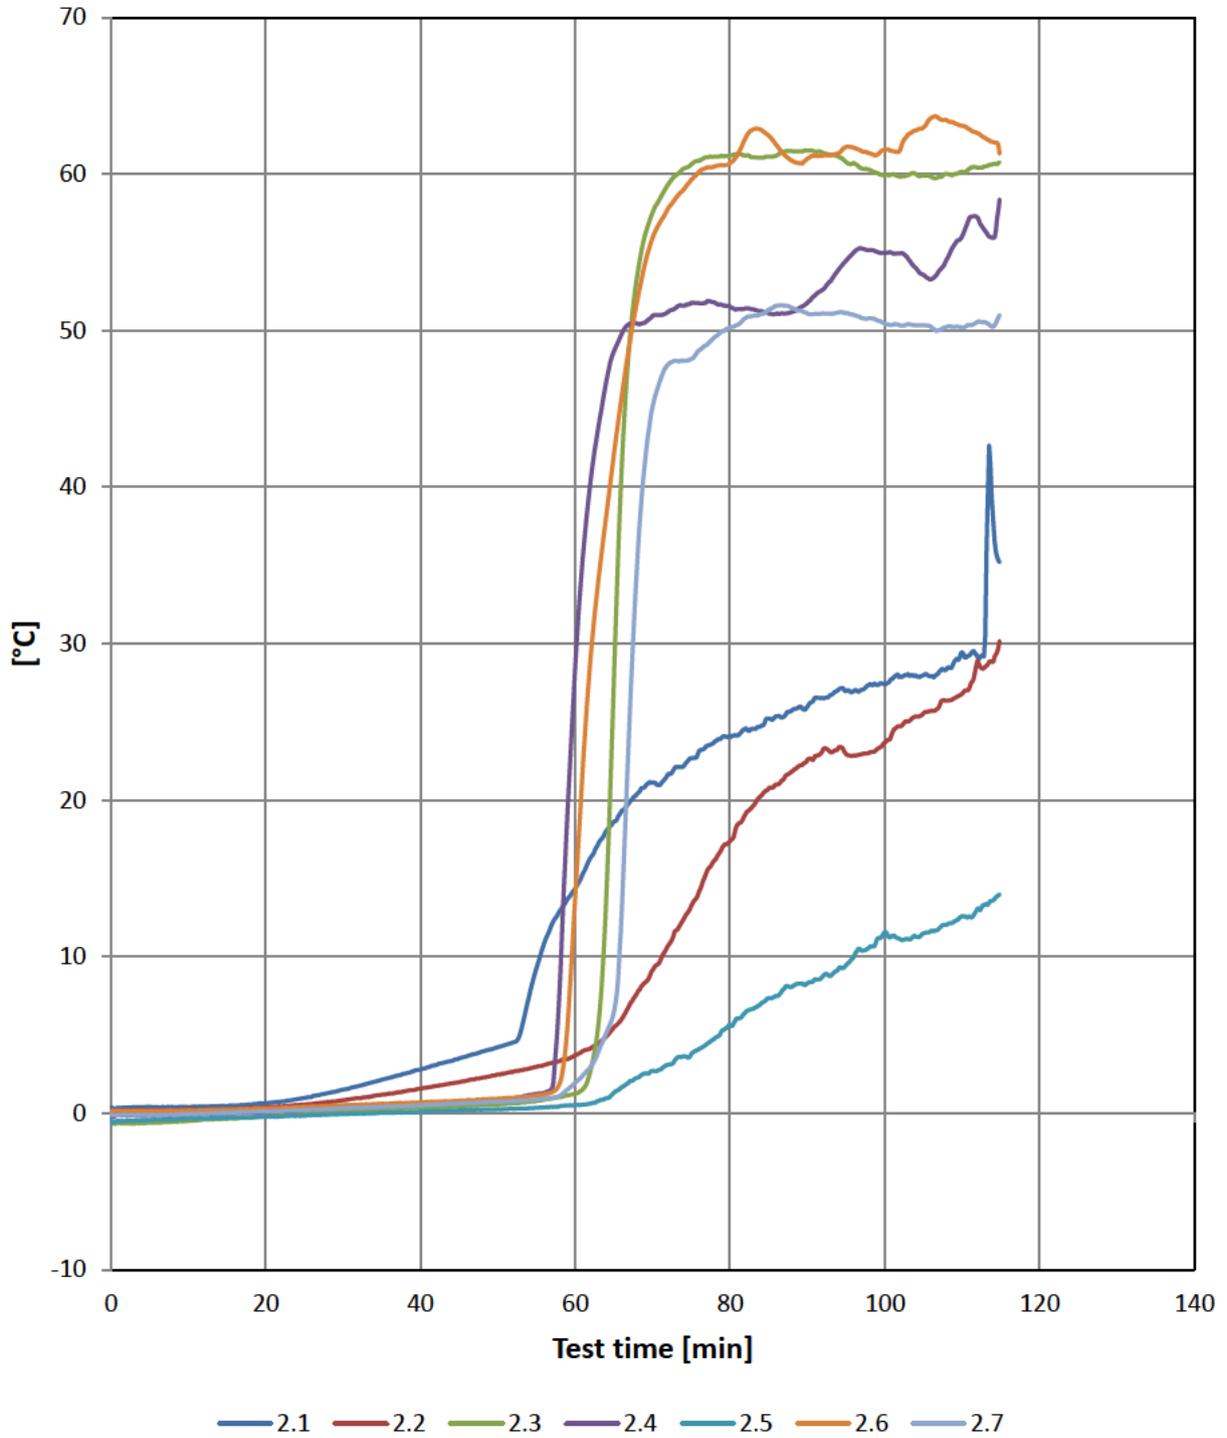
## Maximum temperature rise

Maximum temperatures on the unexposed side

Min. / °C	2.1	2.2	2.3	2.4	2.5	2.6	2.7	2.Max
0	0	0	-1	0	0	0	0	0
5	0	0	-1	0	0	0	0	0
10	0	0	0	0	0	0	0	0
15	0	0	0	0	0	0	0	0
20	1	0	0	0	0	0	0	1
25	1	1	0	0	0	0	0	1
30	2	1	0	0	0	1	0	2
35	2	1	0	1	0	1	0	2
40	3	2	0	1	0	1	1	3
45	4	2	0	1	0	1	1	4
50	4	2	1	1	0	1	1	4
55	9	3	1	1	0	1	1	9
60	14	4	1	29	1	14	2	29
65	19	6	28	49	1	42	6	49
70	21	9	58	51	3	56	45	58
75	23	13	61	52	4	60	48	61
80	24	17	61	52	6	61	50	61
85	25	21	61	51	7	62	51	62
90	26	23	62	52	8	61	51	62
95	27	23	61	54	9	62	51	62
100	27	24	60	55	12	62	50	62
105	28	26	60	54	12	63	50	63
110	29	27	60	56	13	63	50	63
114	38	29	61	56	14	62	50	62

Failure [min]	-	-	-	-	-	-	-	-
Failure °C	180	180	180	180	180	180	180	180
