# TEST REPORT LOADBEARING WALL

<b>Name of sponsor:</b>	Wood:UpHigh		
<b>Product name:</b>	Loadbearing wall		
<b>File no.:</b>	PGA12233A	<b>Revision no.:</b>	1
<b>Test date:</b>	2023-01-11	<b>Date:</b>	12-07-2023
<b>Pages:</b>	11	<b>Encl.:</b>	55
<b>Ref:</b>	JBK / CHB

Subject: Load bearing wall

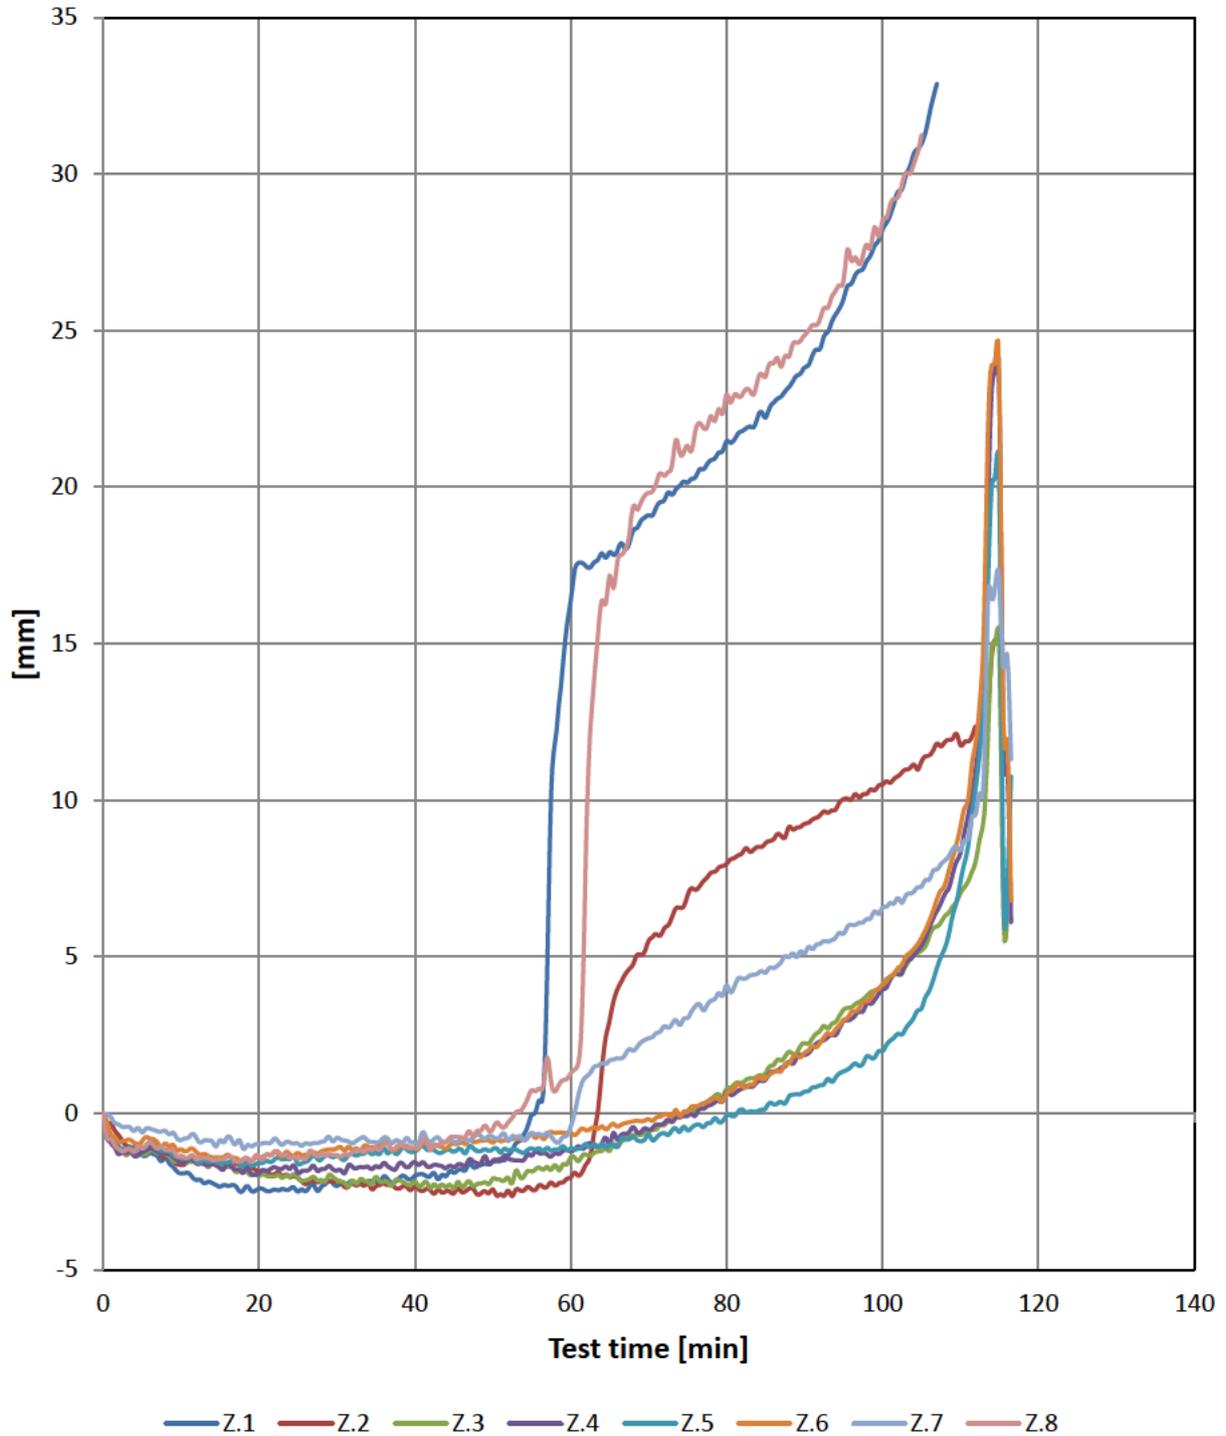
## Horizontal deformation

*Negative values indicate movement towards the furnace*

Min. / mm	Z.1	Z.2	Z.3	Z.4	Z.5	Z.6	Z.7	Z.8
0	0.0	0.0	0.0	0.0	0.0	0.0	0.0	0.0
5	-1.3	-1.2	-1.3	-1.2	-1.1	-0.9	-0.6	-1.1
10	-1.9	-1.6	-1.5	-1.6	-1.4	-1.1	-0.9	-1.4
15	-2.3	-1.7	-1.6	-1.8	-1.6	-1.4	-0.9	-1.5
20	-2.4	-1.9	-2.0	-1.9	-1.6	-1.4	-1.0	-1.4
25	-2.5	-2.1	-2.1	-1.9	-1.6	-1.3	-1.0	-1.4
30	-2.3	-2.2	-2.1	-1.8	-1.3	-1.1	-0.8	-1.3
35	-2.2	-2.3	-2.0	-1.7	-1.3	-1.1	-0.9	-1.1
40	-2.0	-2.3	-2.2	-1.6	-1.2	-1.1	-0.9	-1.1
45	-1.9	-2.6	-2.4	-1.7	-1.2	-1.0	-0.9	-0.7
50	-1.6	-2.4	-2.1	-1.5	-1.1	-0.9	-0.8	-0.5
55	0.0	-2.4	-1.9	-1.4	-1.1	-0.6	-0.6	0.7
60	16.4	-2.1	-1.4	-1.2	-1.1	-0.6	-0.4	1.3
65	17.9	2.9	-1.2	-1.0	-1.0	-0.4	1.7	17.2
70	19.1	5.5	-0.6	-0.5	-0.7	-0.2	2.4	19.8
75	20.1	7.0	0.1	-0.1	-0.6	0.0	3.0	21.3
80	21.5	8.0	0.8	0.7	-0.1	0.6	4.1	23.0
85	22.2	8.6	1.3	1.1	0.1	1.1	4.5	23.5
90	23.8	9.2	2.2	1.9	0.7	1.9	5.1	24.9
95	26.0	10.0	3.3	3.0	1.3	3.0	5.7	26.6
100	28.2	10.5	4.1	4.0	2.0	4.1	6.6	28.5
105	31.0	11.2	5.2	5.4	3.4	5.6	7.2	31.3

110	0.0	11.7	7.0	8.3	7.4	9.1	8.4	0.0
115	0.0	15.3	14.6	22.8	19.7	23.3	17.0	0.0
116	0.0	0.0	6.2	11.1	7.0	12.0	14.7	0.0

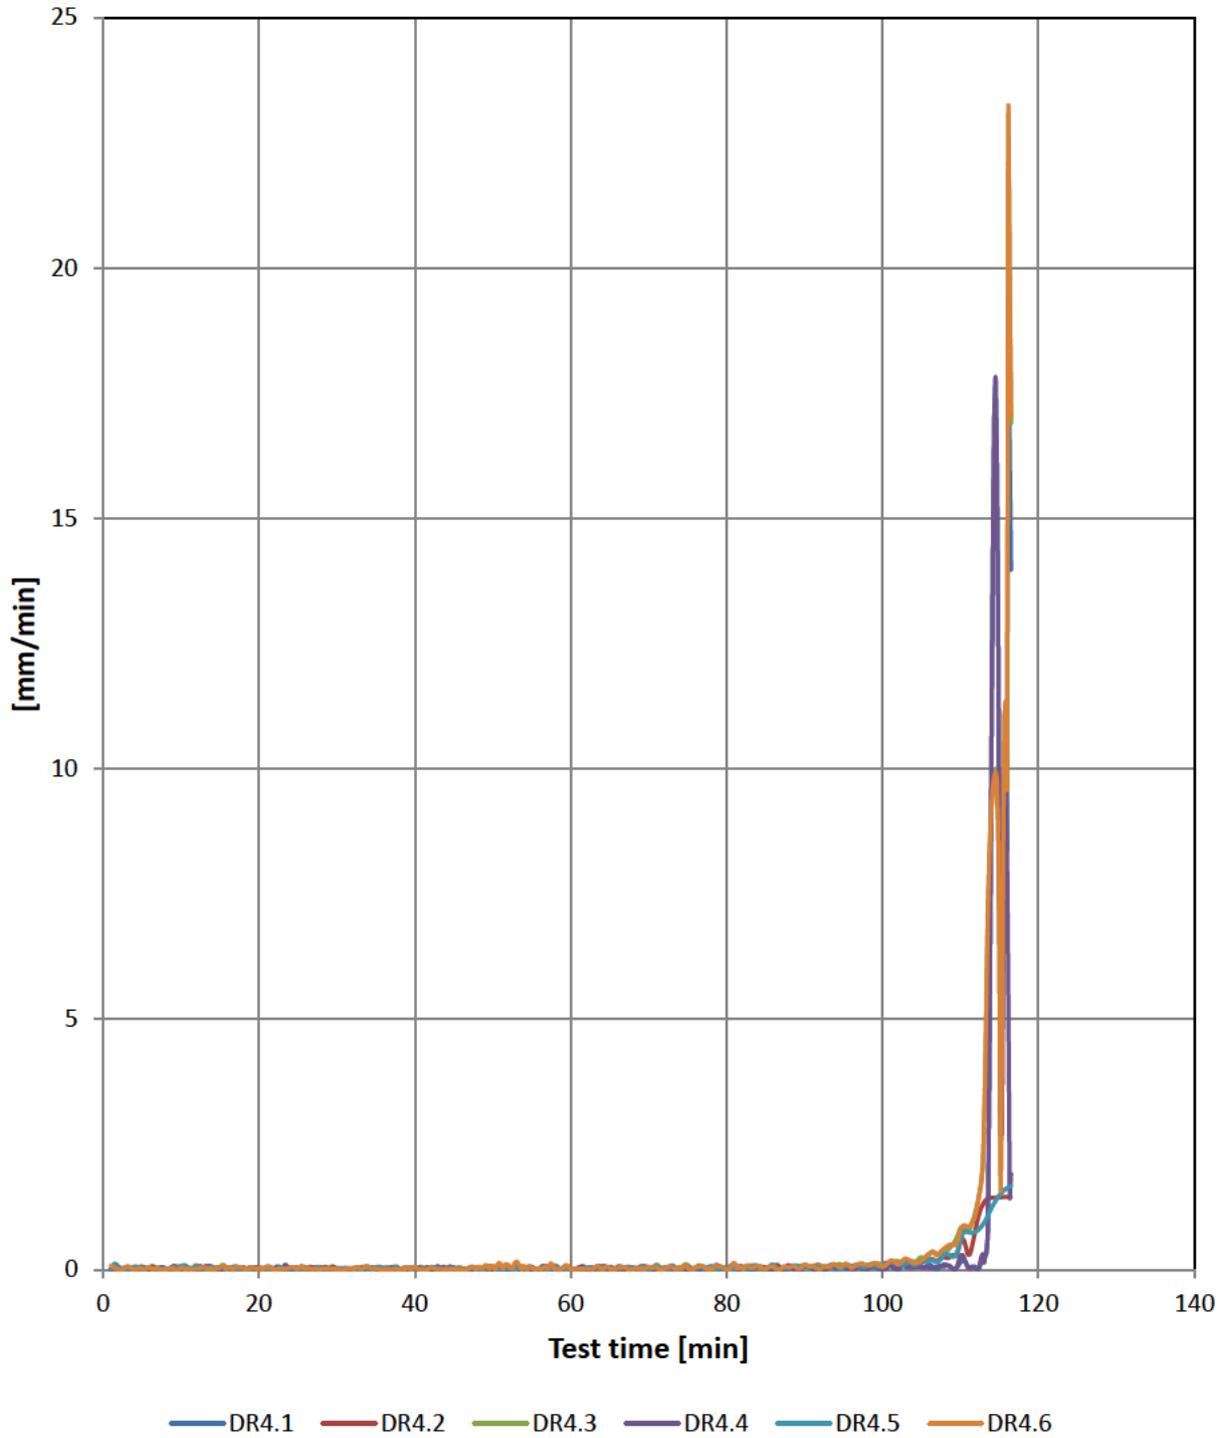
### Vertical deformation rate

Min. / mm/min	DR4.1	DR4.2	DR4.3	DR4.4	DR4.5	DR4.6	DR4.Max
0	0.00	0.00	0.00	0.00	0.00	0.00	0.00
5	0.07	0.02	0.05	0.03	0.00	0.02	0.00
10	0.03	0.05	0.04	0.07	0.07	0.04	0.00
15	0.05	0.05	0.05	0.00	0.05	0.04	0.00
20	0.00	0.04	0.04	0.00	0.03	0.03	0.00
25	0.02	0.02	0.03	0.02	0.01	0.01	0.00
30	0.04	0.01	0.03	0.00	0.01	0.00	0.00
35	0.02	0.00	0.02	0.00	0.04	0.03	0.00
40	0.02	0.02	0.01	0.00	0.01	0.06	0.00
45	0.04	0.04	0.02	0.00	0.04	0.02	0.00
50	0.00	0.01	0.03	0.00	0.04	0.08	0.00
55	0.03	0.06	0.03	0.00	0.05	0.04	0.00
60	0.02	0.02	0.02	0.00	0.01	0.00	0.00
65	0.03	0.02	0.02	0.05	0.05	0.03	0.00
70	0.01	0.01	0.02	0.03	0.00	0.06	0.00
75	0.02	0.04	0.10	0.02	0.06	0.05	0.00
80	0.01	0.03	0.01	0.02	0.06	0.01	0.00
85	0.04	0.05	0.01	0.02	0.02	0.02	0.00
90	0.02	0.05	0.04	0.06	0.08	0.11	0.00
95	0.08	0.09	0.08	0.03	0.05	0.10	0.00
100	0.02	0.08	0.11	0.03	0.09	0.06	0.00
105	0.04	0.16	0.25	0.07	0.17	0.19	0.00
110	0.15	0.56	0.83	0.28	0.58	0.79	0.00

Failure [min]	113.83	-	113.83	113.83	-	113.83	-
Failuremm/mi	9.00	9.00	9.00	9.00	9.00	9.00	9.00

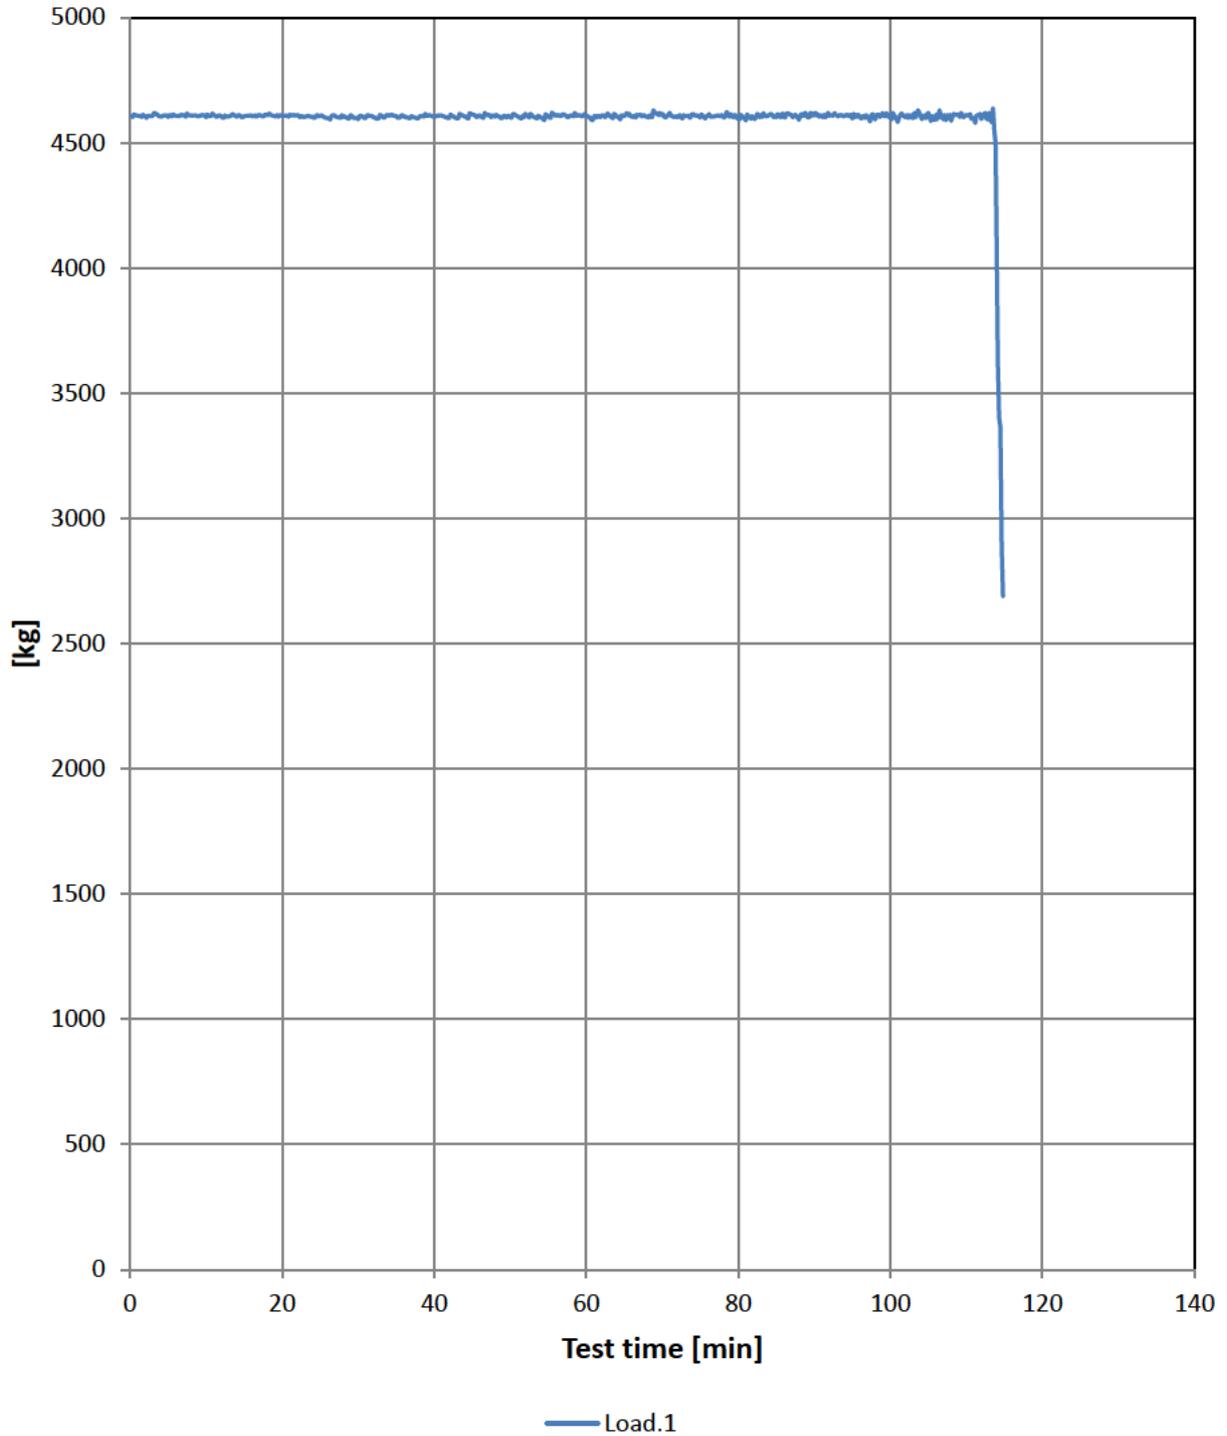
## Load per cylinder

*Load per cylinder during test*

The load was applied centrally on the horizontal top beam, e.g. there was no eccentricity in the loading conditions.

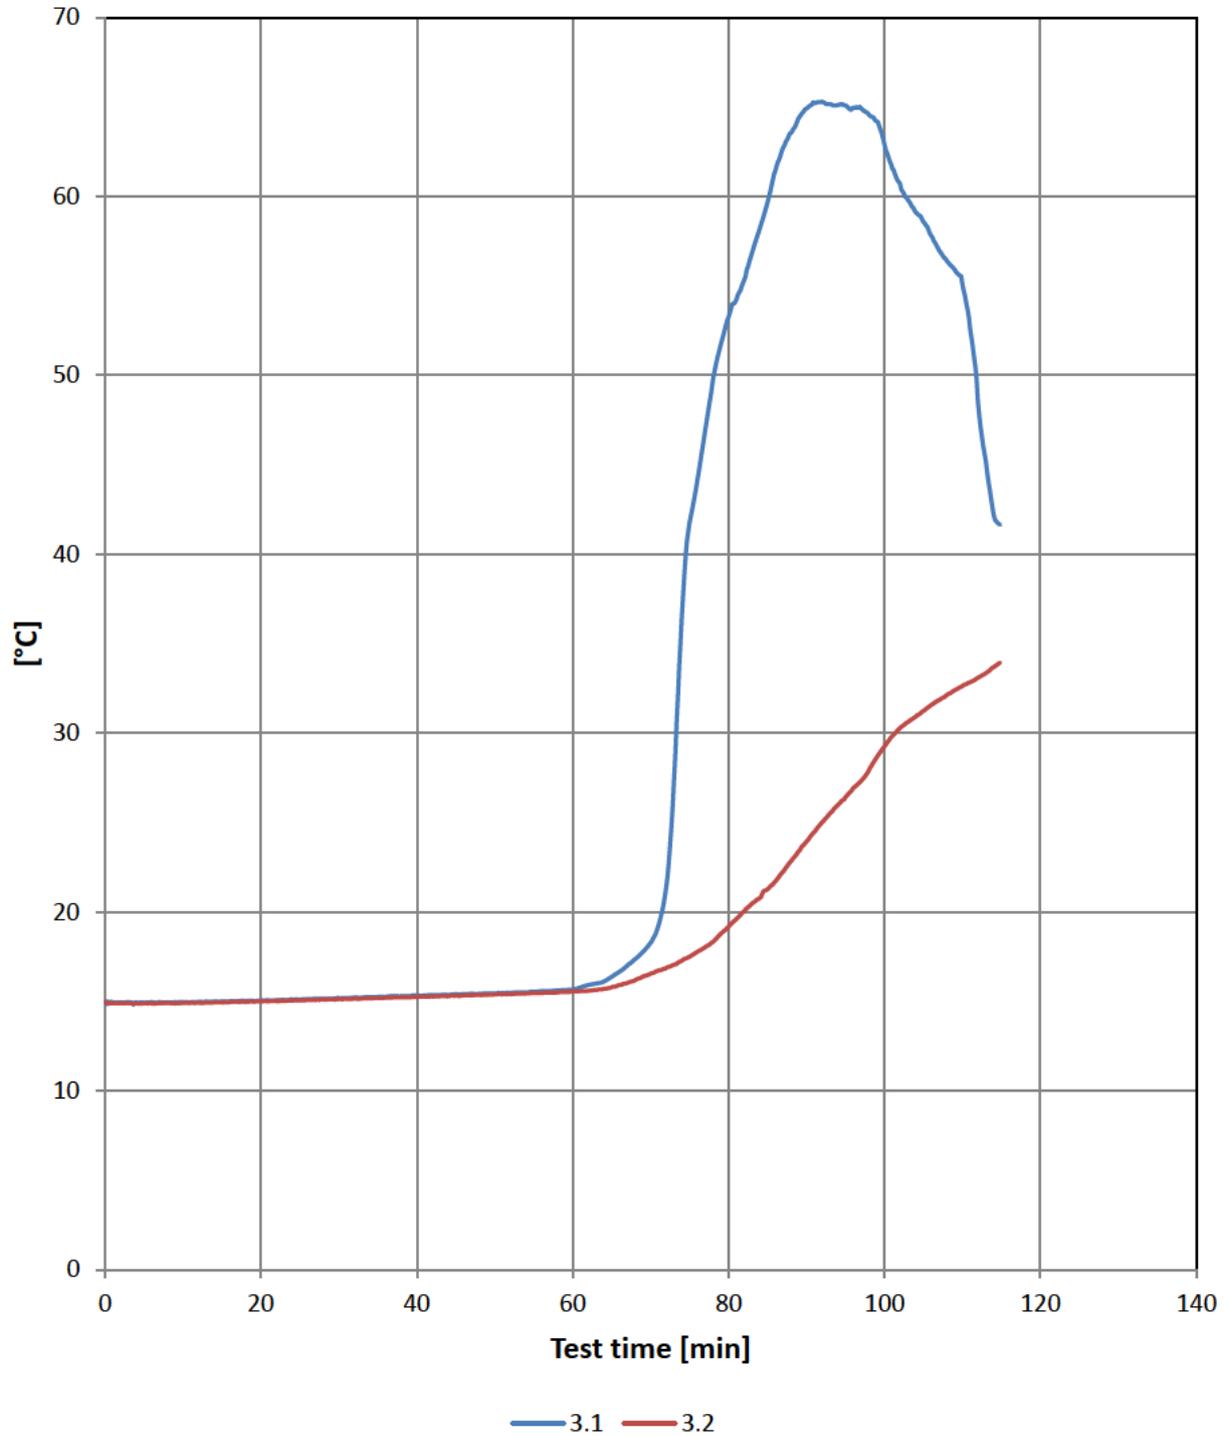
## Internal temperature - between studs and windbreaker

*1 on second element, 2 on center element seen from unexposed side*

Failure [min]	-	-	-
Failure °C	270	270	270

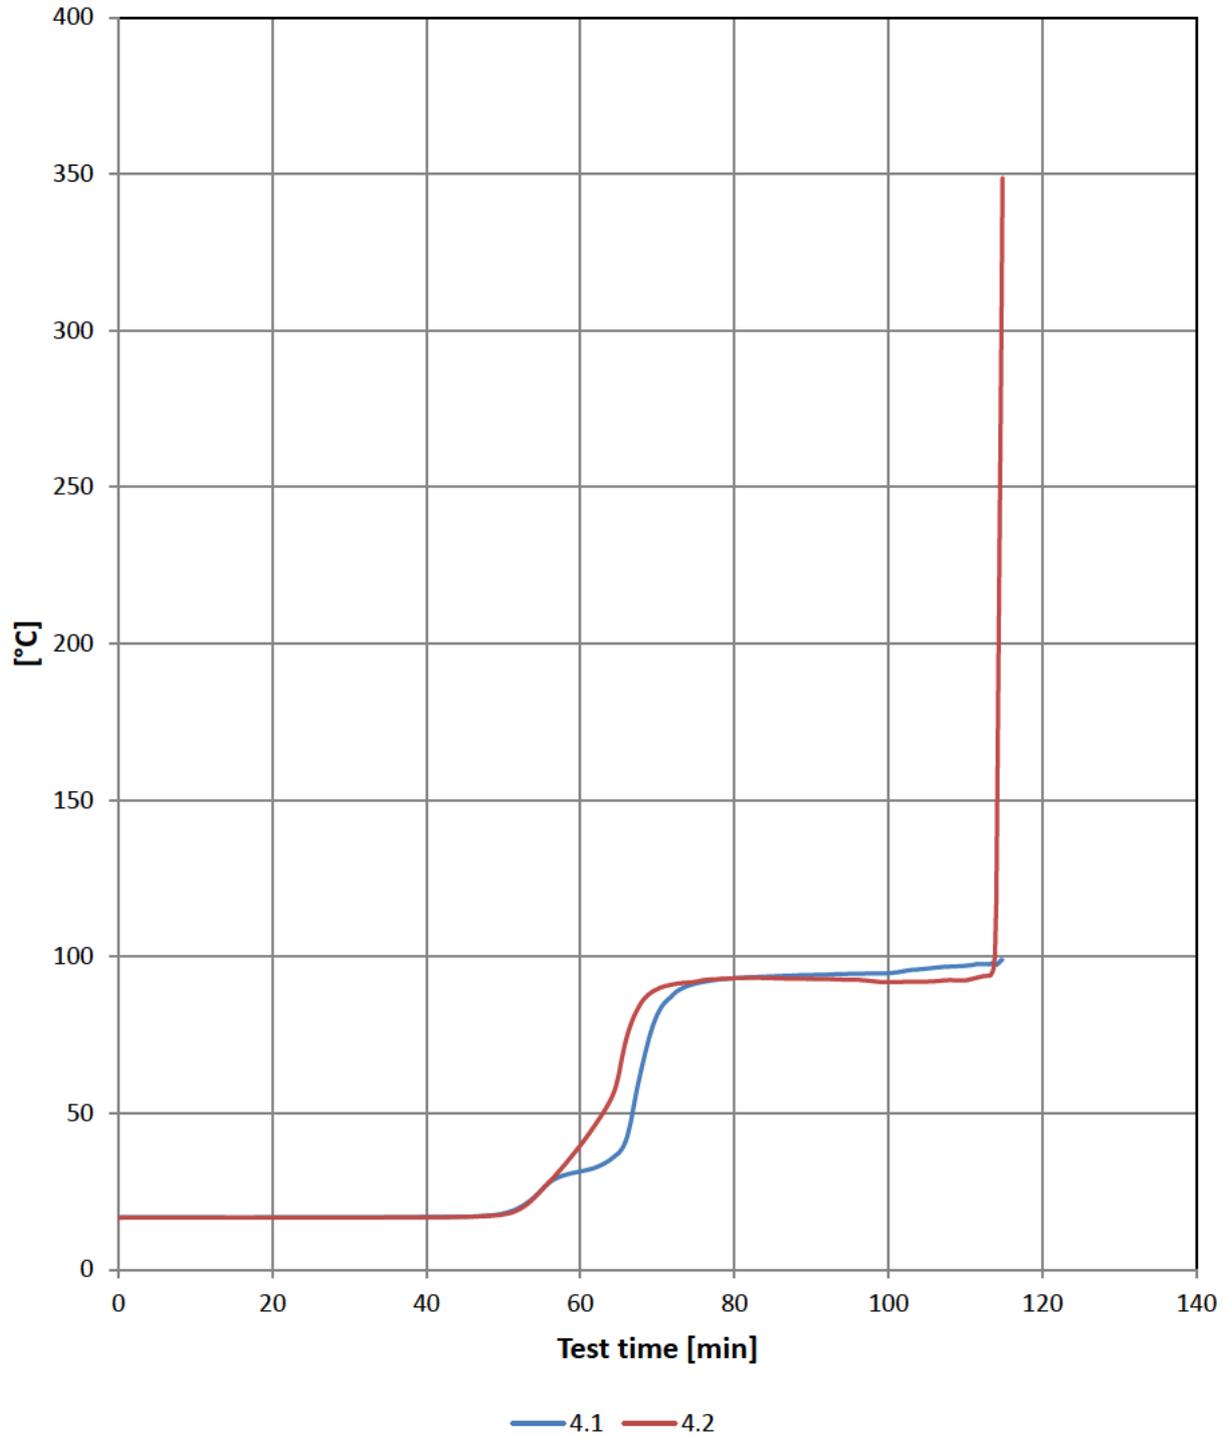
## Internal temperature - Center of studs

1 on second stud, 2 on center stud seen from unexposed side

Failure [min]	-	114.50	114.50
Failure °C	270	270	270

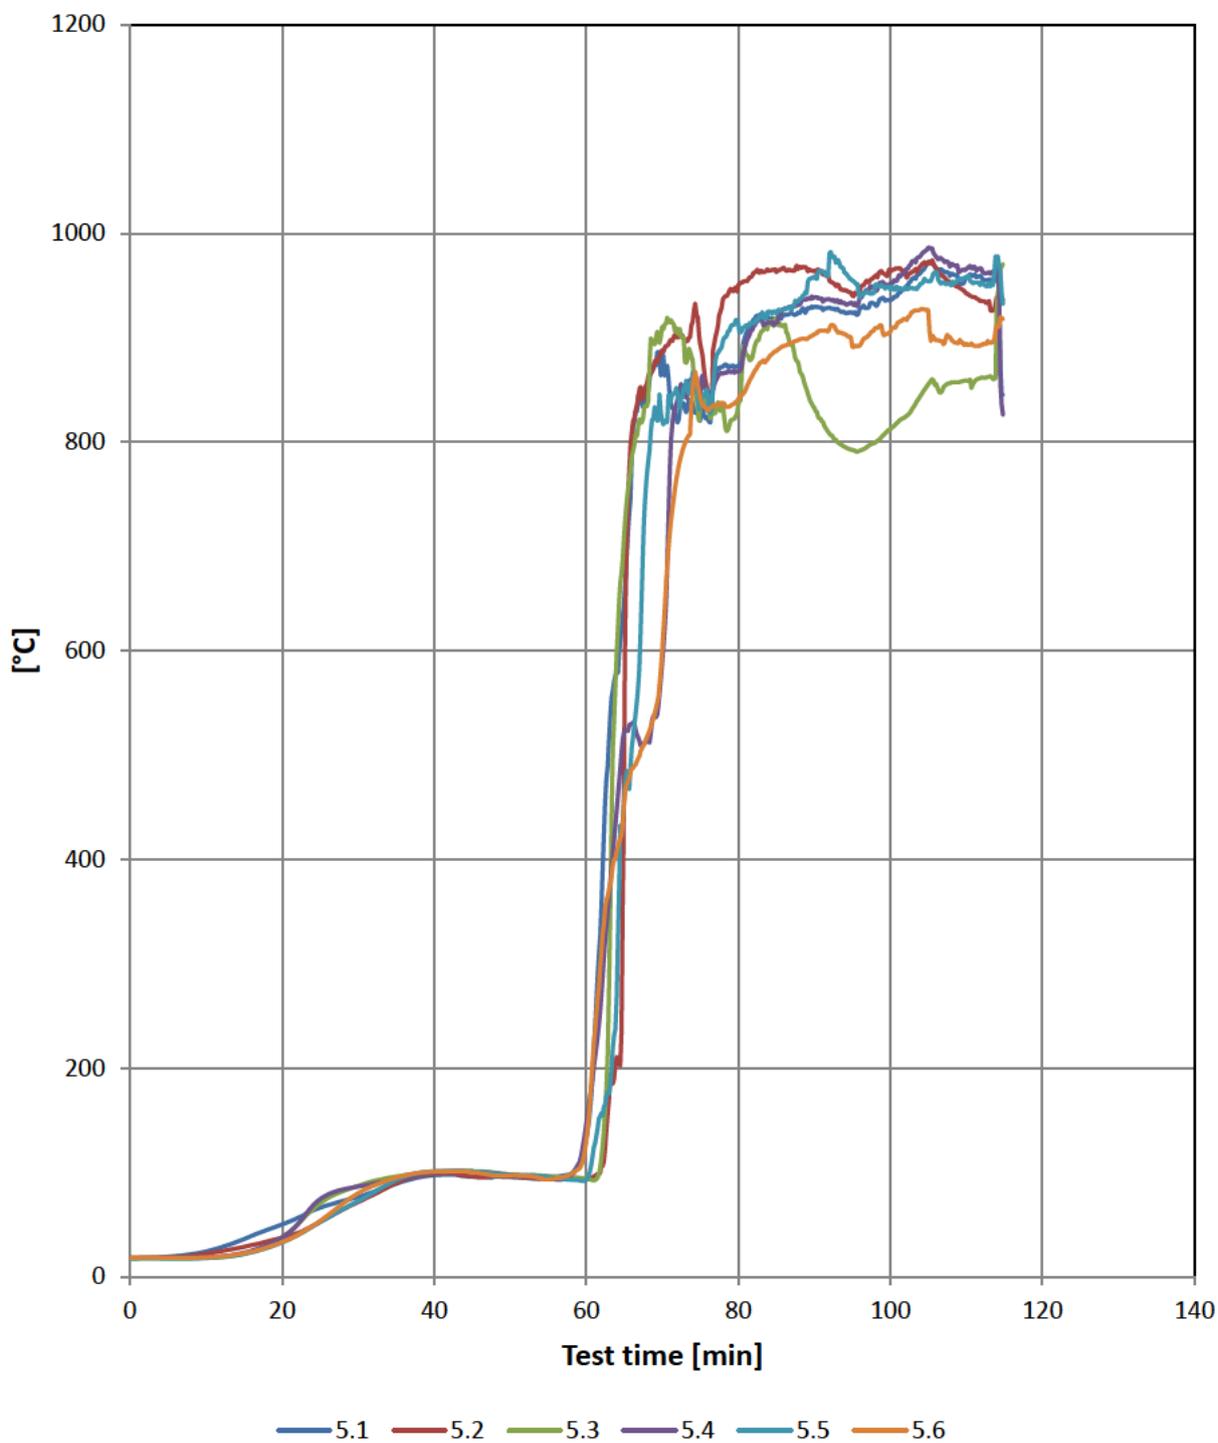
## Internal temperature - between studs and chipboard

Measured in each quarter section and at the center, and 6.6 on mid height of stud.

Failure [min]	61.33	64.67	62.83	61.83	64.00	61.50	61.33
Failure °C	270	270	270	270	270	270	270

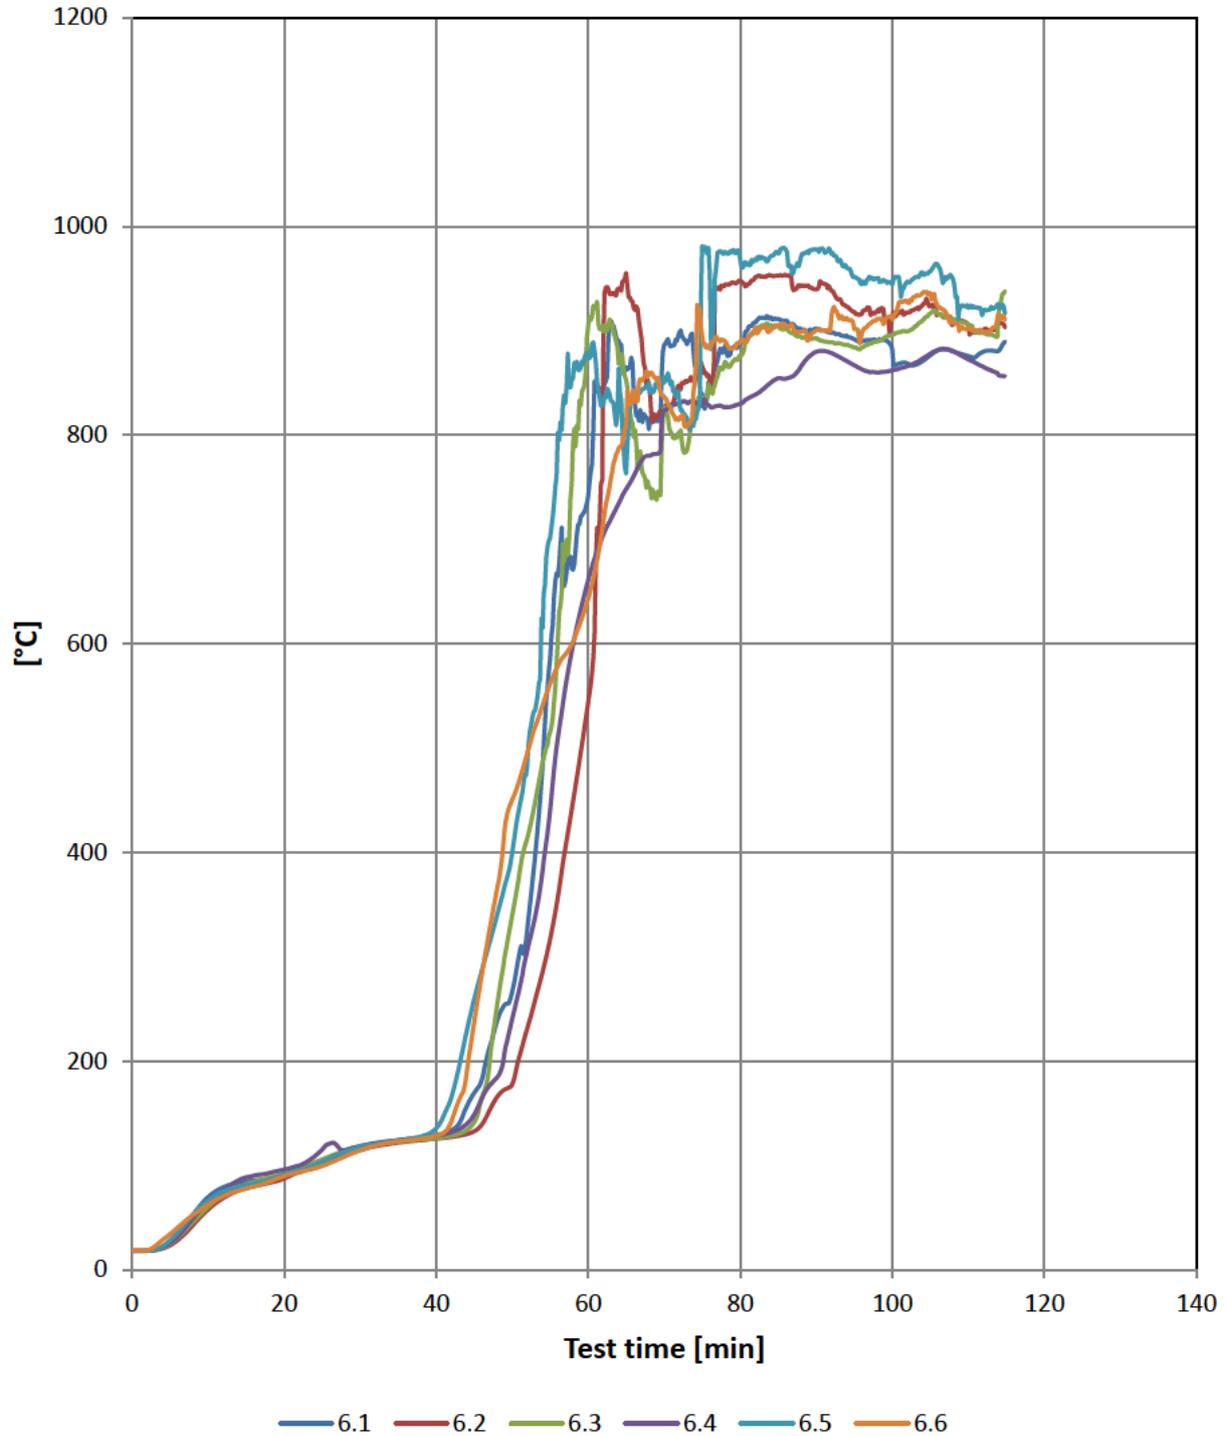
## Internal temperature - between chipboard and fiber gypsum boards

Measured in each quarter section, and 6.5 and 6.6 at mid height.

Failure [min]	50.00	53.33	48.33	50.83	45.33	45.67	45.33
Failure °C	270	270	270	270	270	270	270

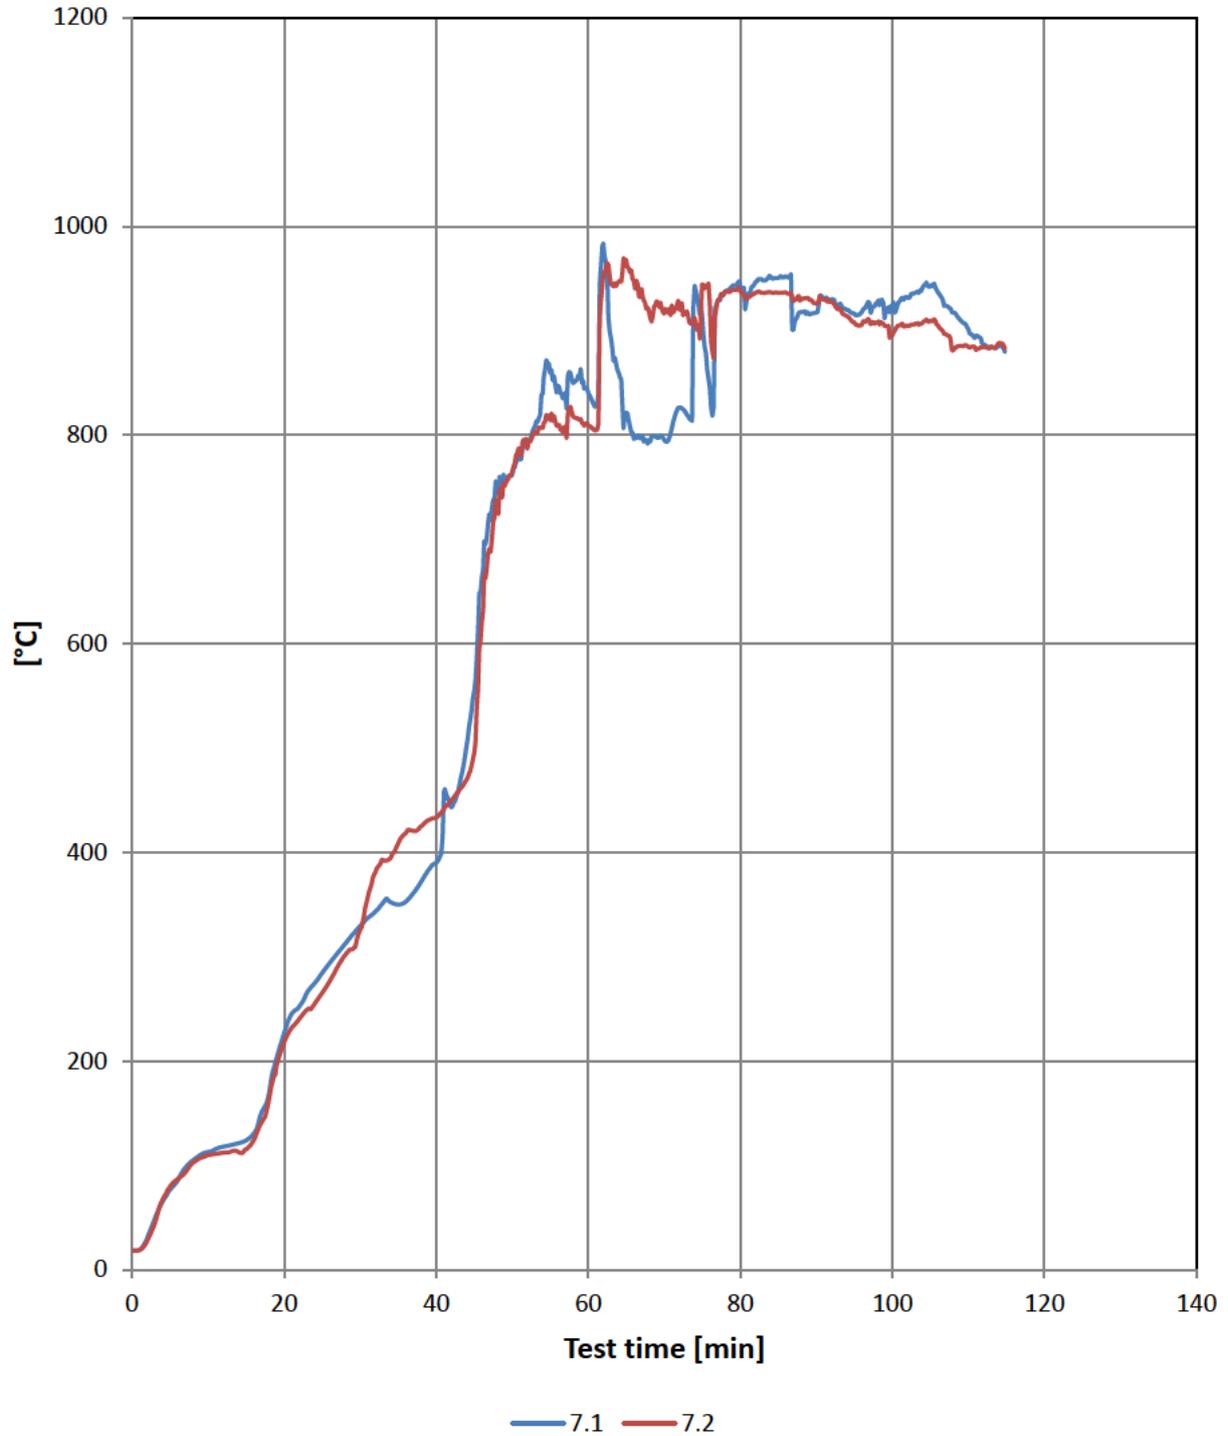
## Internal temperature - between fiber gypsum boards

*mid height of studs. 1 on 2nd stud from the right and 2 on center stud seen from unexposed side*

Failure [min]	23.50	25.33	23.50
Failure °C	270	270	270

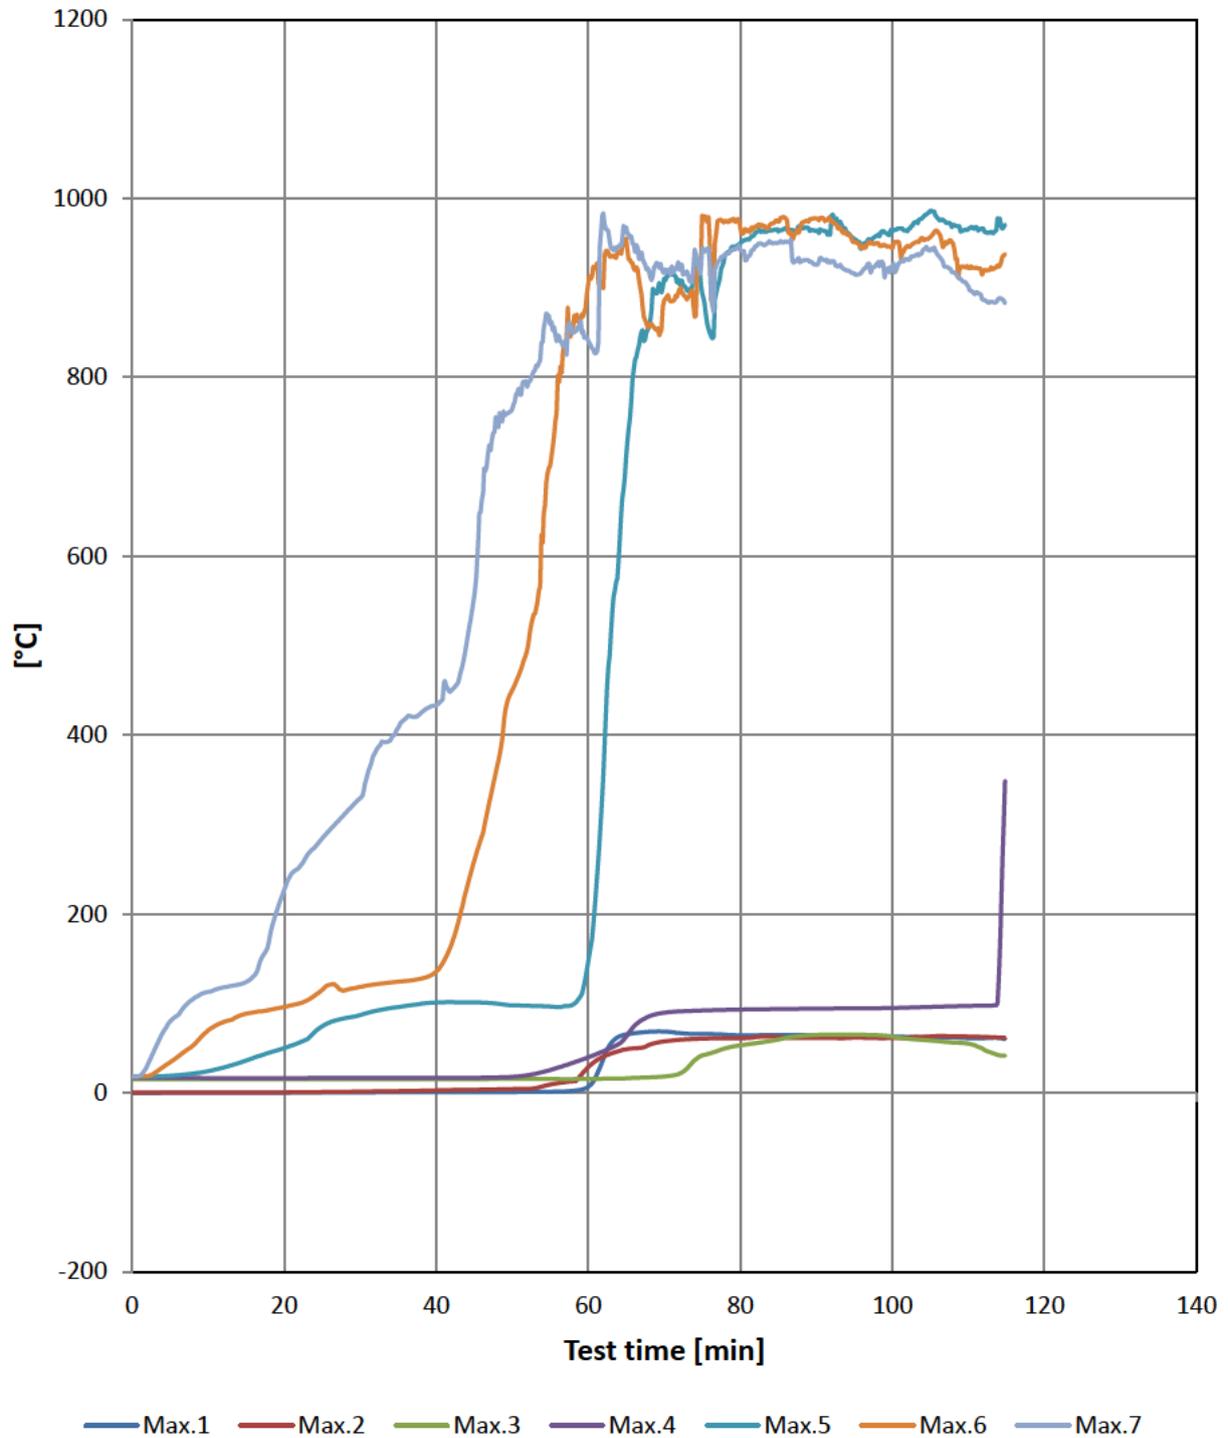
## Temperature development through the construction

Each thermocouple represents the maximum temperature in all measured layers

Failure [min]	-	-	-	114.50	61.33	45.33	23.50	-
Failure °C	270	270	270	270	270	270	270	270

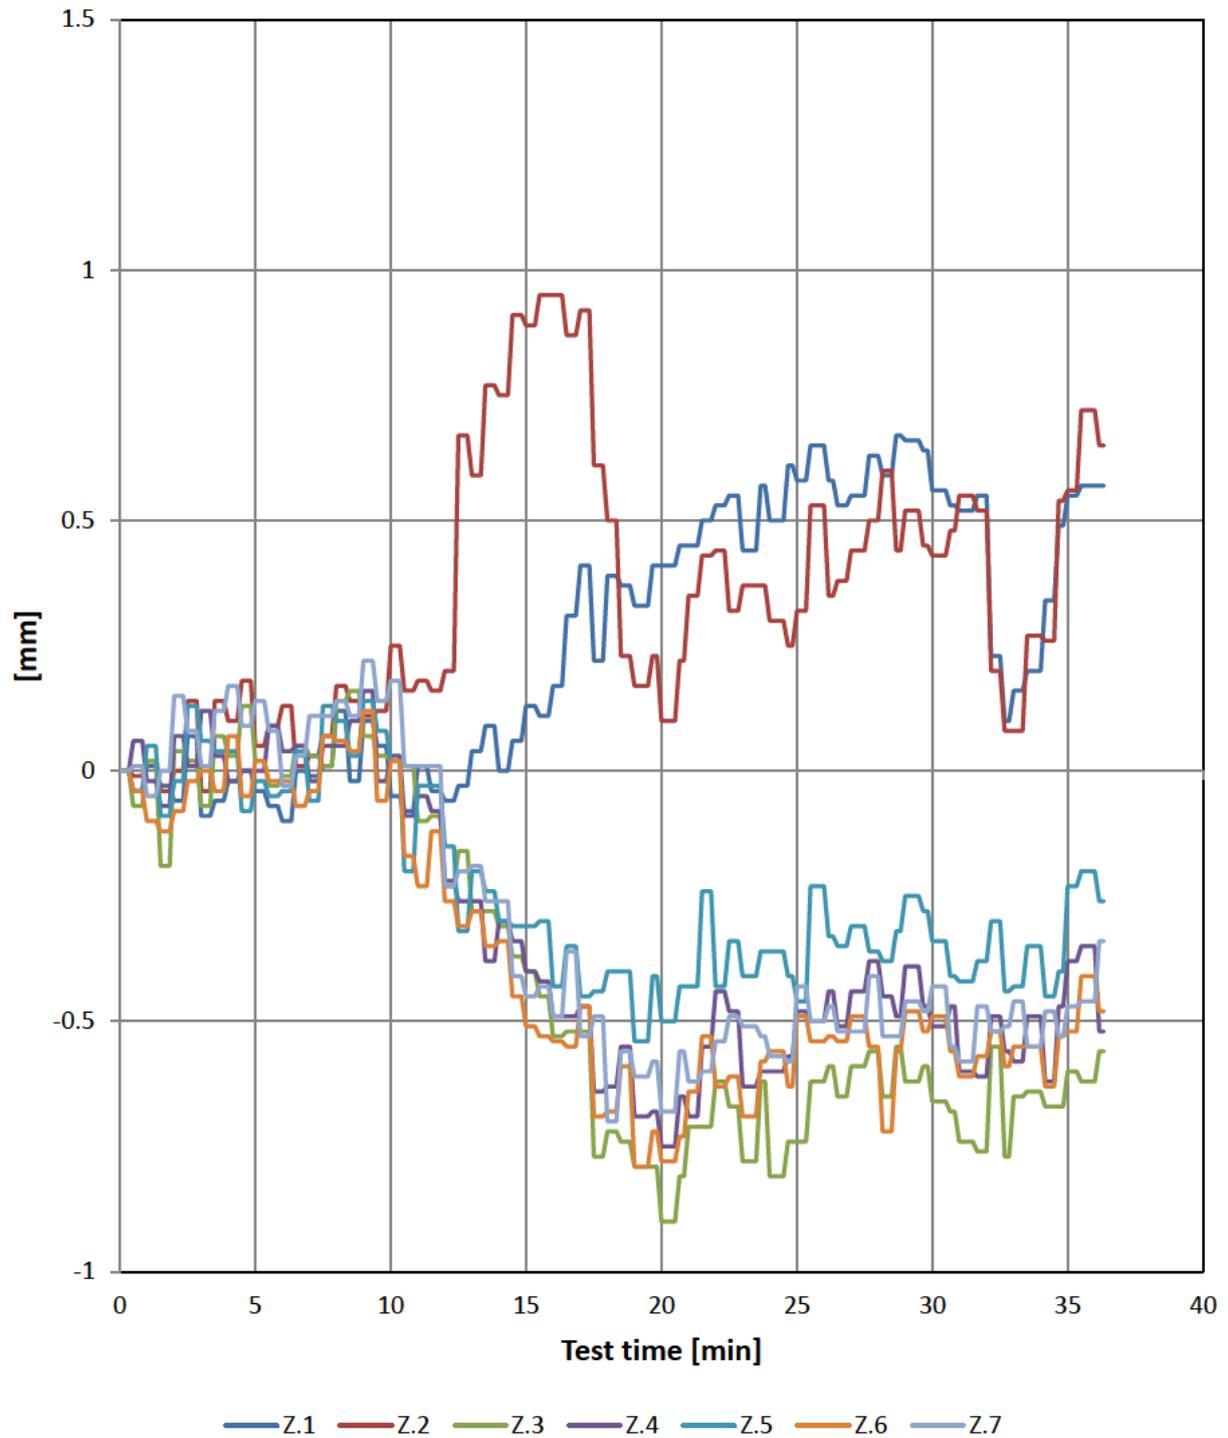
## Horizontal deformation during loading phase

Negative values indicate movement towards the furnace

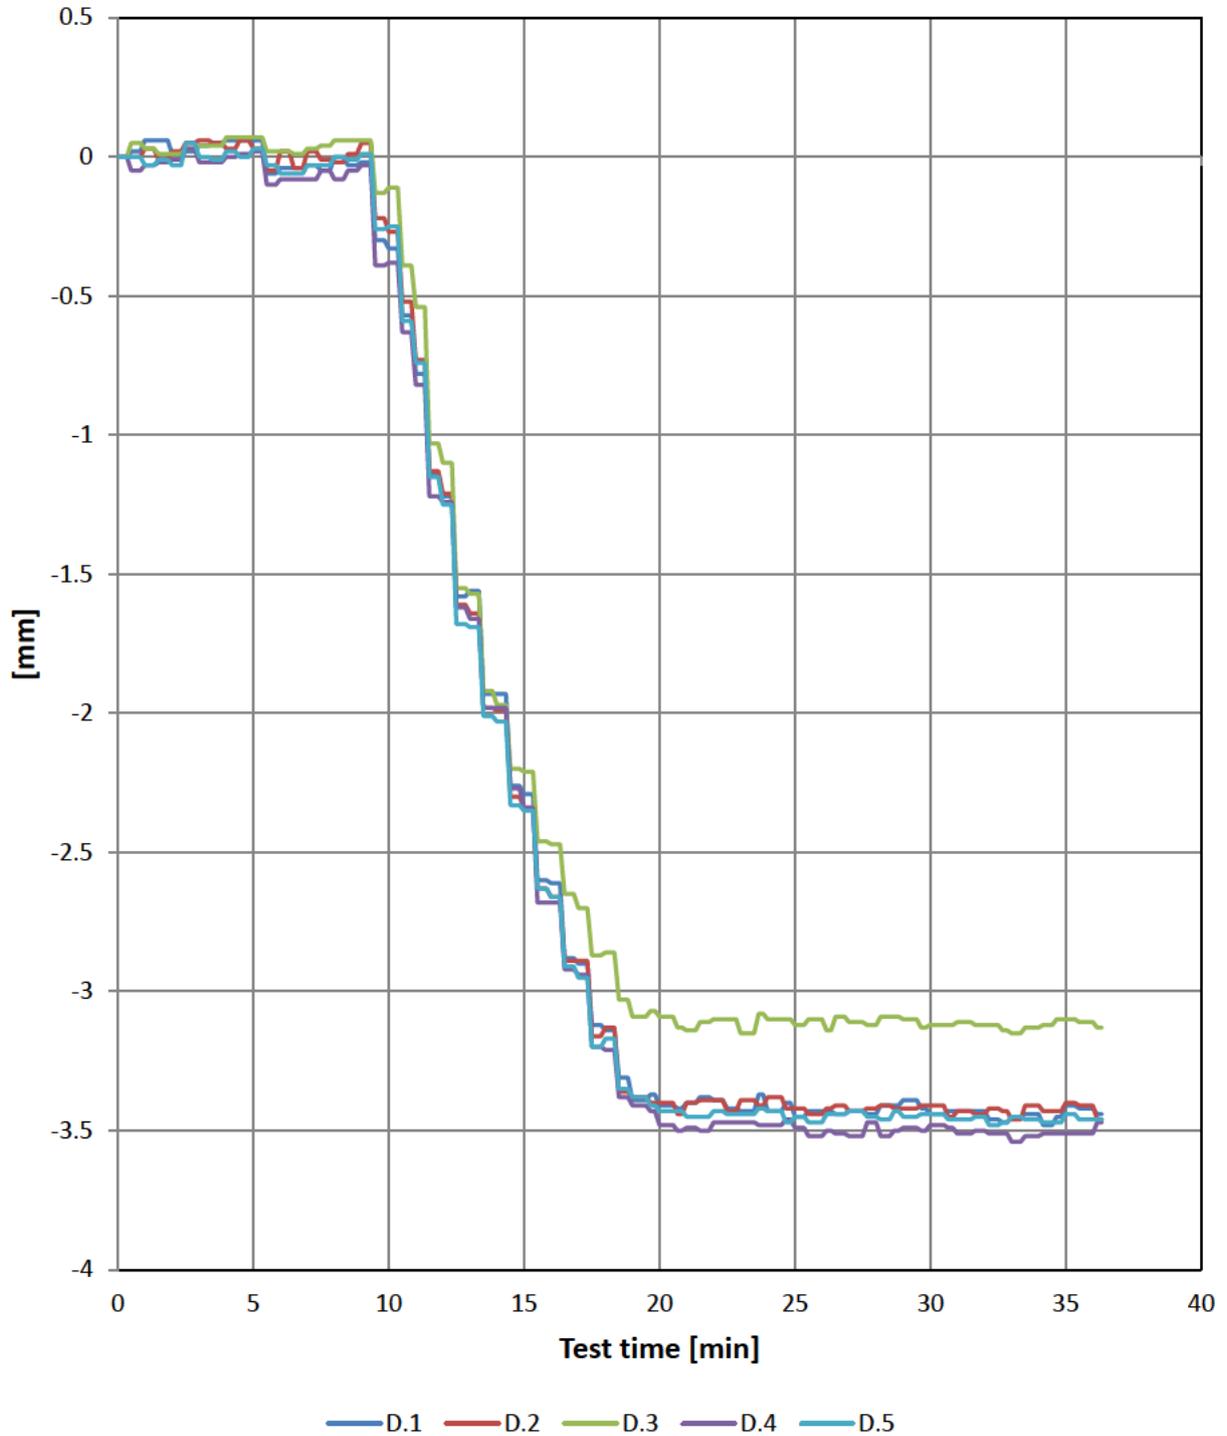
## Vertical deformation during loading phase

*Negative values indicate downwards movement*

35	-3.4	-3.4	-3.1	-3.5	-3.4
36	-3.4	-3.4	-3.1	-3.5	-3.5

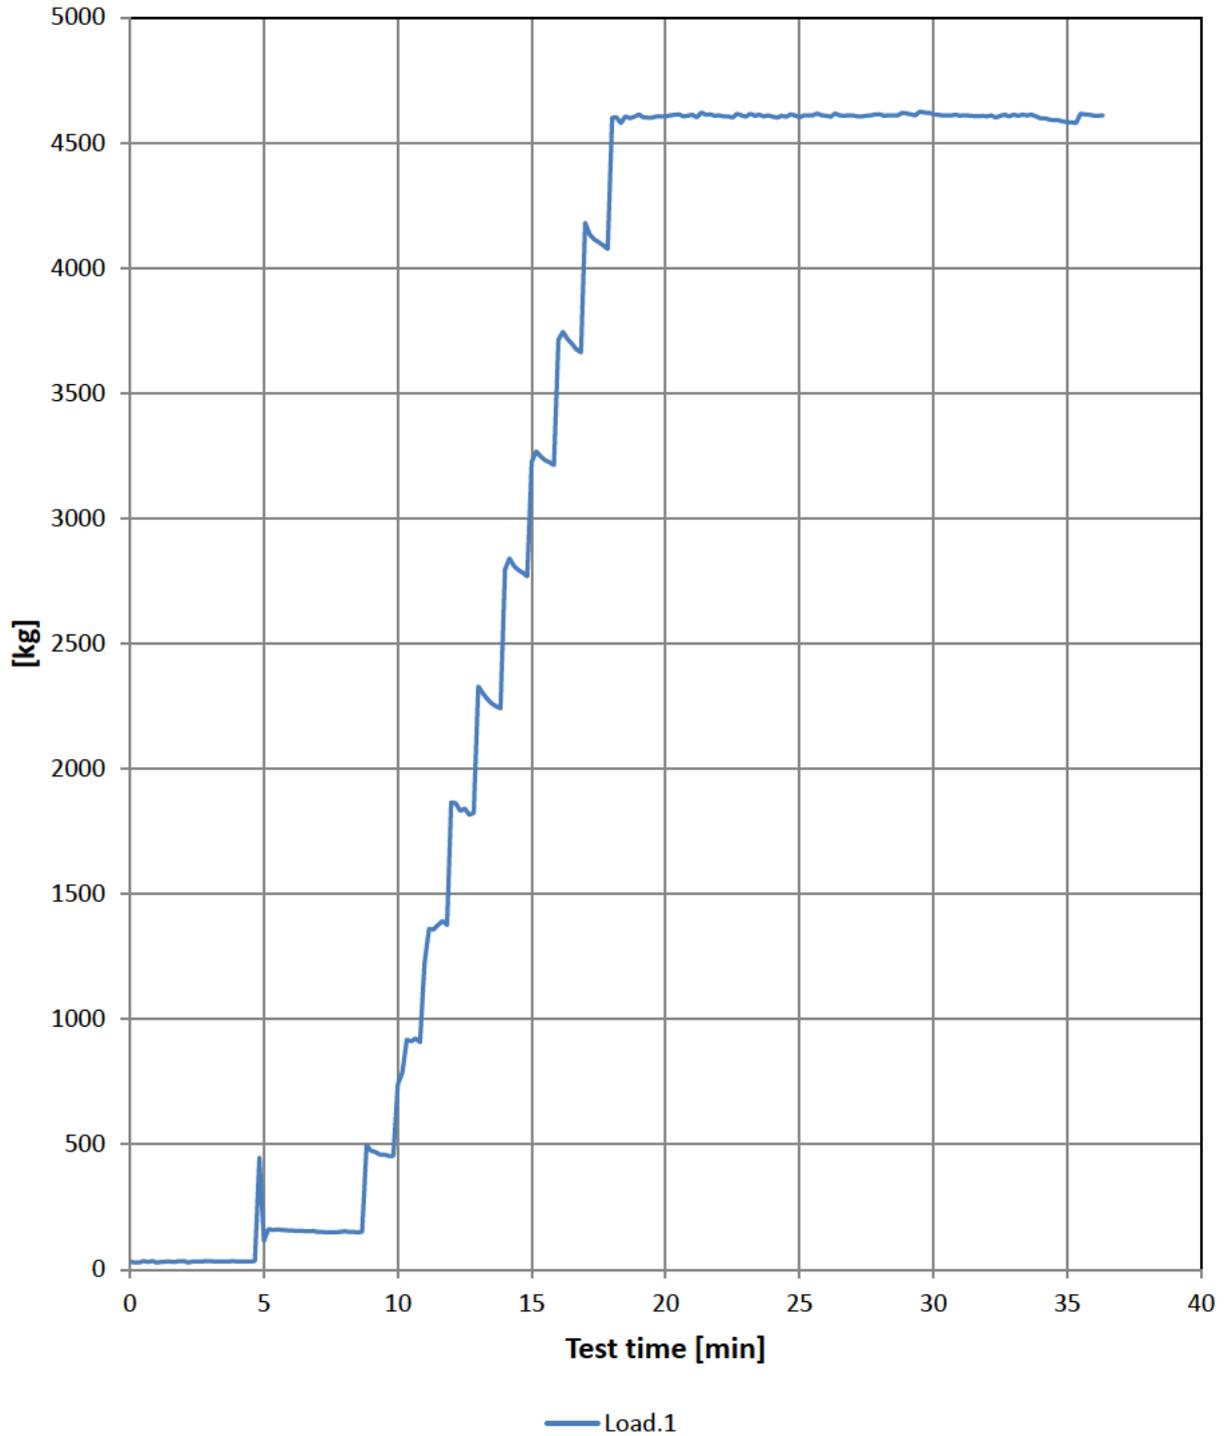
### Load per cylinder during loading phase

Min. / kg	Load.1
0	33
1	29
2	35
3	35
4	33
5	115
6	157
7	151
8	153
9	475
10	740
11	1223
12	1867
13	2329
14	2797
15	3226
16	3715
17	4181
18	4601
19	4614
20	4607
21	4612
22	4610
23	4605
24	4605
25	4603
26	4608
27	4610
28	4614
29	4618
30	4614
31	4608
32	4607
33	4612
34	4599
35	4584
36	4608

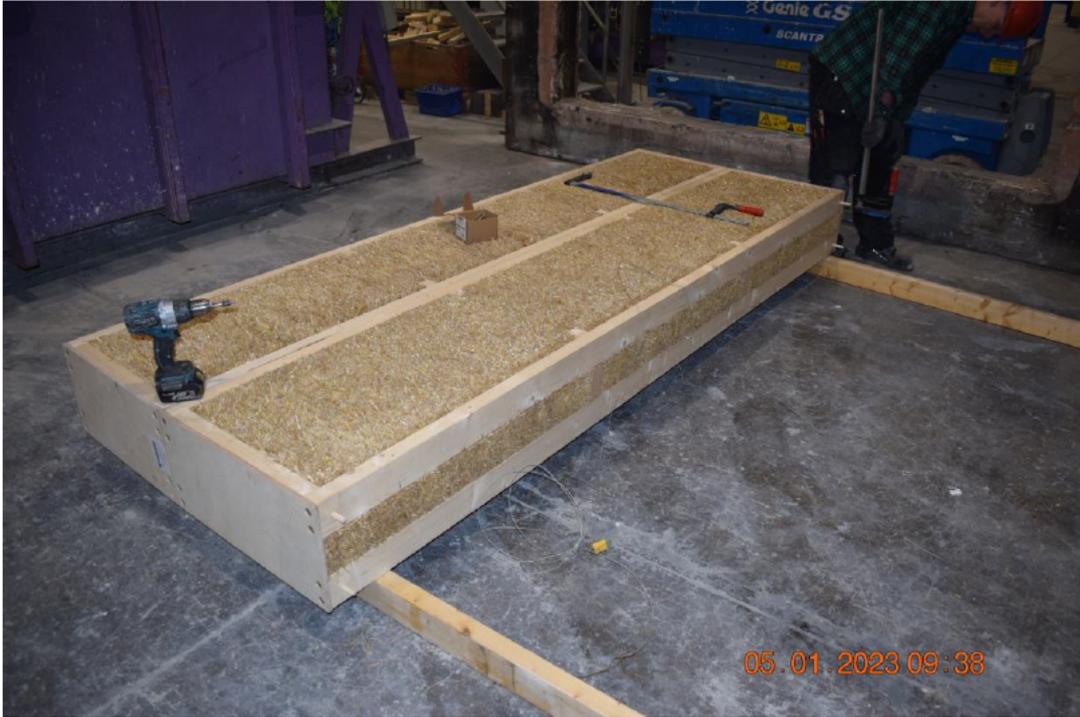
Photo No. 1 Mounting of the first part of the wall assembly
