# TEST REPORT LOADBEARING WALL

<b>Name of sponsor:</b>	Wood:UpHigh		
<b>Product name:</b>	Loadbearing wall		
<b>File no.:</b>	PGA12233A	<b>Revision no.:</b>	1
<b>Test date:</b>	2023-01-11	<b>Date:</b>	12-07-2023
<b>Pages:</b>	11	<b>Encl.:</b>	55
<b>Ref:</b>	JBK / CHB

Subject: Load bearing wall

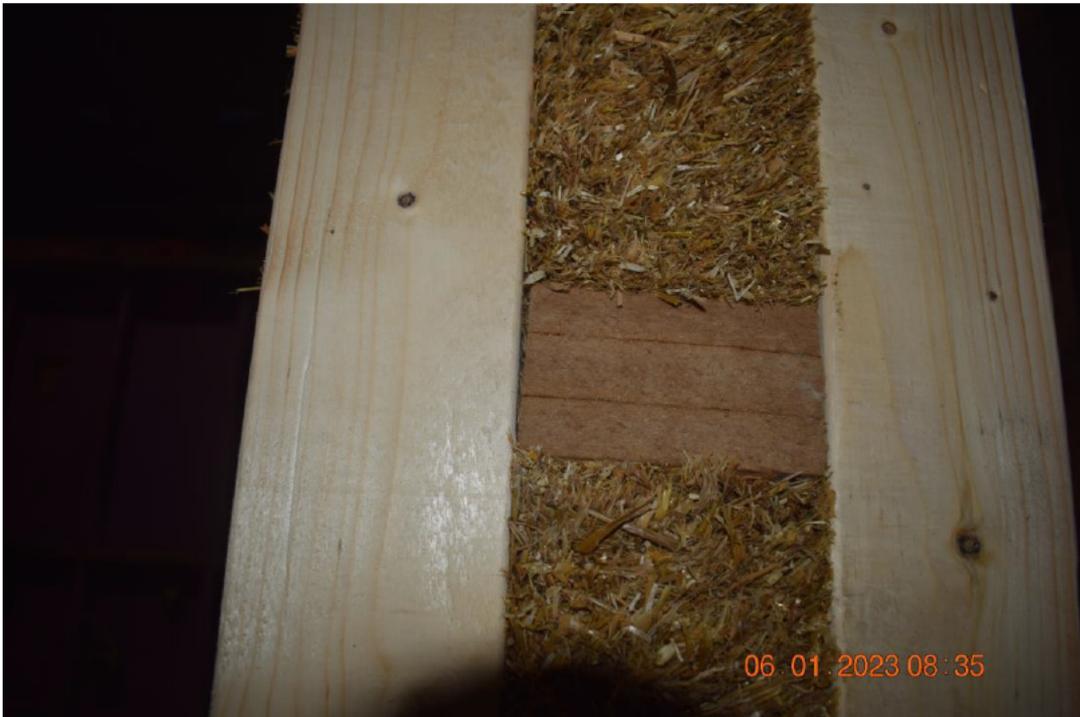
Photo No. 2 Straw insulation between the load bearing studs.

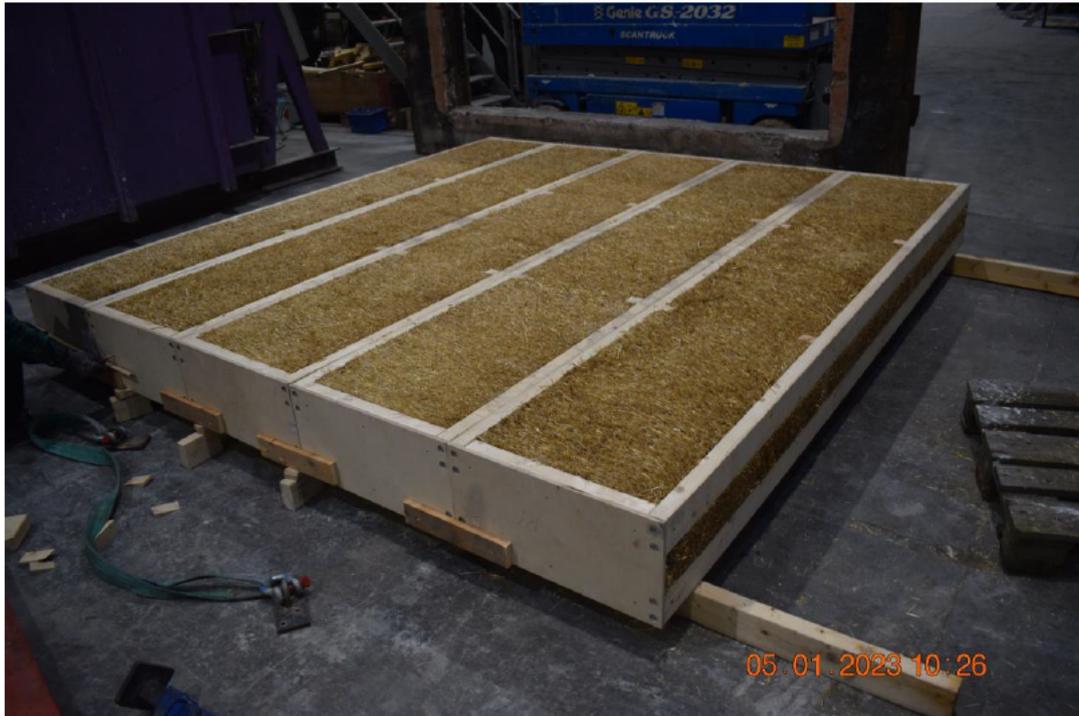
Photo No. 3 Wall element assembly finished.

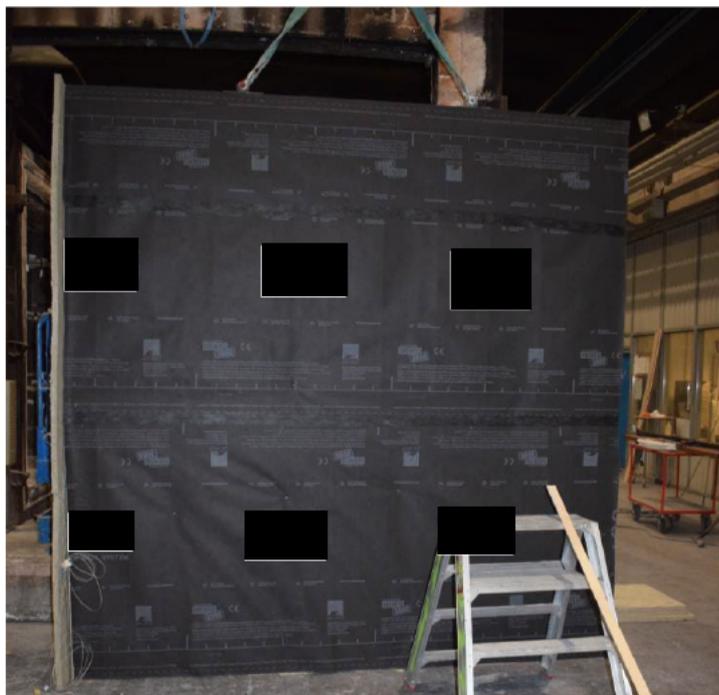
Photo No. 4 Mounting of felt membrane to the unexposed side of the specimen.

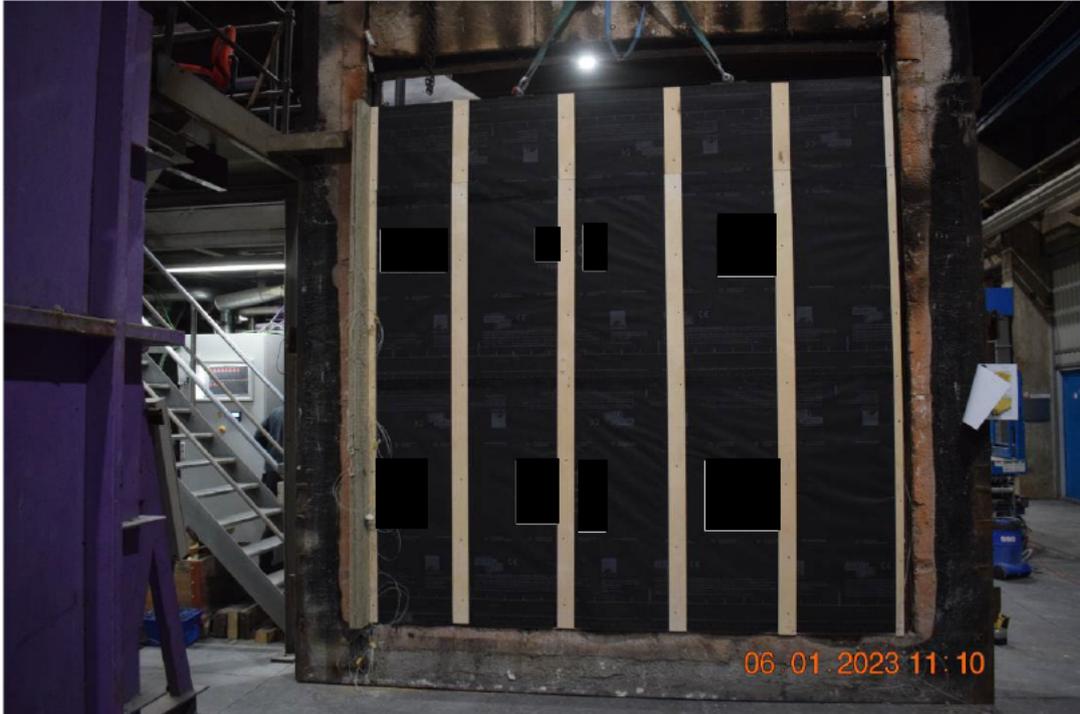
Photo No. 5 Unexposed side finished with wood spacers.

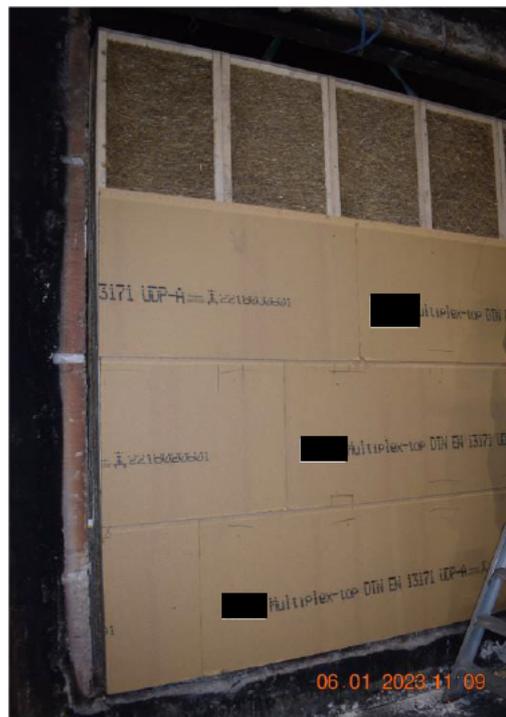
Photo No. 6 Mounting of wood fibre board, exposed side.

Wood fiber board	See sponsor drawing no. 2 and photo no. 6.
Fibre gypsum boards	<p>Two layers of 12.5 mm thick gypsum fibre boards designated [REDACTED] (type EN 15283-2, ETA-03/0050) with a nominal density of 1150 kg/m<sup>3</sup> were fixed with designated [REDACTED] 30 mm at a c/c of 200 mm. The staples were fixed 10 mm from the board edges and 50 mm from the board corners. A full-size board measured 900 x 1200 mm.</p> <p>Approximately 2 mm thick layer of spackle was applied to the joints on the gypsum boards. The designated spackle was [REDACTED].</p> <p>See sponsor drawing no. 4 and photos no. 9 - 10.</p>
<b>Outer layers (unexposed side)</b>	Sarking and roofing felt with monolithic TEEE-Membrane were fixed to the unexposed side of the straw elements with staples. The felt was designated [REDACTED]. The felt consisted of 3 layers and was highly diffusion open $s_d = 0.05$ m and $g$ -value = 0.25 MNs/g.

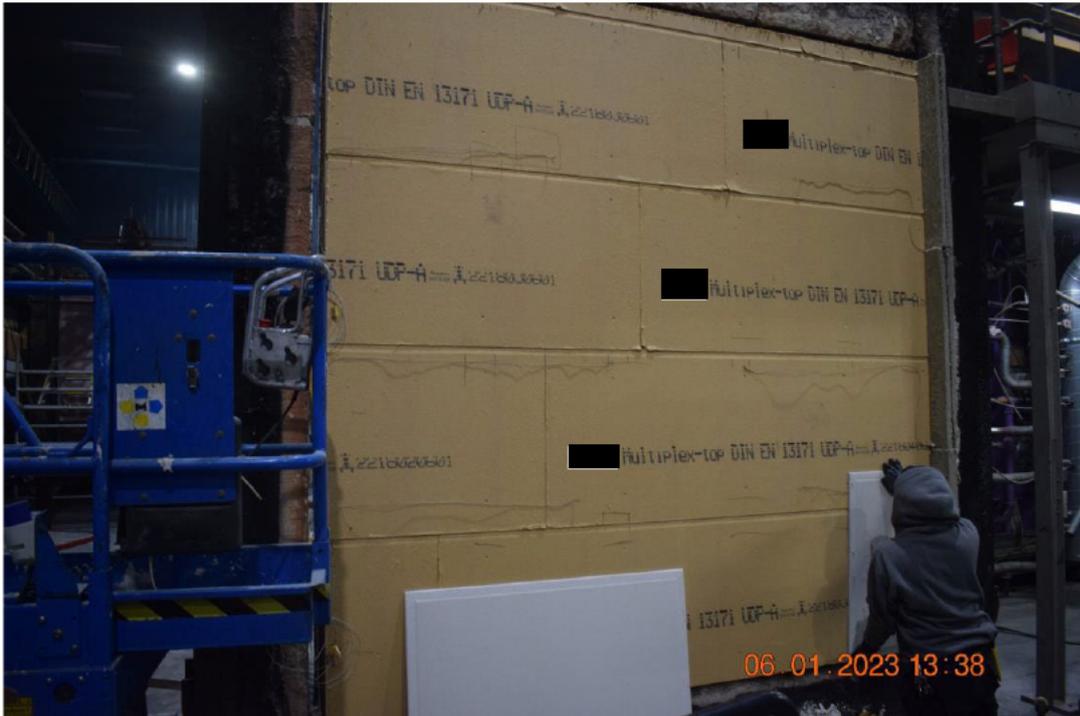
Photo No. 7 Mounting of gypsum boards, exposed side.

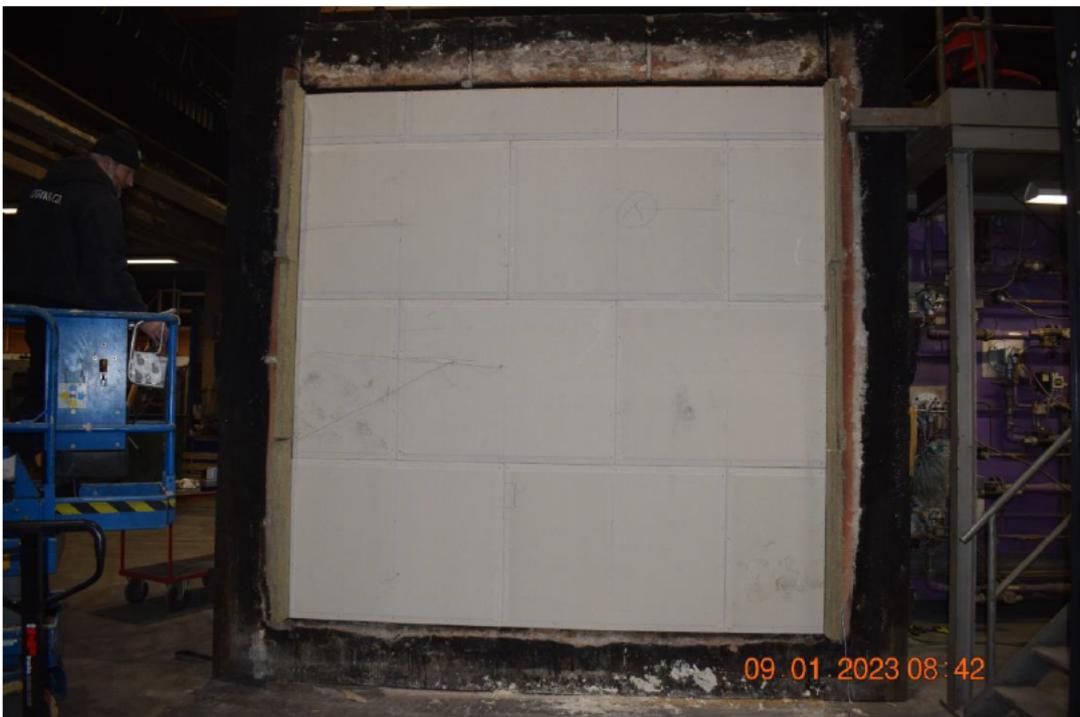
Photo No. 8 Gypsum mounted on exposed side of specimen.

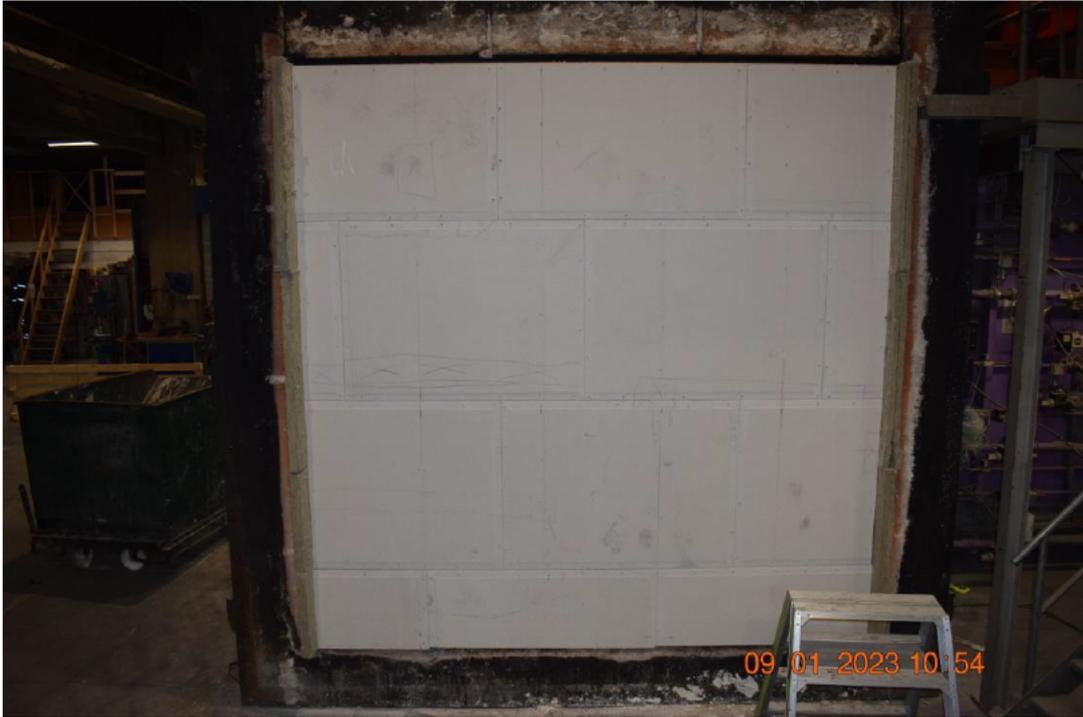
Photo No. 9 Gypsum mounted on exposed side of specimen.

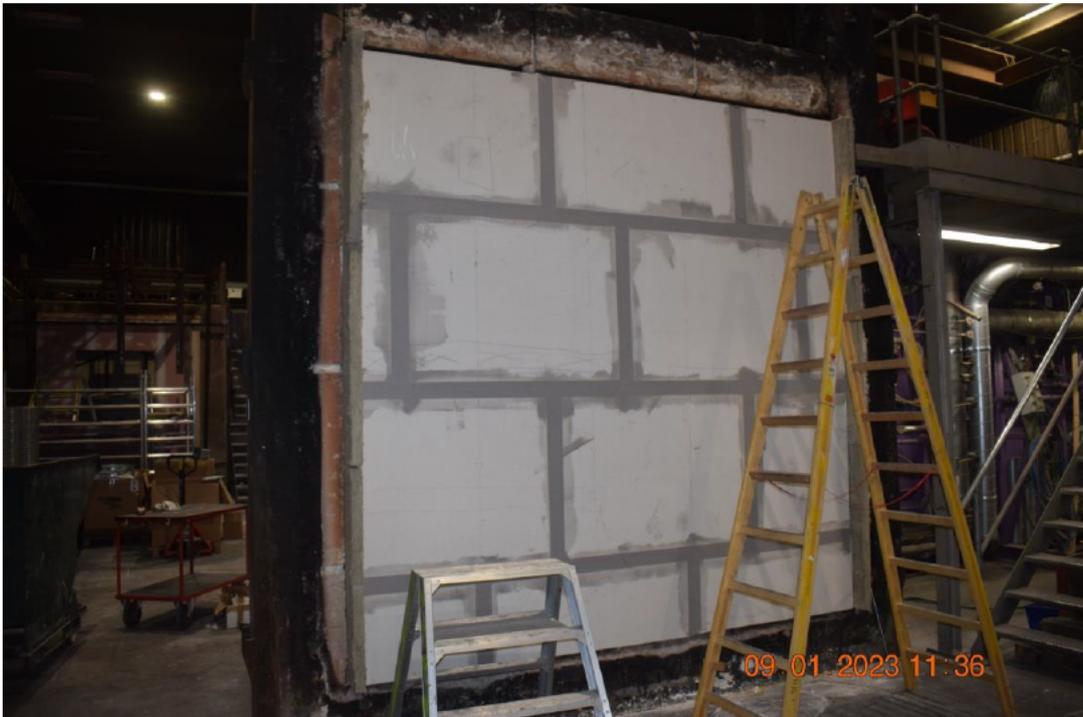
Photo No. 10 Spackle applied over the joints of the gypsum board.

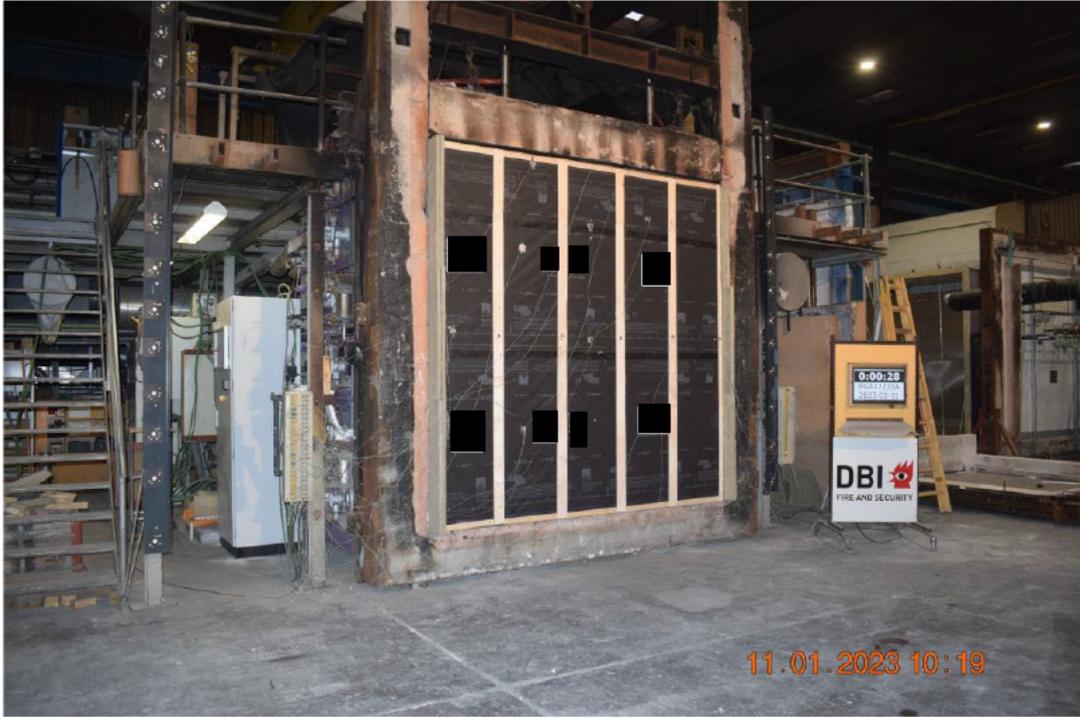
Photo No. 11 Start test.

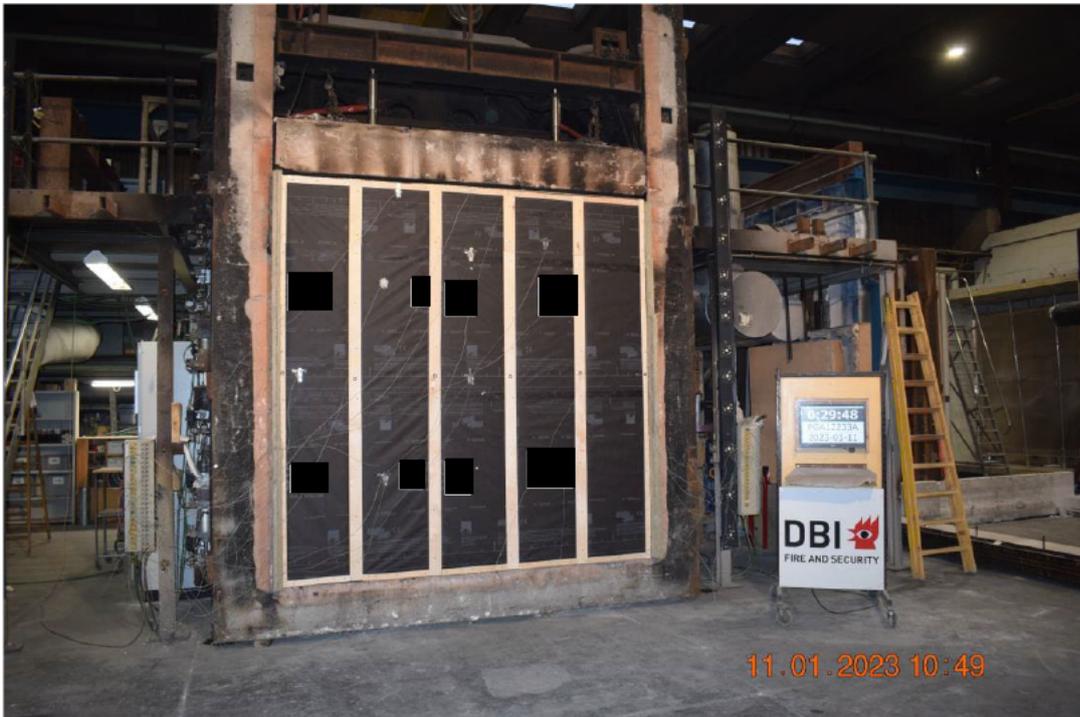
Photo No. 12 Specimen after 30 minutes of testing.

Time / Minutes	Visual observations:	U = Unexposed side E = Exposed side
0	Start	
13	Cracks in the plaster are visible around the edge.	E
20	Cracks are larger on the exposed side between boards	E
28	Faint smoke from the free edge	E
31	Boards are loosening a little along the edge; they are still attached.	E
35	No changes on unexposed side.	U
38	Large vertical cracks in the board along the centerline	E
50	Smoke form right free edge, smoke from left free edge is stopped.	U
51	Both layers of gypsum are cracked with large vertical cracks.	E
53	Outer layer is falling, small pieces of the inner layer is falling down.	E
59	No critical place for cotton	U
60	Cracks in the wood fiber board	E
63	Slight increase in smoke from both the free edges	U
64	The smoke decreased from both free edges	U
69	Straw elements are exposed in places	U
71	No change on unexposed	U
78	Liquid is running down the construction	U
79	Very faint smoke from the bottom right panel	U

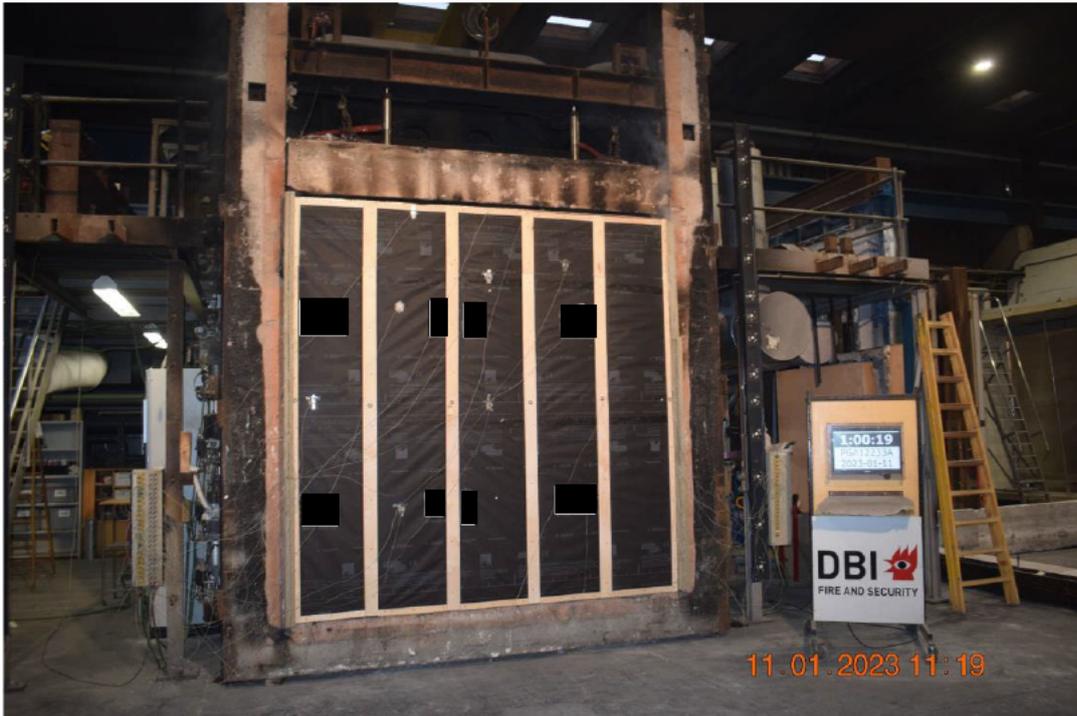
Photo No. 13 Test specimen after 60 minutes of testing.

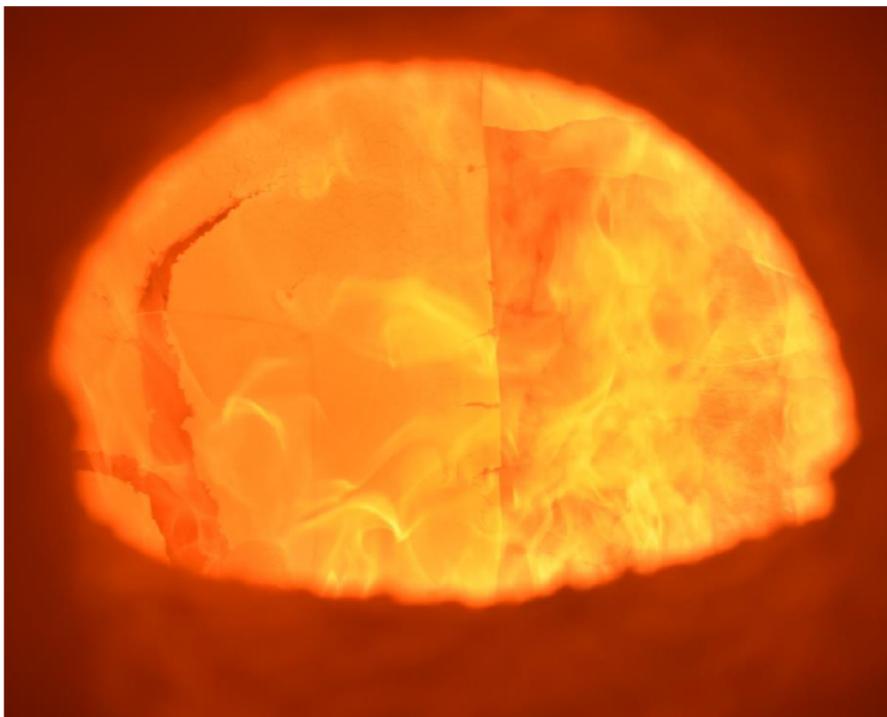
Photo No. 14 Exposed side of specimen after 90 minutes of testing.

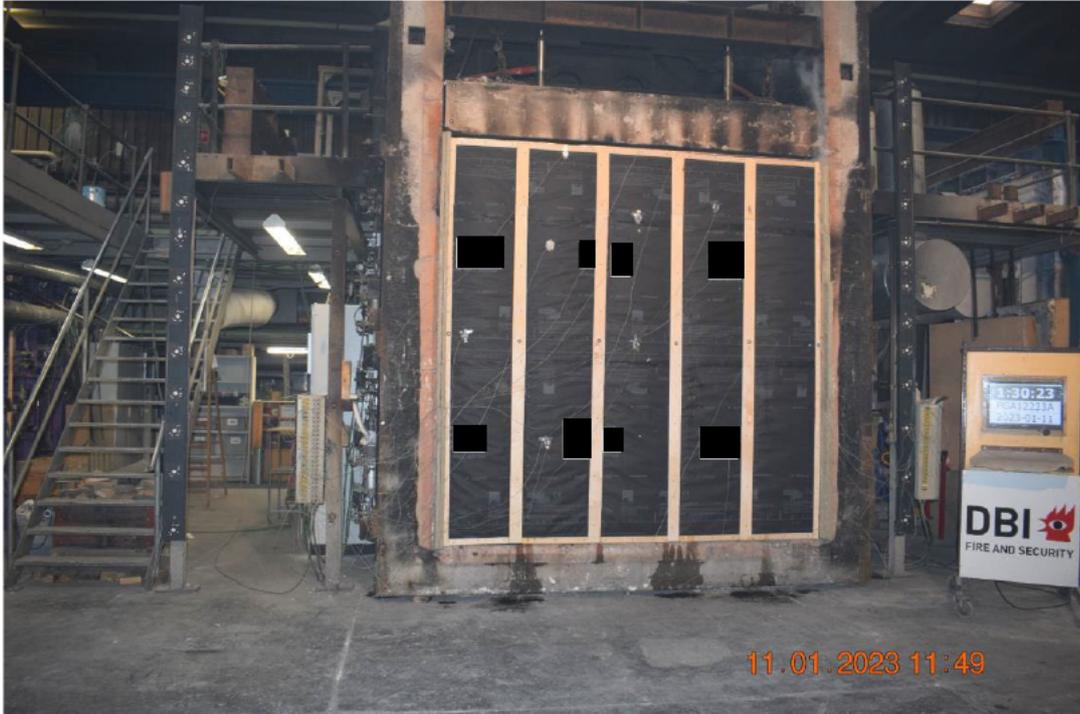
Photo No. 15 Unexposed side after 90 minutes of testing. Liquid is starting to run down the bottom of the specimen.

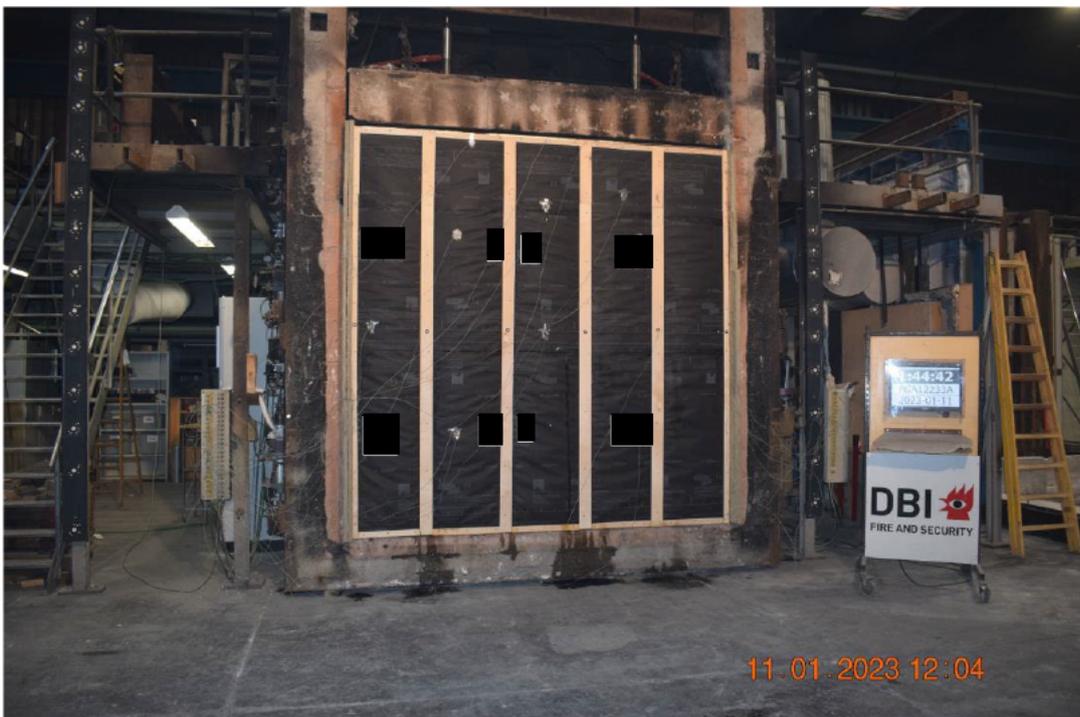
Photo No. 16 Specimen after 104 minutes of testing.

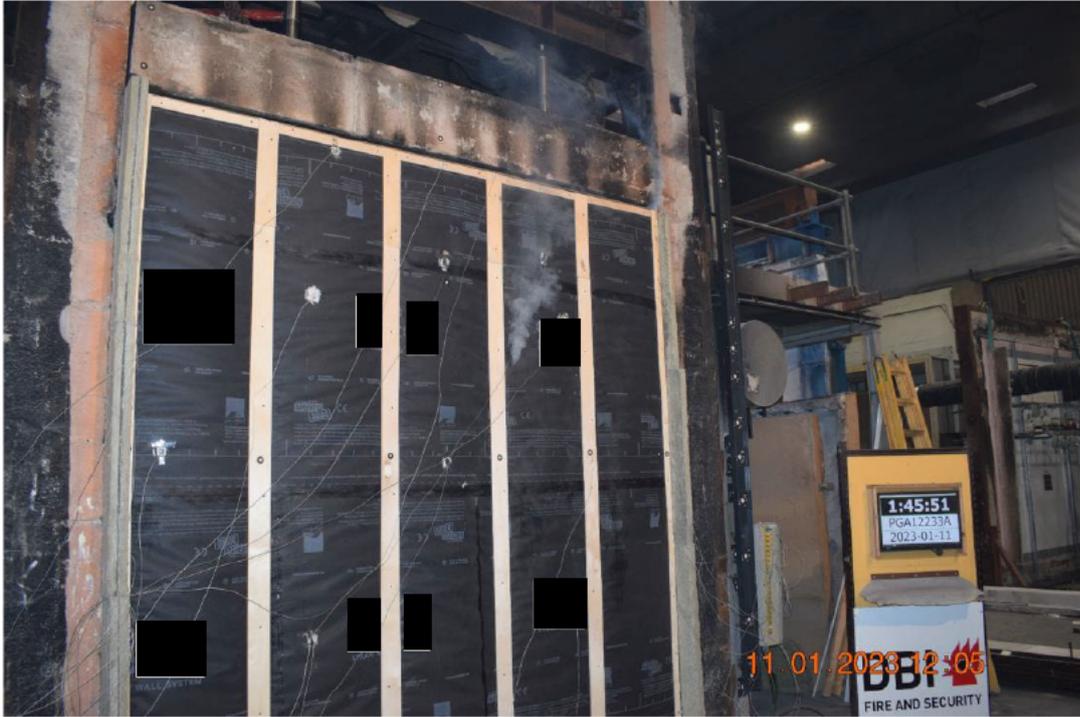
Photo No. 17 Specimen after 105 minutes of testing, starting to smoke form unexposed side of specimen.

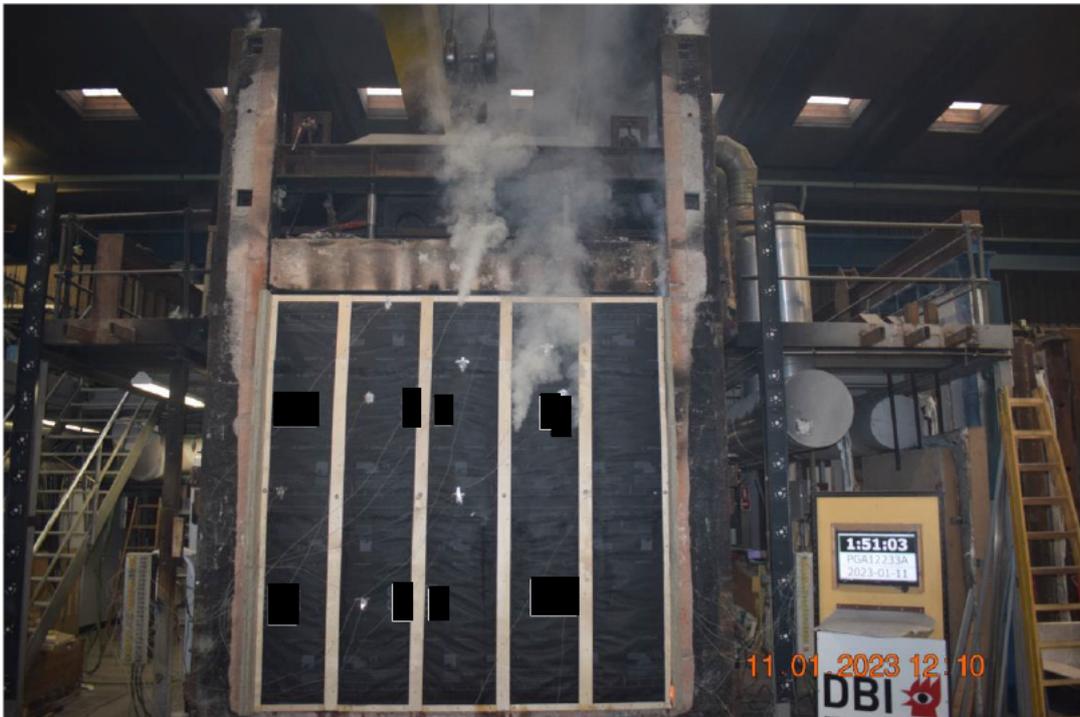
Photo No. 18 Specimen after 111 minutes of testing, more smoke form unexposed side of specimen mid and top.

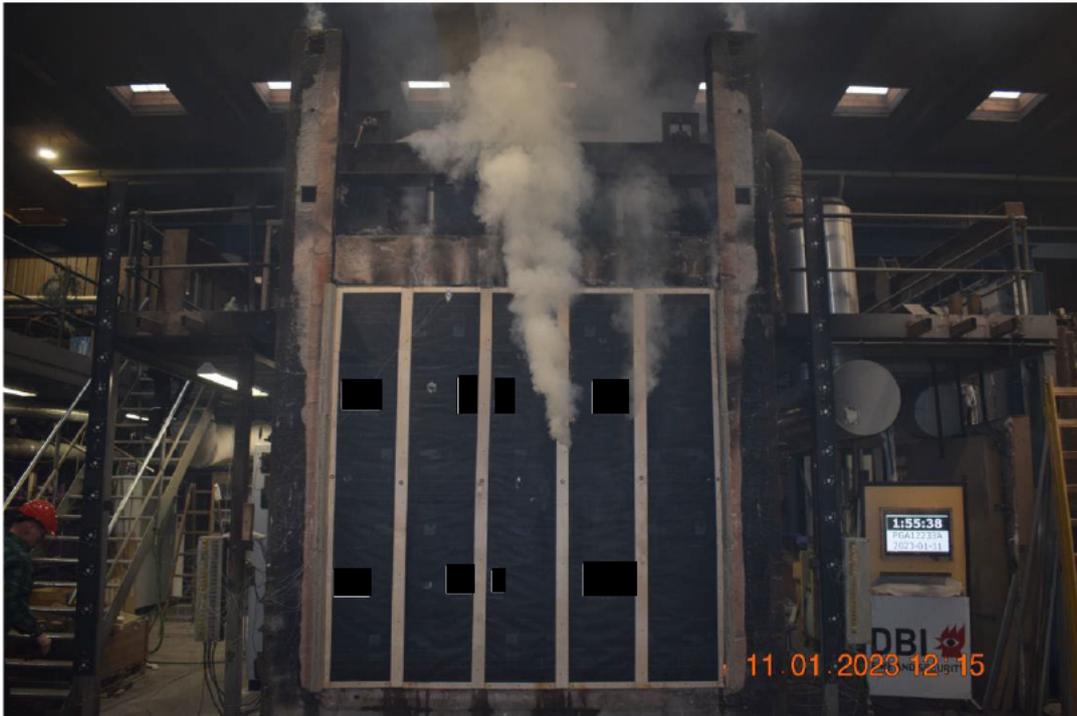
Photo No. 19 Test ended after 114 minutes of testing.

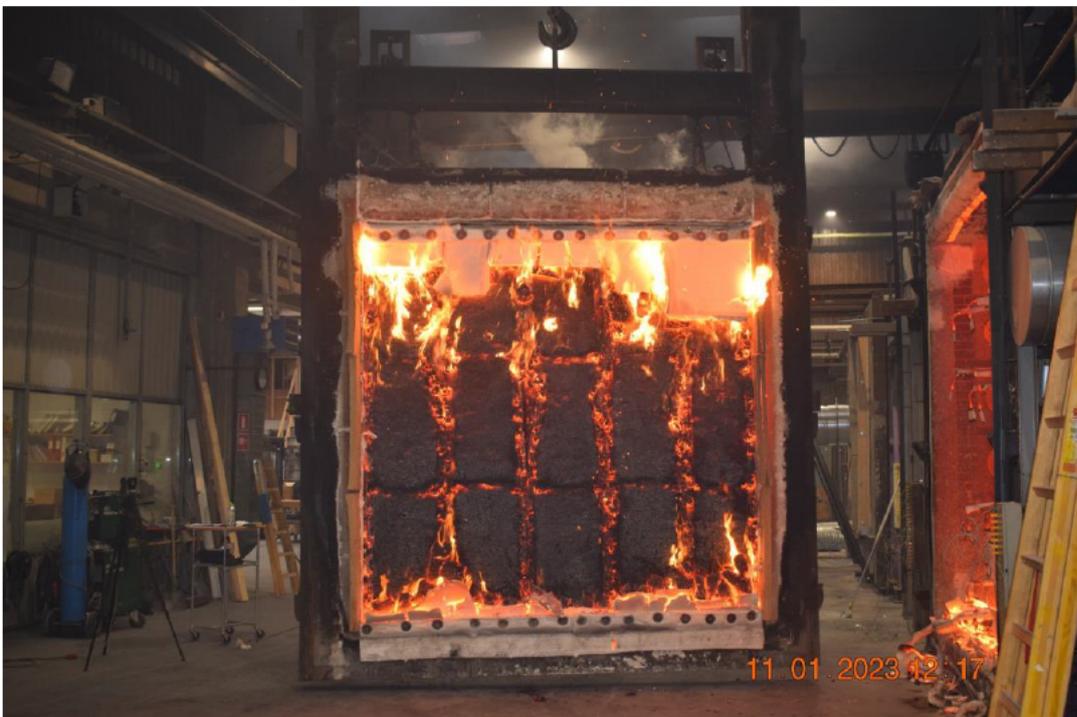
Photo No. 20 Exposed side after test ended.

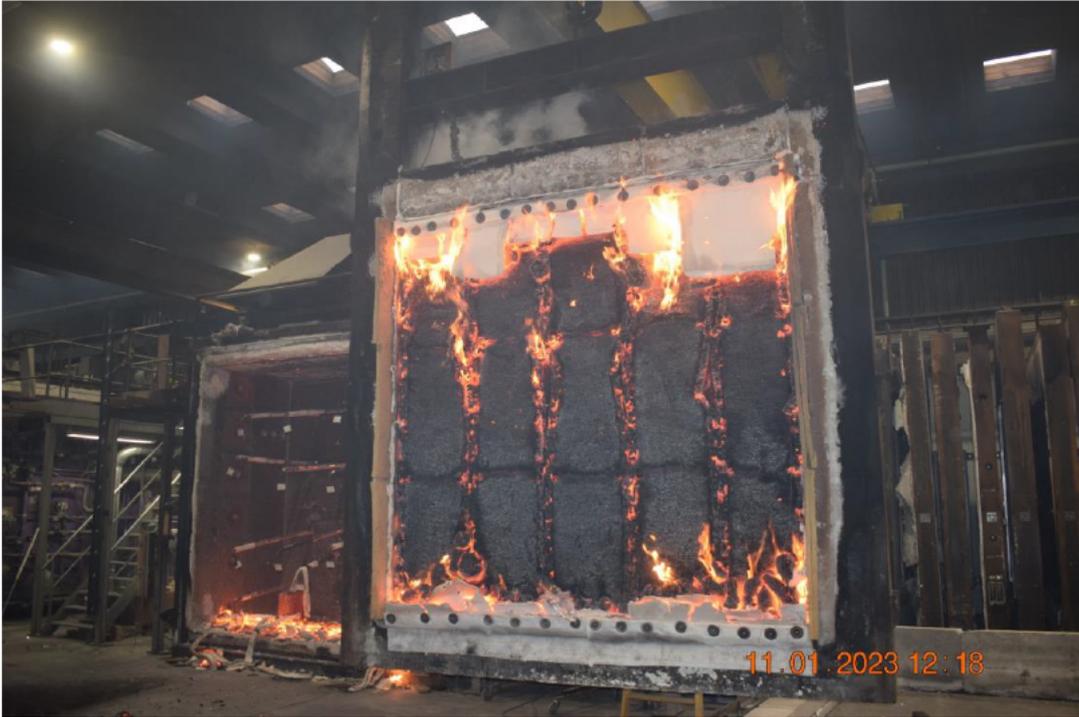
Photo No. 21 Unexposed side after test ended.
