TEST REPORT EU FACADE TEST 4

| Product name: | EU facade test draft 6 | | |
| File no.: | PGC10028A | Revision no.: | 1 |

Examination of the fire performance of a façade using the large fire exposure.

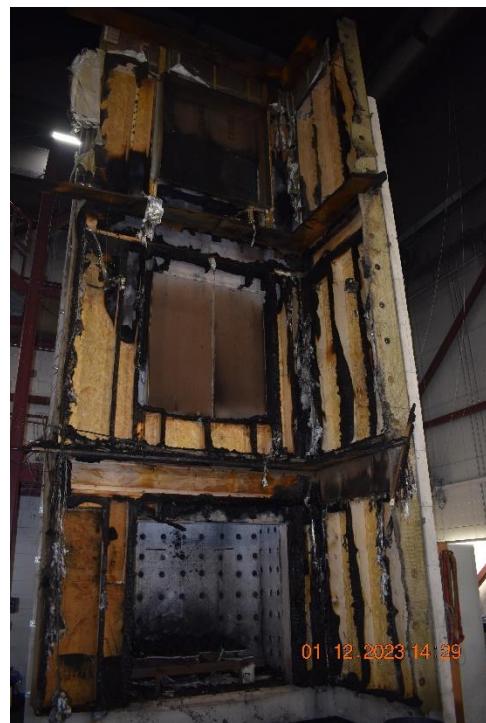
Photo No. 30 Test specimen 56 minutes into the test.

| 56 | Approx. 30 x 10 cm piece dropped on the floor and continue burning |

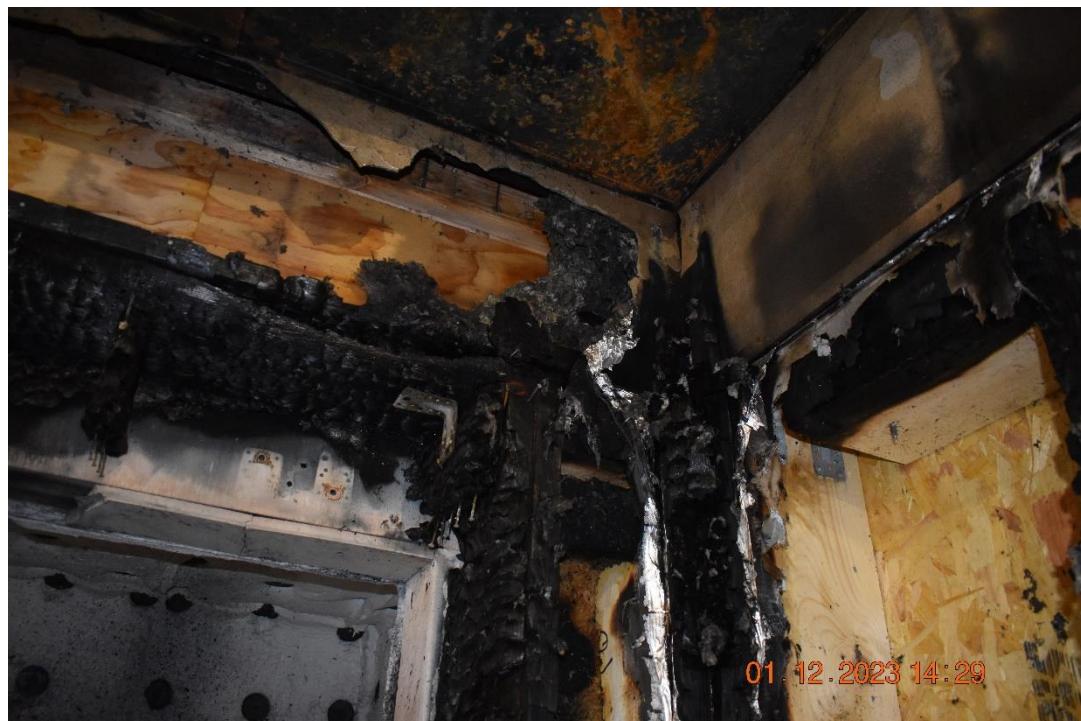
Photo No. 32 Test specimen after the test. Detailed photo of the top of fire chamber.

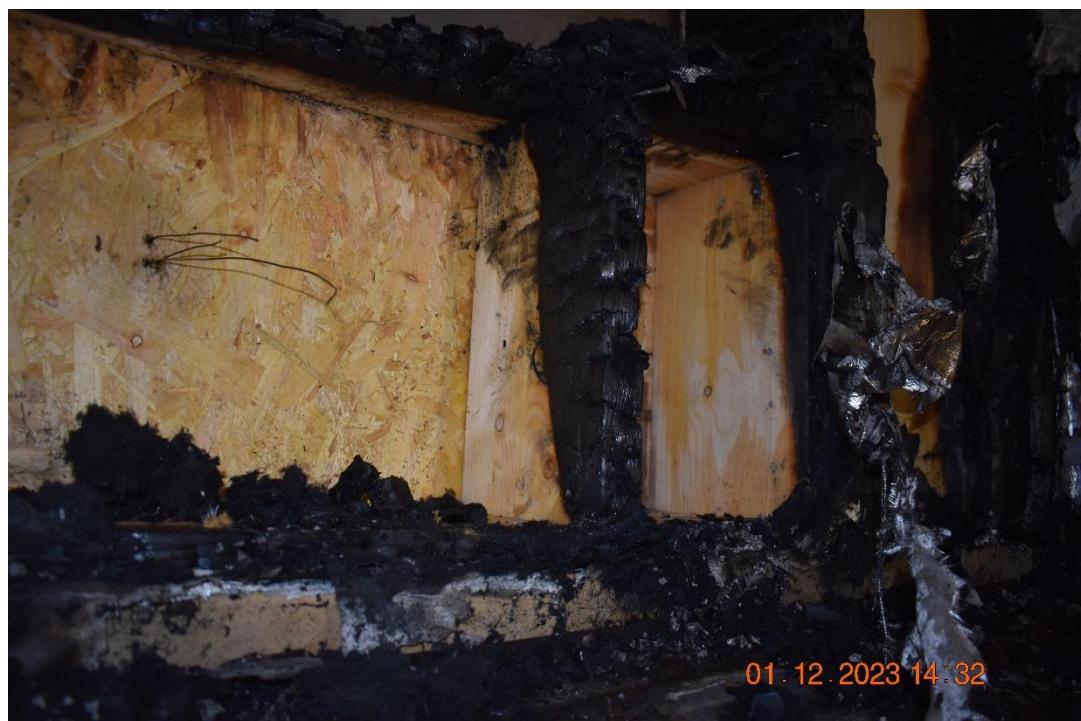
Photo No. 33 Test specimen after the test. Corner below the first flame deflector.

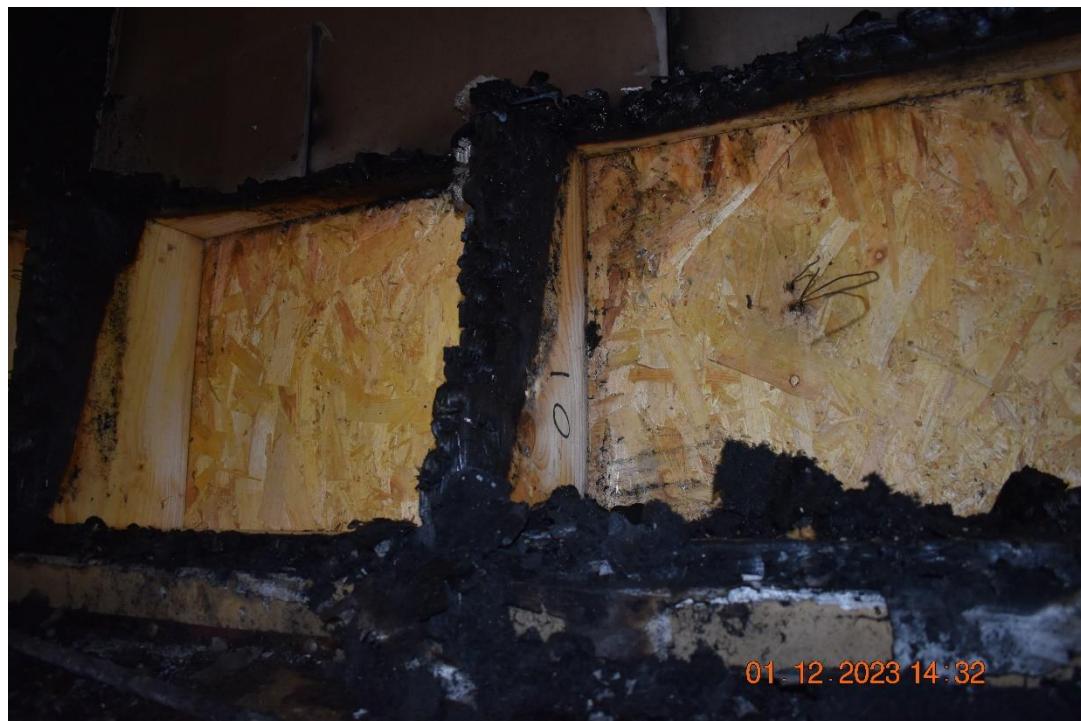
Photo No. 34 Test specimen after the test. Corner above the first flame deflector.

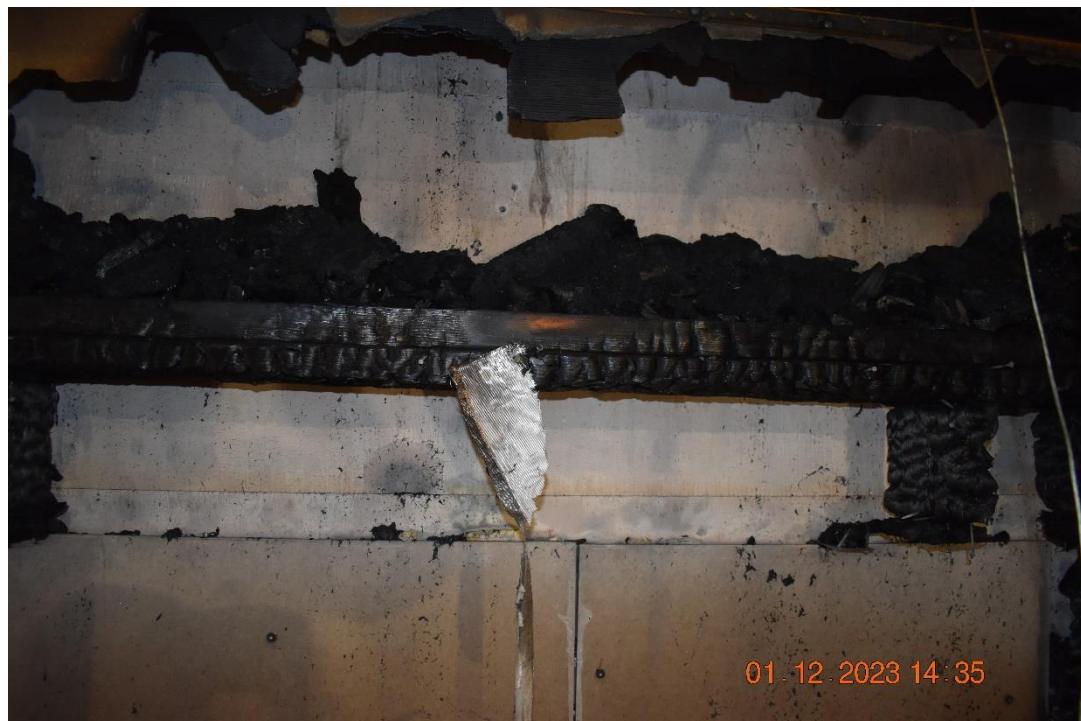
Photo No. 36 Test specimen after the test. Corner below the second flame deflector.

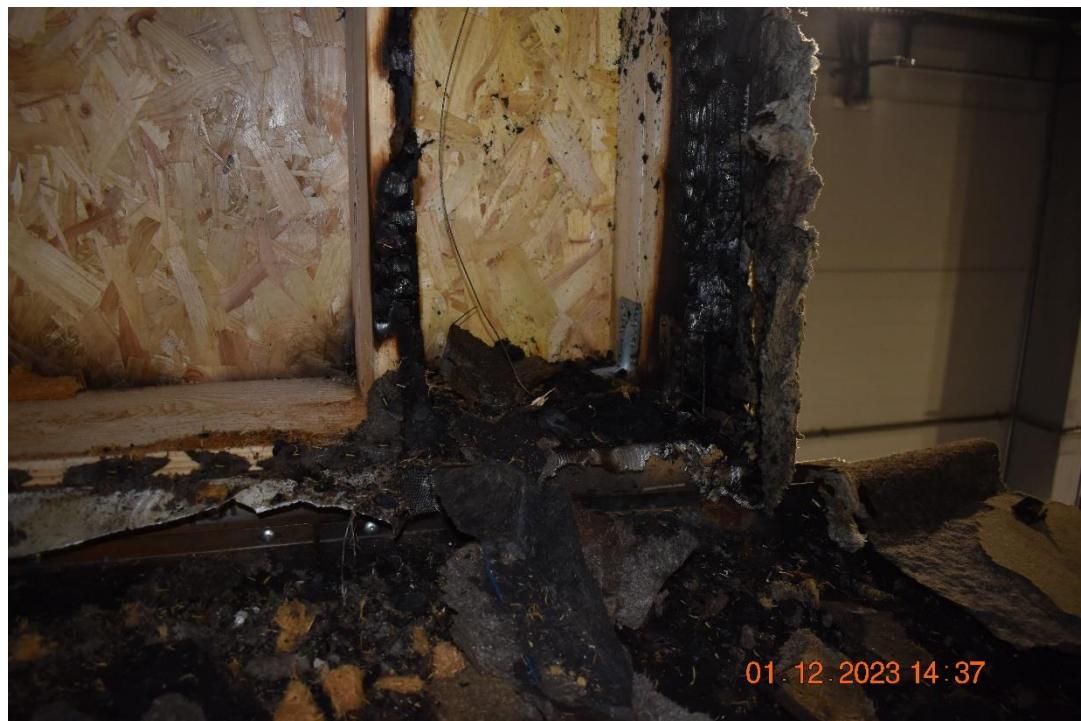
Photo No. 38 Test specimen after the test. Corner below the second flame deflector.
